### 3.0 Southgate Watershed

#### 3.1 General Description

### 3.2 Potential Watershed Restoration/Project Sites

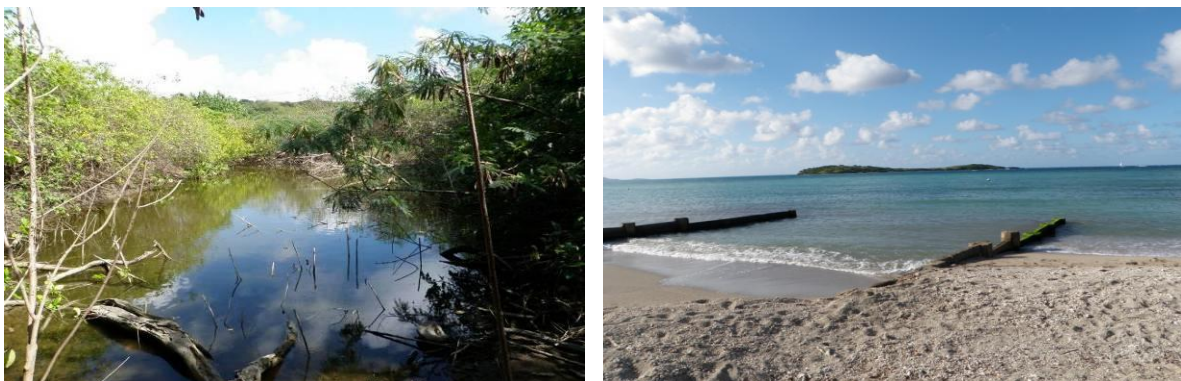
**Figure 3.2.** East gut below East End Rd. culvert (left) and at the discharge location between the Chenay Bay Resort and Southgate Pond (right). Green Cay NWR can be seen in the distance.

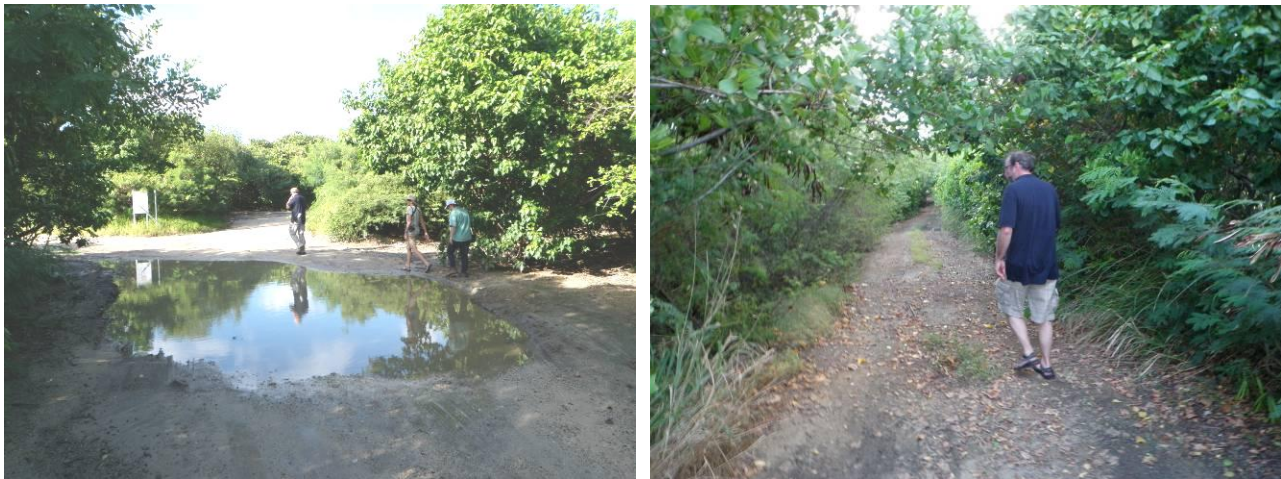
### *Southgate Pond Preserve*

According to the St. Croix Environmental Association, there are a number of restoration activities being pursued at the Preserve including: 1) Raising the existing embankment which separates Southgate Pond from the marina, 2) removing the existing building near East gut, and 3) installing permeable pavers on the entrance road and relocated parking area (Figure 3.4). Raising the embankment is intended to increase capacity of the pond and help expand fringing vegetation and associated habitat. Reconnecting the floodplain of the East gut on the Preserve property may also be a restoration opportunity.

**Figure 3.4.** Standing water in the current road/parking area (left); the embankment (right).

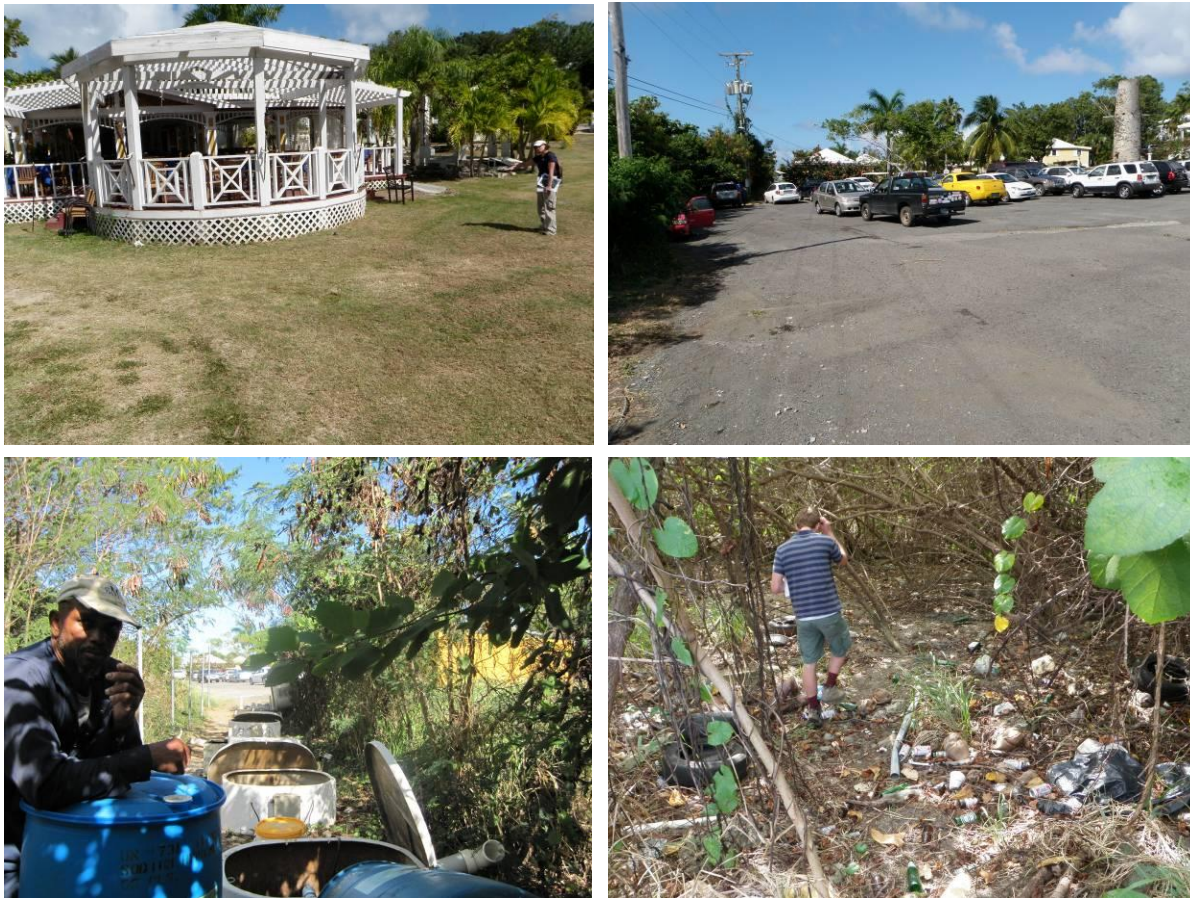
### *Chenay Bay Hotel (SG-R-20)*

The wastewater system, parking lot, and lawns directly abut the East gut, and in some cases are within 25-feet from the wetland resource. There is a lot of trash and debris in the wetland. Very little erosion was found at the site; however, two locations for potential stormwater retrofits were identified including at the paved parking lot and near the restaurant, as well as trash and buffer management recommendations (Figure 3.5).

**Figure 3.5.** Two locations to capture and treat stormwater runoff (top); active upgrade of wastewater system (bottom, left); and trash/debris in adjacent wetland (bottom, right).

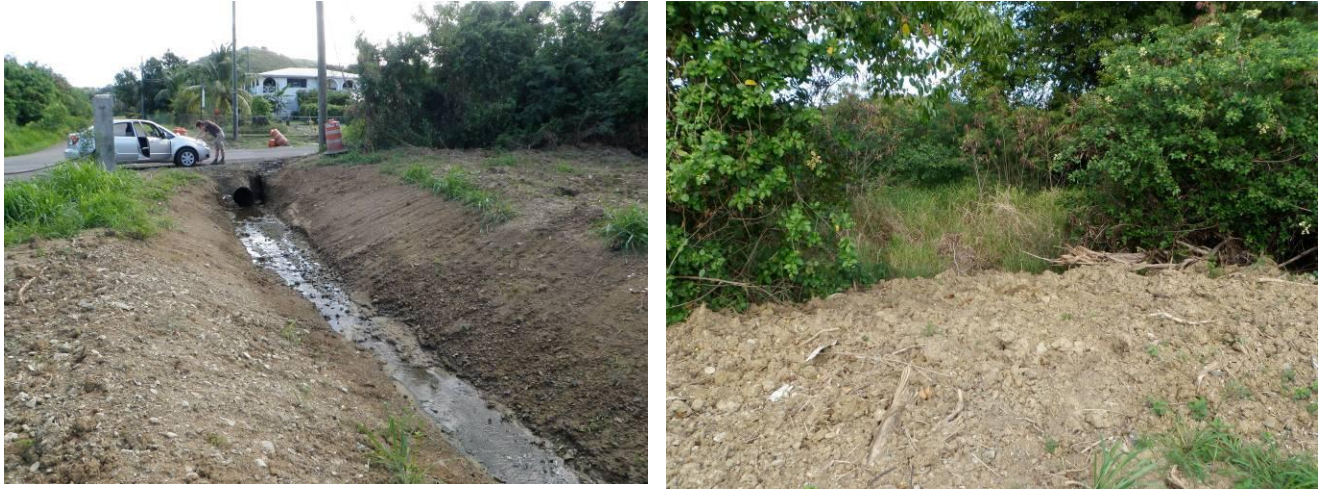
#### *South Shore Rd./Tipperary New Culverts(SG-RC-31/32)*

excavated to expedite flow to the nearest gut/wetland. There was a missed opportunity to install water quality structures into the design, such as a sediment forebay or check dams. The outfall was not stabilized with riprap. Exposed soils, channel bottom, and sideslopes were not stabilized to prevent erosion. In addition, buffer vegetation was cleared up to the wetland boundary and no protective sediment barriers were installed to prevent sediment from migrating into the wetland vegetation (Figure 3.6).

**Figure 3.6.** Missed opportunity to demonstrate water quality designs and proper soil stabilization techniques at newly installed culverts.

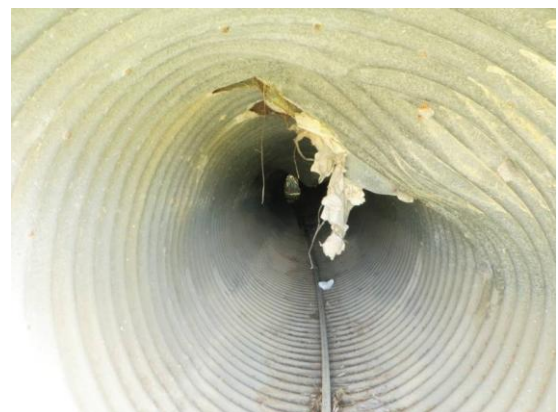
### *Seven Seas Culvert (SC-R-2)*

Across the street from Cheeseburgers is the entrance drive to the Seven Seas Water Supply Company. The culvert under this driveway is a large, 36-inch corrugated metal pipe capturing a significant amount of drainage area. On inspection, it was noticed that there is pipe failure below the driveway (Figure 3.11).

**Figure 3.11.** Pipe failure evidenced in culvert.

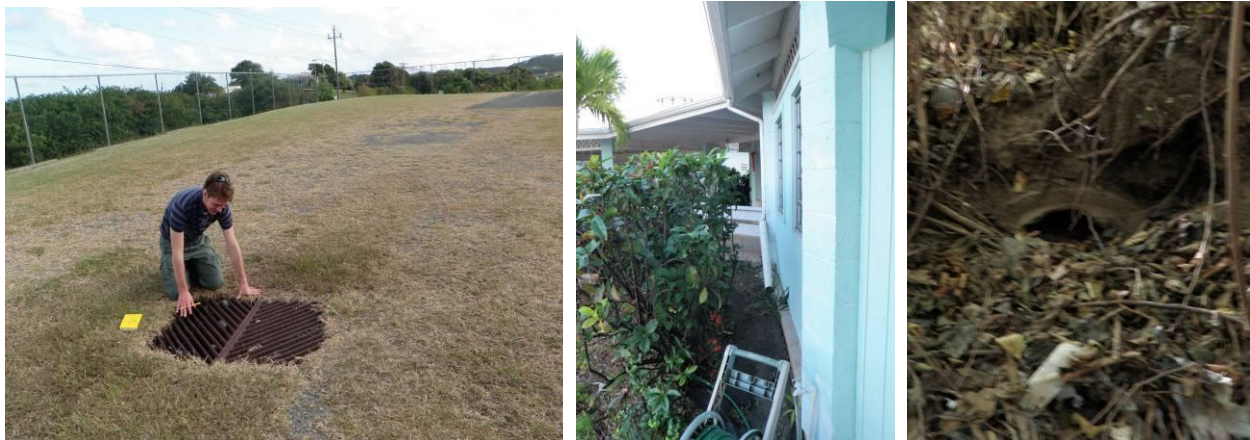
### *Southgate Baptist Church (SG-R-6, SG-RC-20)*

There was no evidence of erosion in the gravel/grassed parking lots, around the basketball court, or along the site entrance. There are two large drain inlets in the lower parking lot that drain directly to the blocked/corroded culvert along East End Rd. (SG-RC-20). The lower parking lot sits above/behind a large concrete revetment along East End Rd. and appears to have been originally gravel, but now has extensive grass cover. Rooftop runoff is primarily collected in cisterns with the exception of a downspout at the entryway to the property, which could easily be converted into a demonstration rain garden (Figure 3.12). The Church could provide a convenient meeting location for watershed meetings. The area around the basketball court may be suitable for tree planting.

**Figure 3.12.** Drain inlet in lower parking lot (left); downspout to existing flowerbed that could be converted to a rain garden or collected for irrigation (middle); almost completely blocked culvert (right).
