5.0 Teague Bay Watershed

5.2 Potential Watershed Restoration/Project Sites

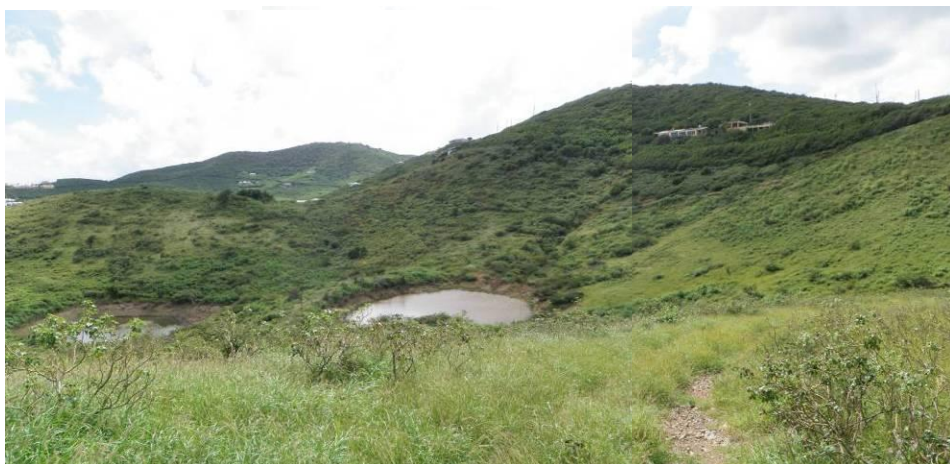
Skov Goat Farm Ponds (TB-ID)

The Skov property is undeveloped, except for the houses/structures at the top of the driveway and barns/sheds housing the goats. The issues identified for this property consisted of accelerated erosion from a gut draining into the upper pond (see Figure 5.2). In addition, while

the vegetation on the property is clearly affected by the grazing of the goats, erosion of the property itself appeared to be minimal. The farm ponds have limited capabilities to hold water, with the down-gradient pond being more permeable the up-gradient pond. Future management would require installation of either a clay or synthetic liner. There has been previous discussion on techniques to better manage erosive hillside runoff from Buena Vista Rd. by stabilizing drainage outlets and installing erosion control checks along the flow path.

Figure 5.2. Skov farm ponds. The pond on the left is leaking, the one on the right is receiving sediment from hillside erosion.

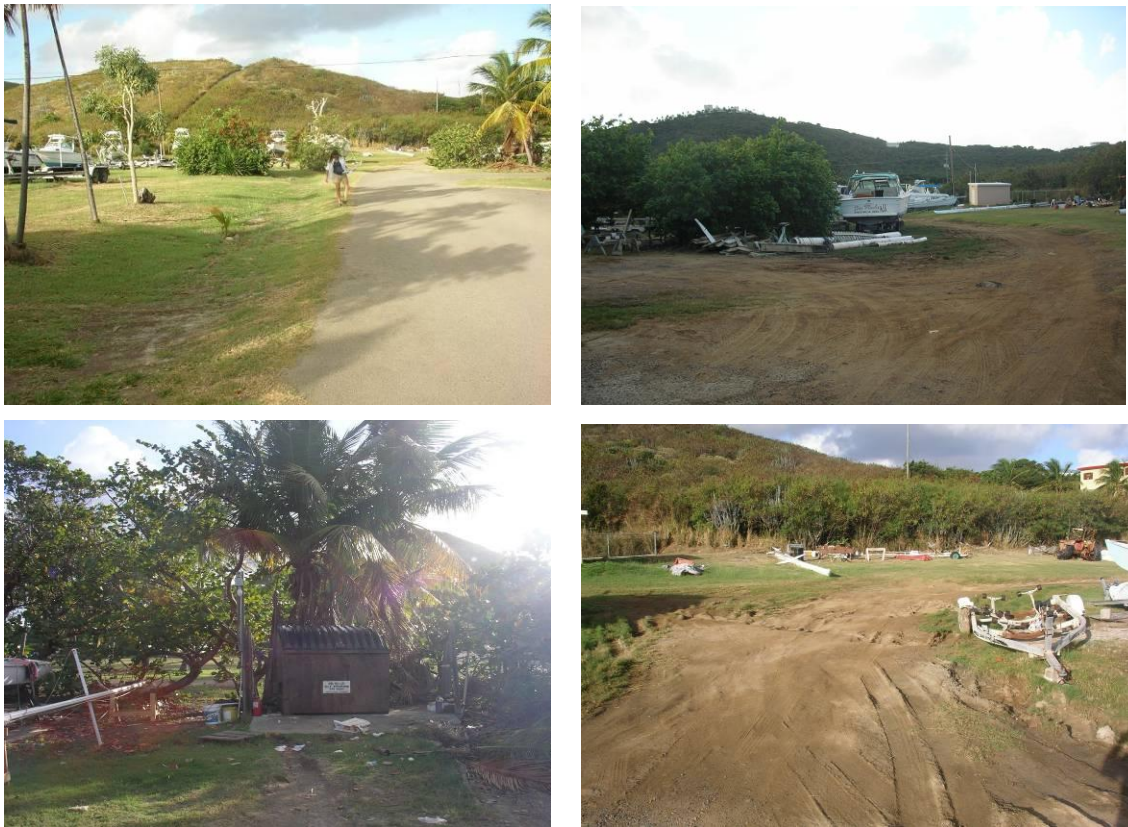
St. Croix Yacht Club (TB-R-2)

The St. Croix Yacht Club is located on the north side of Route 82 on Teague Bay. A clubhouse and storage shed are located along the beach front. The paved entry drive leads to four paved parking bays, all with turf parking spaces. The areas surrounding the clubhouse and parking lot are designated for boat storage and maintenance activities and are primarily in turf with eroded, unimproved dirt roadways. Stormwater currently drains from the roadway and other up-gradient areas over-land through the boat storage and parking space to a channel immediately west of the clubhouse. Trash, debris, and significant erosion exposed soils were observed. The eroded areas and exposed soils could be restored and stabilized with soil amendments or gravel (Figure 5.4). The construction of a road-side swale would facilitate the flow of runoff into a proposed sediment forebay structure adjacent to the existing gut channel. The sediment forebay would increase the on-site stormwater storage capabilities and greatly improve water quality by reducing the amount of sediment and marine/boat associated toxins and debris reaching the nearshore waters.

Figure 5.4. Drainage from a large portion of the watershed comes through this swale (top left); Stormwater flows overland across unvegetated/muddy boat storage/parking areas (top right and bottom photos).

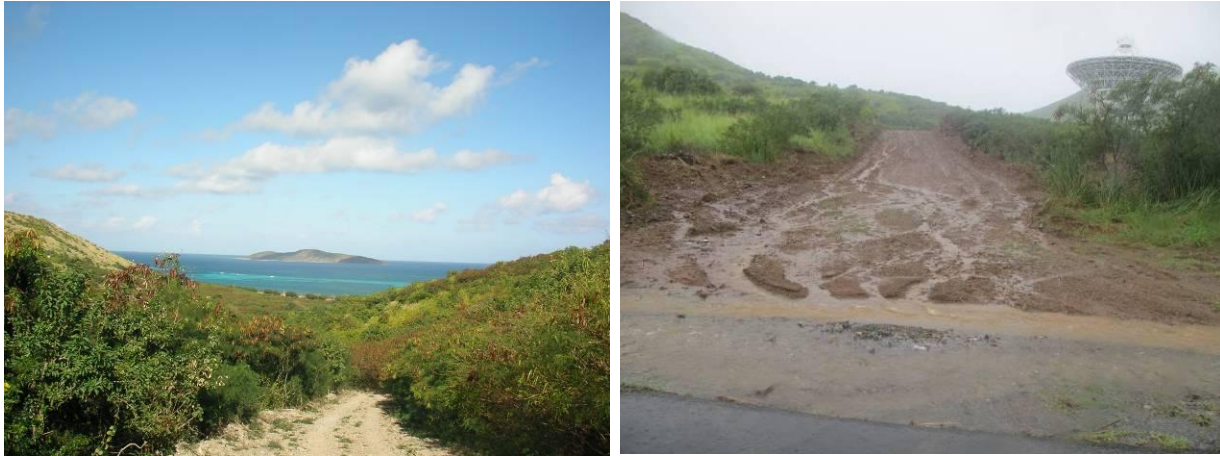
Goat Hill Rd./TNC (TB-RC-4)

Goat Hill Rd. is located along the south side of East End Rd. (Rt. 82) across from Cramer Park and immediately east of the base array telescope located on lands owned by The Nature Conservancy (TNC). Goat Hill Rd. begins at the base of the hill on East End Rd. and traverses up the hill through a series of switchbacks up and over the ridge line. The road is an unimproved dirt roadway. The base of the road is owned by the Department of Housing, Parks, and Recreation and the remainder (after the first hill break) is owned by TNC. Unauthorized road maintenance and access improvements were conducted by others in the fall of 2010. This resulted in substantial widening of the road to nearly twice its previous width and the creation of a dirt/gravel berm on the valley side of the roadway. This berm prevents stormwater from flowing off the road and instead directs it within the graded area of the road. Large portions of the road are highly eroded with deep ruts and gullies. At the base of the road, stormwater generally flows west into a shallow swale and then into a concrete swale that crosses East End Rd. to Cramer Park. This road may serve as a primary source of sediment into Cottongarden Bay (Figure 5.6).

Figure 5.6. View of Cottogarden Bay from the Goat Hill Rd. (left); the base of Goat Hill Rd. (photo courtesy of TNC and UVI) (right).

A series of minor, low maintenance improvements could be conducted along Goat Hill Rd. Multiple water bars and outlets (i.e., breaches in the dirt berm on the road shoulder) would

reduce the velocity of the water and redirect flows into the forested valley for infiltration and sediment attenuation. This would also alleviate the potential for flooding and pooling at the base of Goat Hill Rd. along East End Rd.

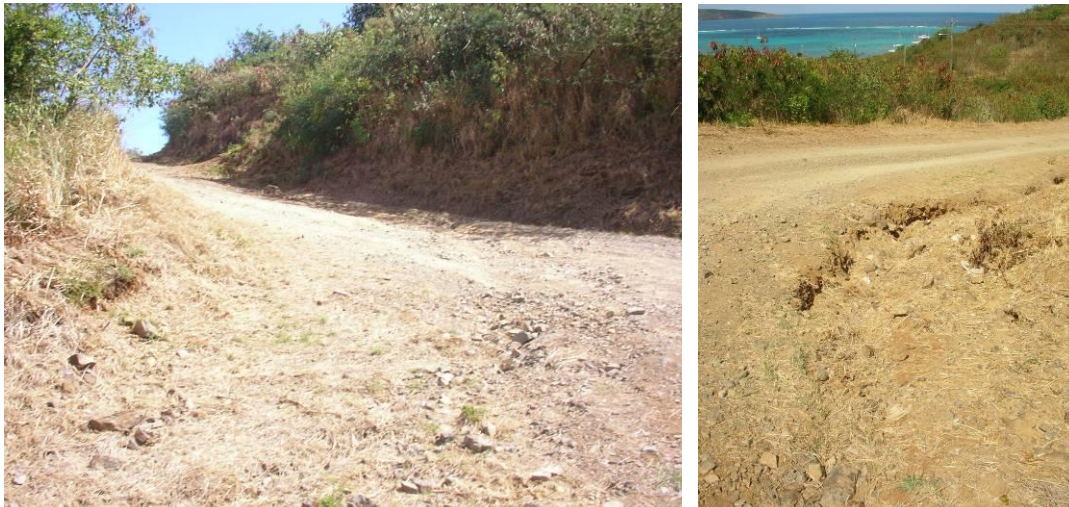
Ridge Rd. at East End Rd. (TB-RC-3)

The lower portion of Ridge Rd. immediately off East End Rd. (east of Reef Golf) is unpaved and severely eroding along the first segment of road up to the first switchback (Figure 5.6). Sediment was observed to be accumulating at the base of Ridge Rd. at East End Rd. This section of Ridge Rd. is a candidate for paving to alleviate erosion. The remainder of Ridge Rd. (up-gradient) is paved. The installation of water bars or paving are options to control the flow of runoff and reduce erosion.

Figure 5.7. Gullying and erosion observed along Ridge Rd.
