Reduction and control of sediment-laden runoff near critical coral reef and other coastal ecosystems through the implementation of BMPs in Culebra, Puerto Rico FY-2016

FINAL REPORT
August 2017

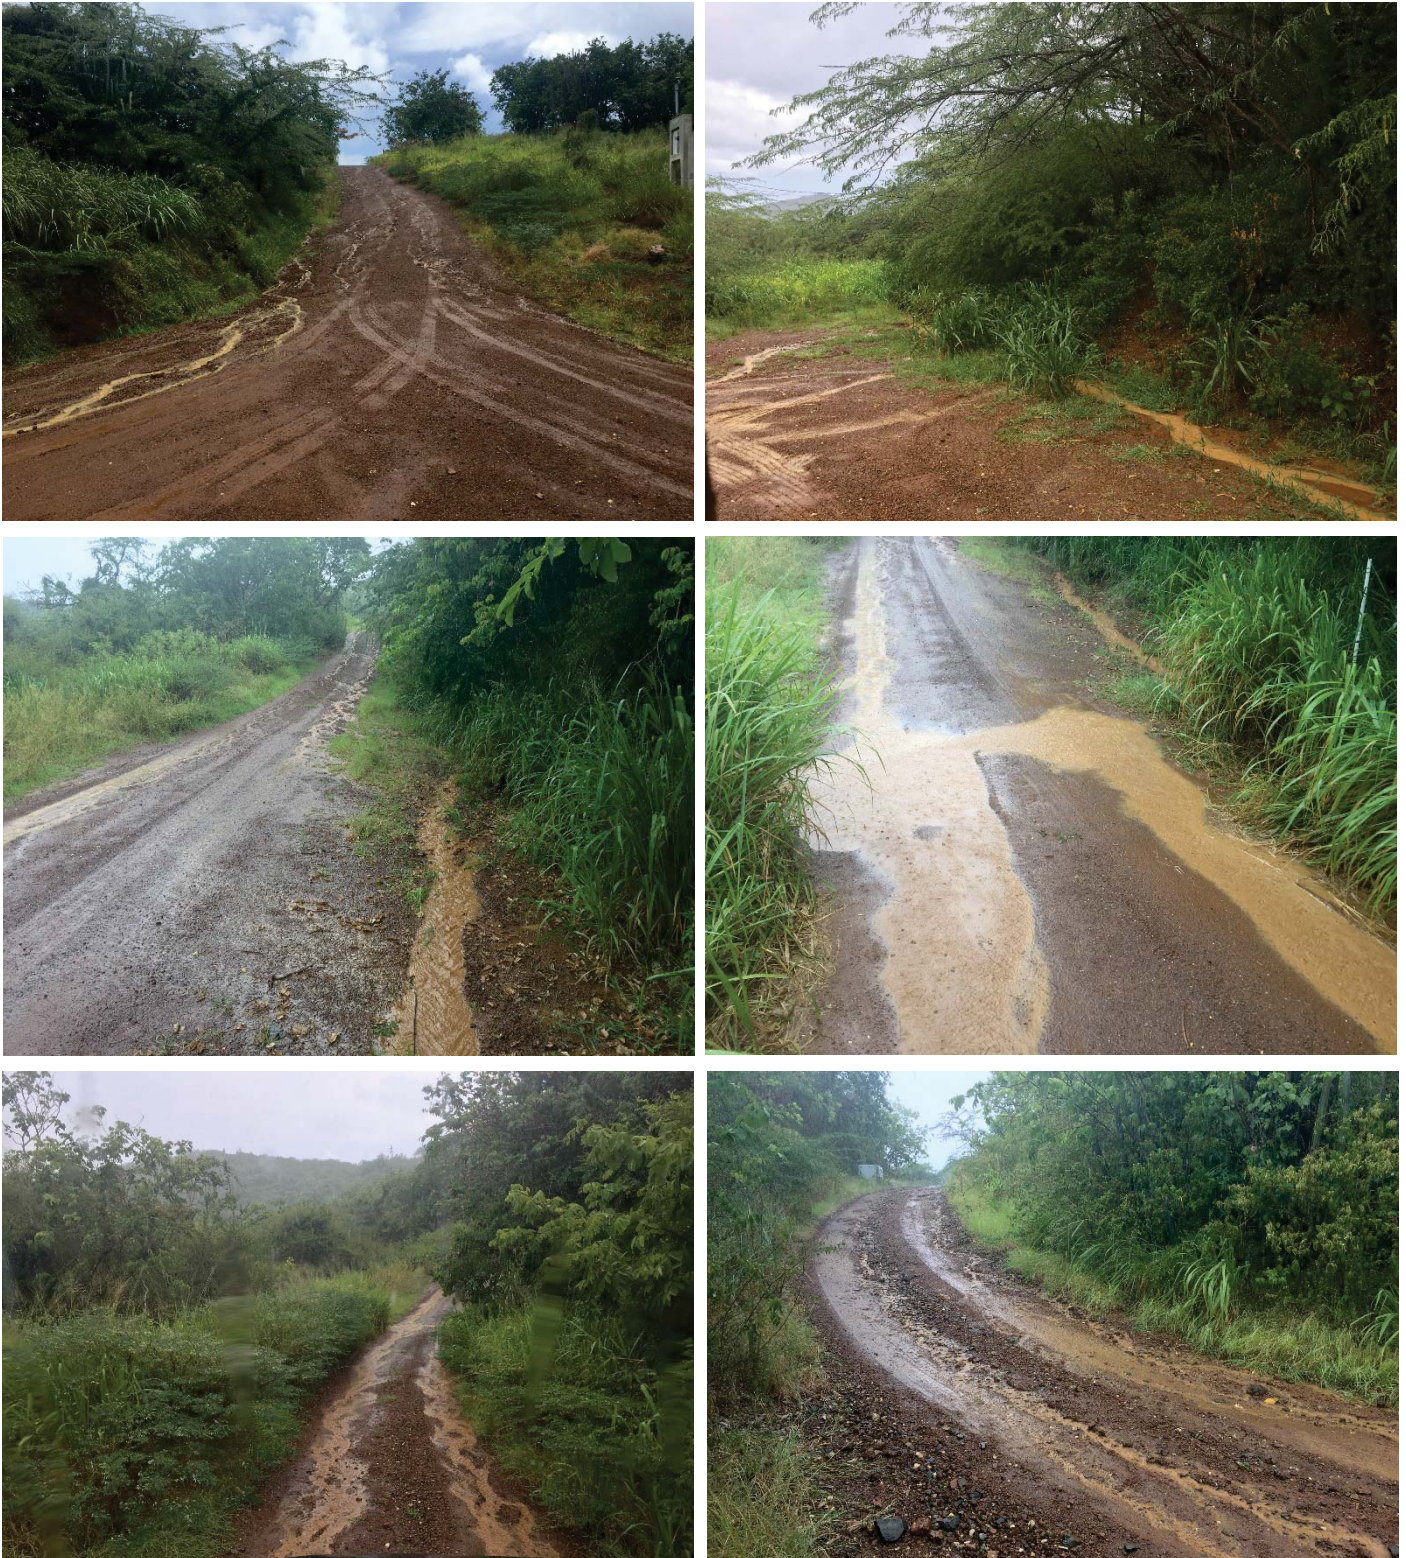
Figures 2. Sediment runoff and accumulation along dirt road at Punta del Viento during a small rain event prior to stabilization.

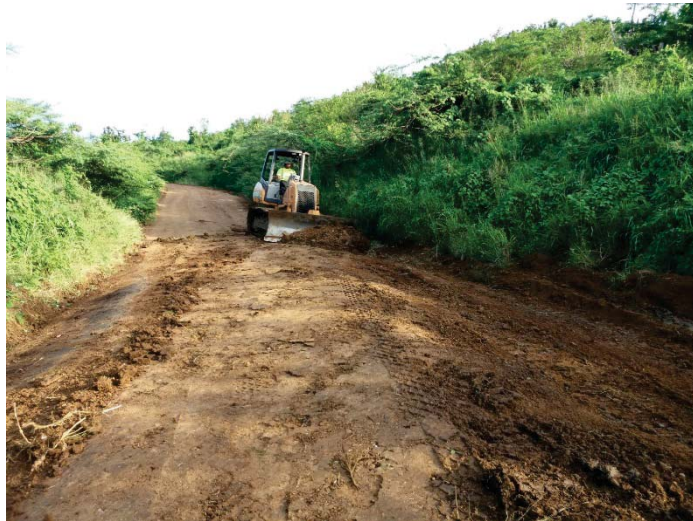
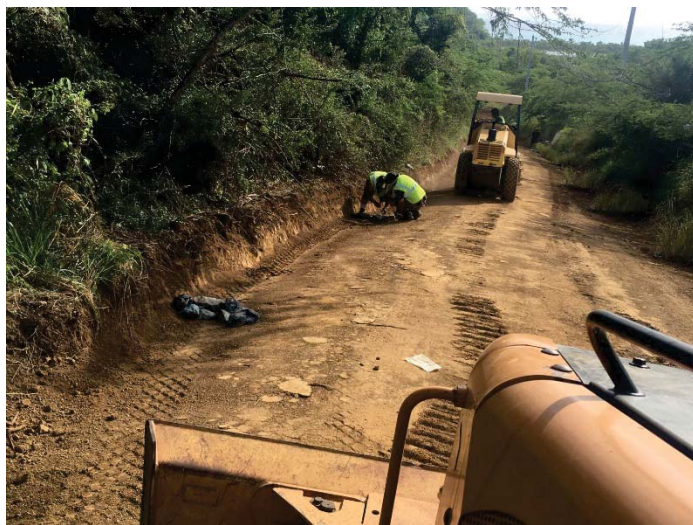
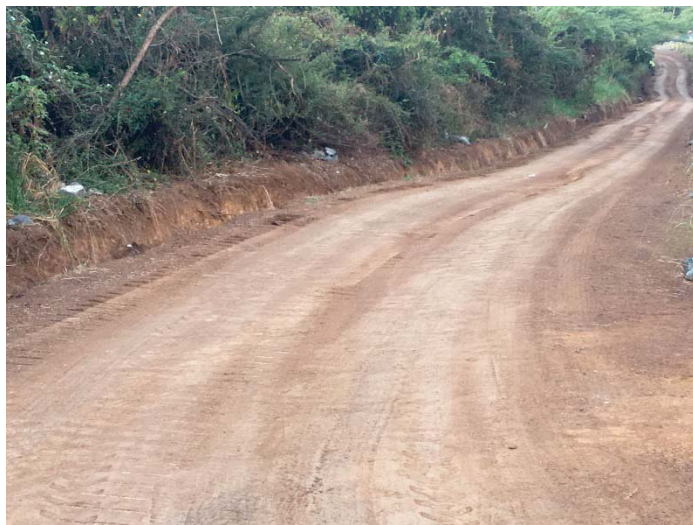
Figure 3. Regrading and compaction process during dirt road stabilization.

All the dirt road stabilized was regraded to the desired hydrological patterns and compacted (Figure 3). Runoff was conveyed into continuous swales with 4-12" stones and Vetiver grass check dams at intervals of approximately 25-50 ft., depending on the slope (Figure 4). The regrading process was conducted using a Crawler dozer, and soil was compacted with a 15-ton compacting roller.

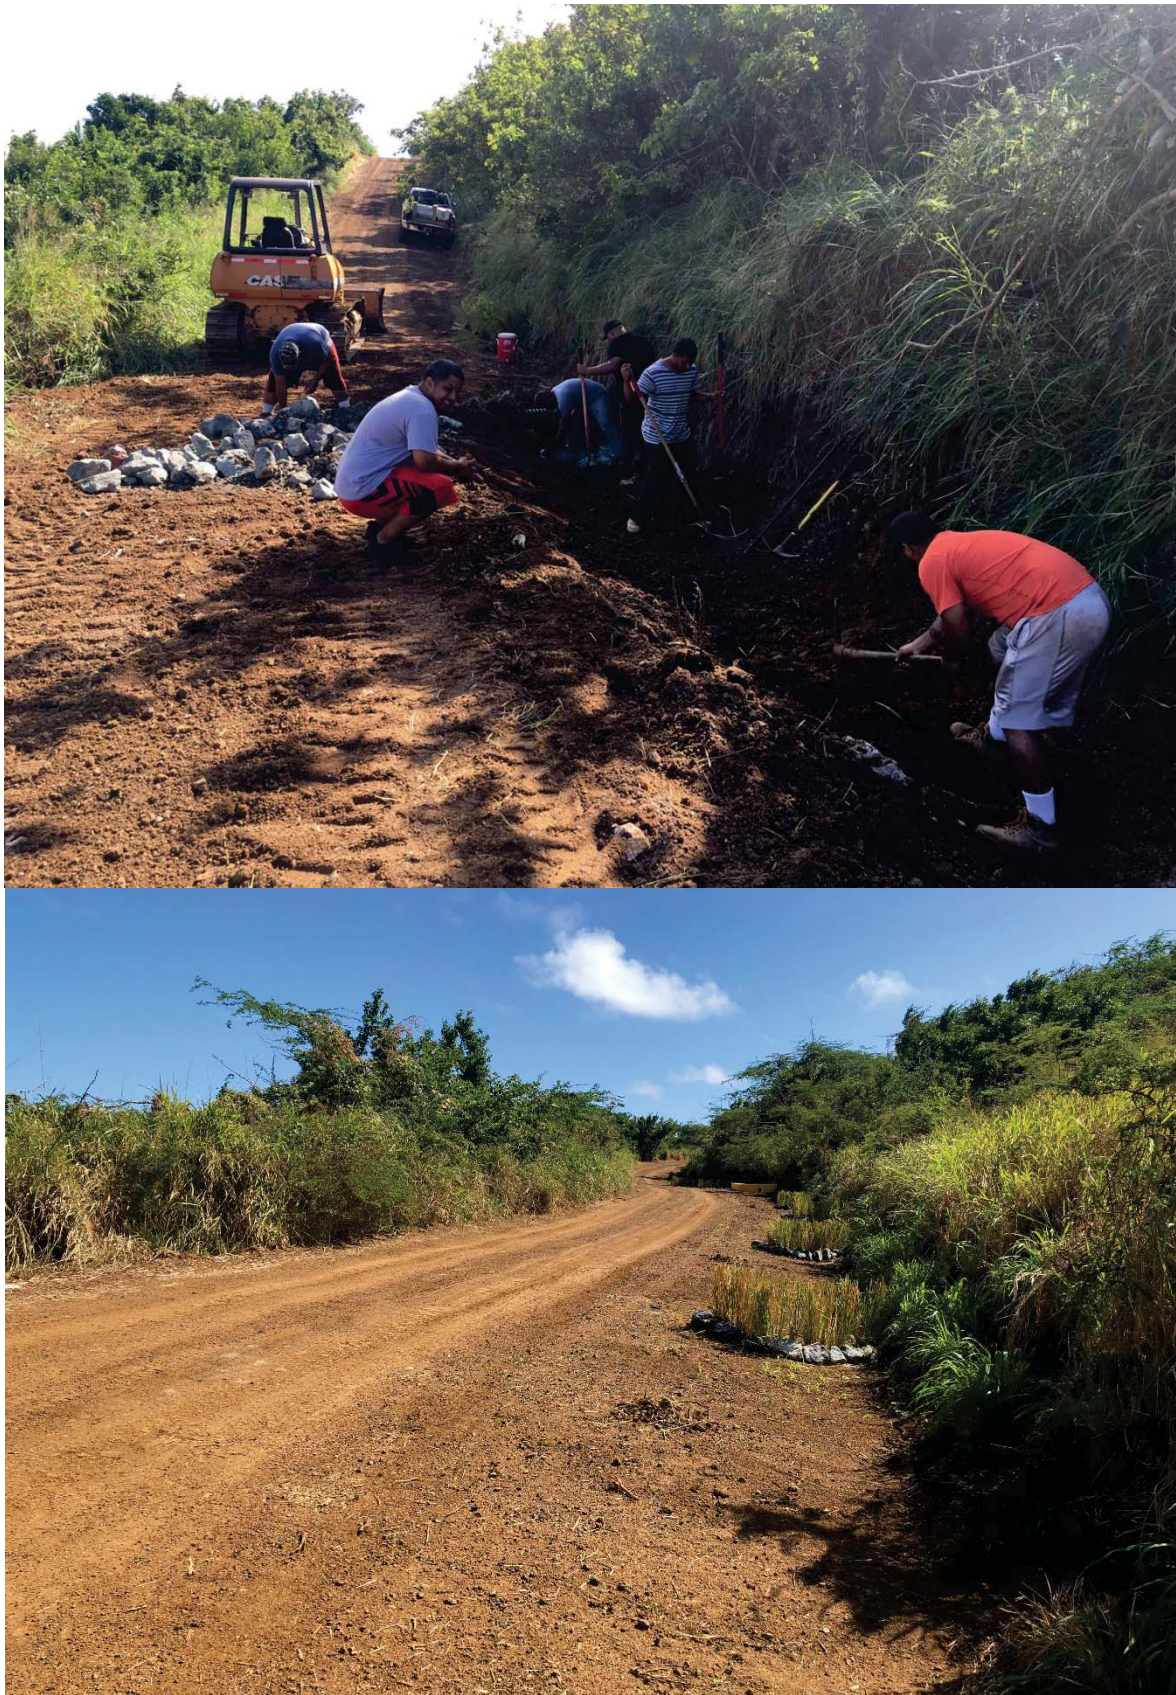
Figure 1. Construction process of installing check dams.

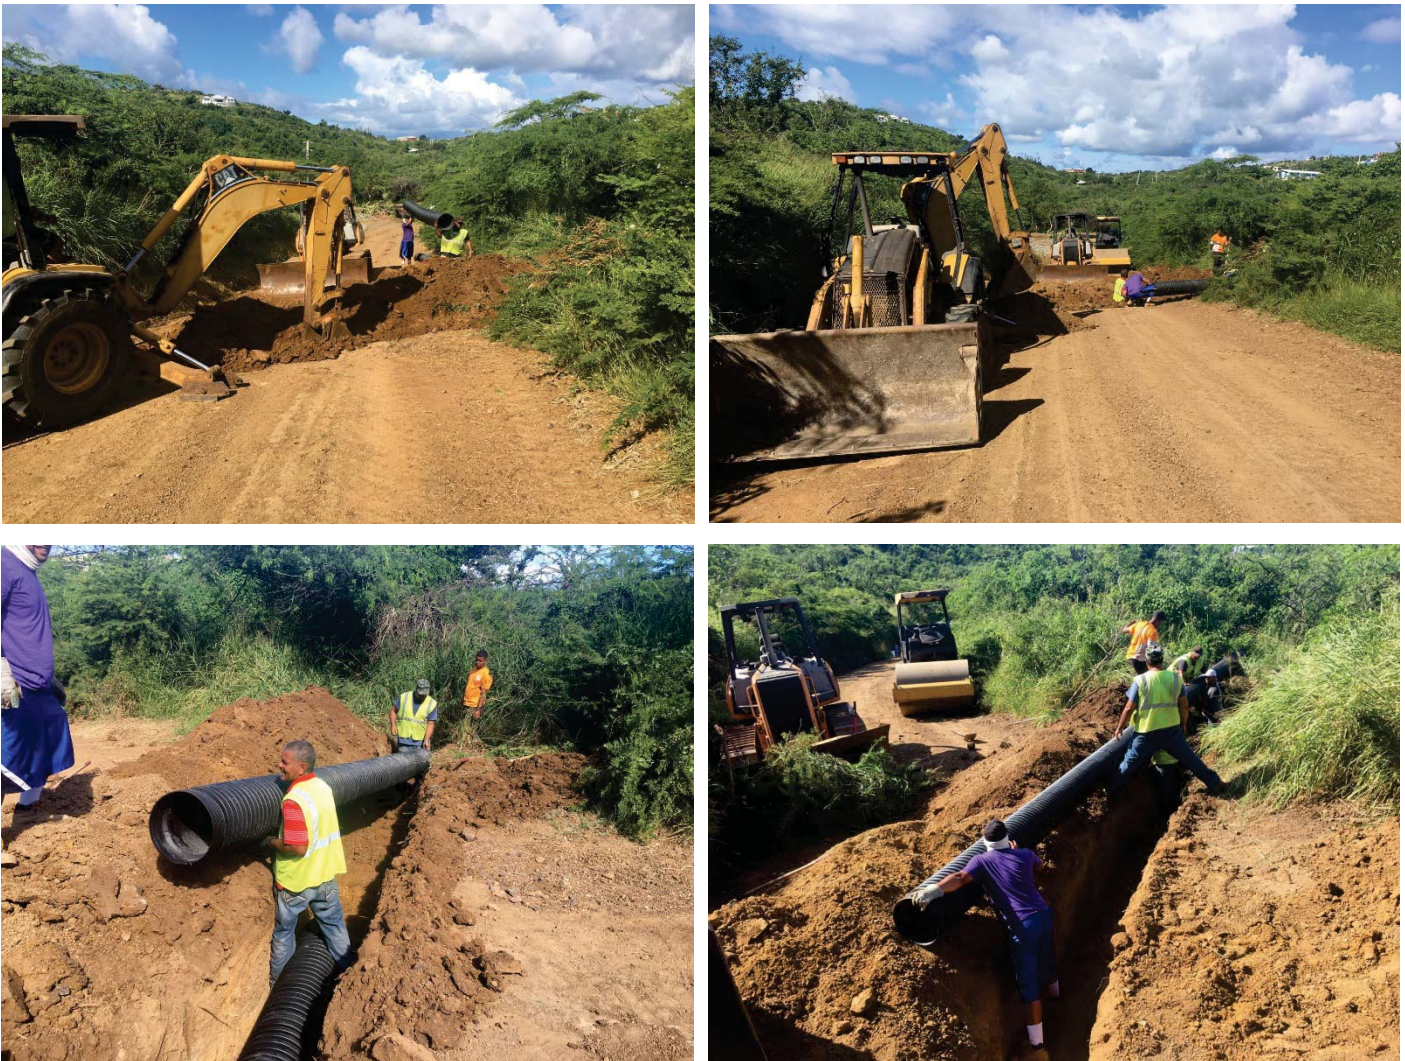
Figure 5. Process of installation of crossing pipes.

A series of crossing corrugated pipes were installed to cross runoff from one side of the road to another into forested areas (Figure 5). After the pipes were installed the soil was regraded and recompact (Figure 6). A total of 13 crossings were installed on all sloped segments of the stabilized areas. Concrete catchments were constructed with overflow spillways on the inflow side of the crossing pipes (Figure 7). On the outfall side, cascade type rip-rap were installed in combination with Vegetative buffers (Figure 8). A series of rip-rap terraces were built on the areas that less pipes were installed because of the proximity of houses (Figure 9).

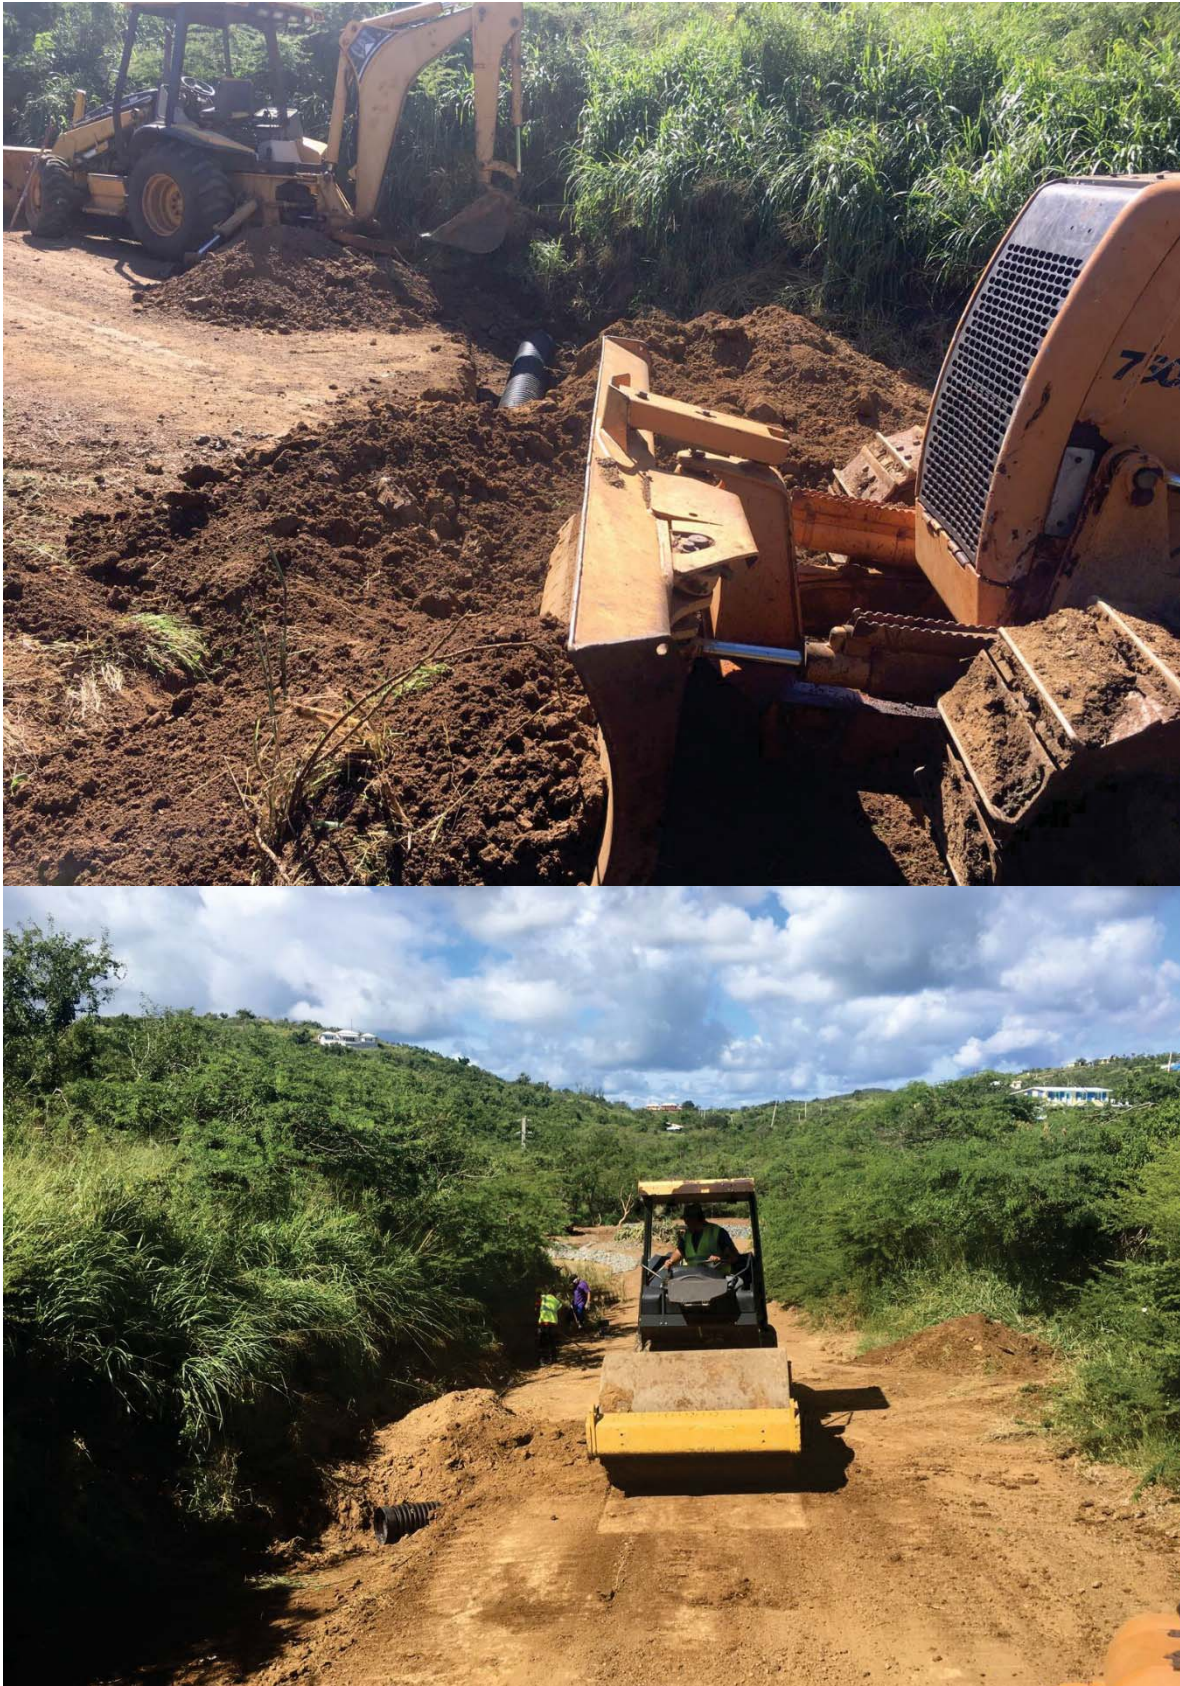
Figure 6. Regrading and compaction of road after installation of crossing pipes.

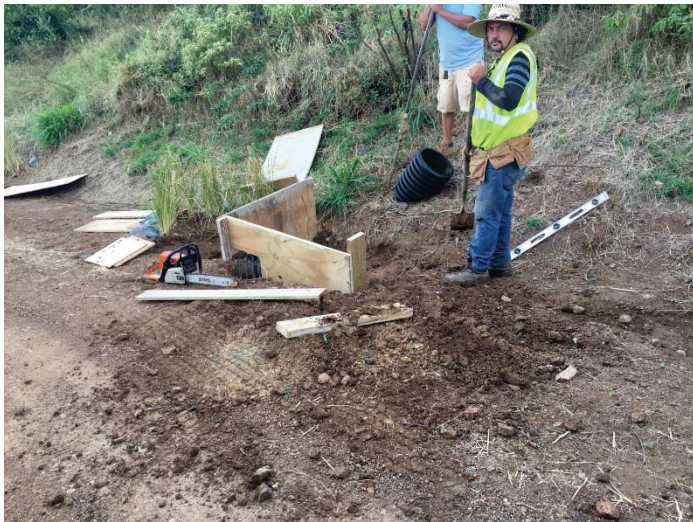
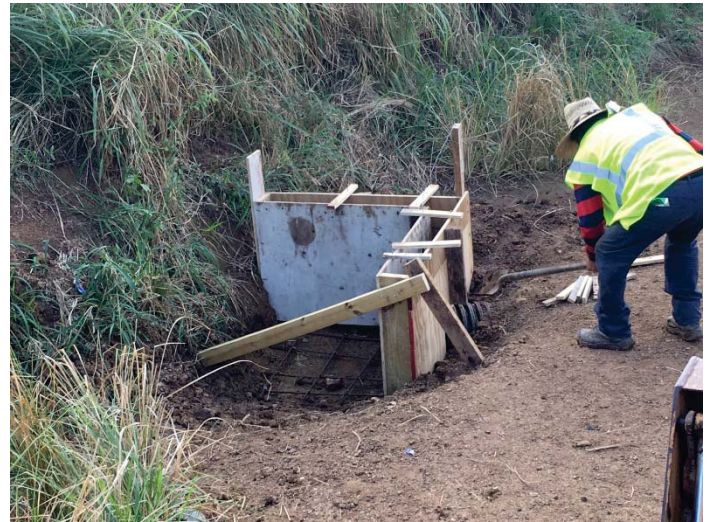
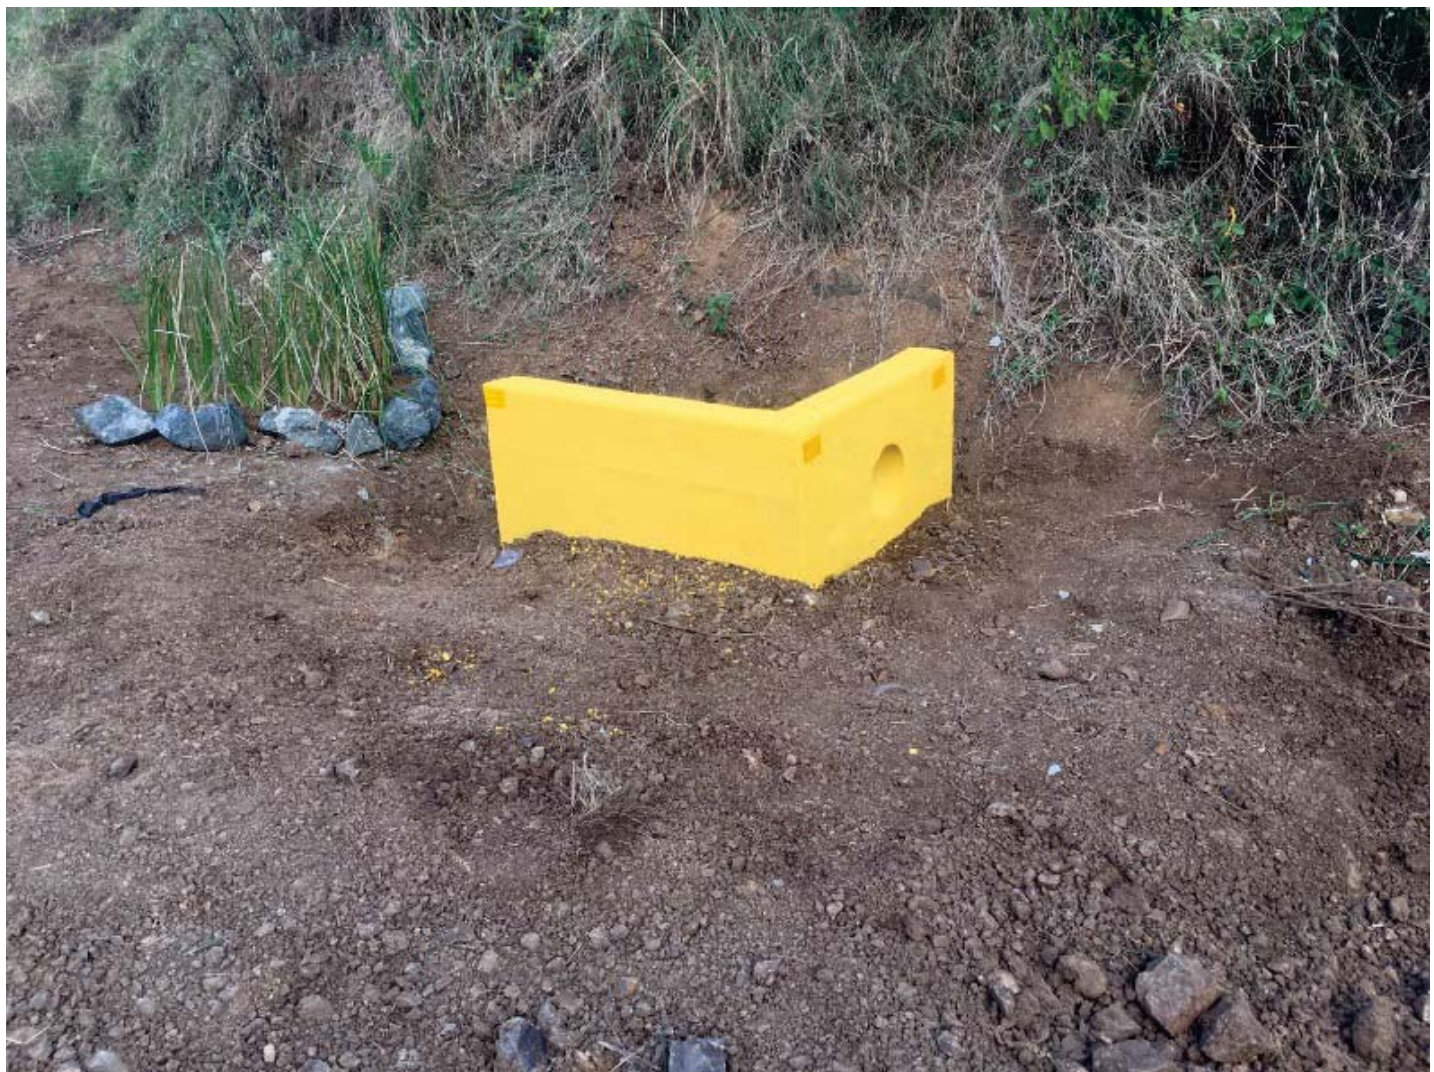
Figure 7. Construction process of installing concrete catchments for the crossing pipes.

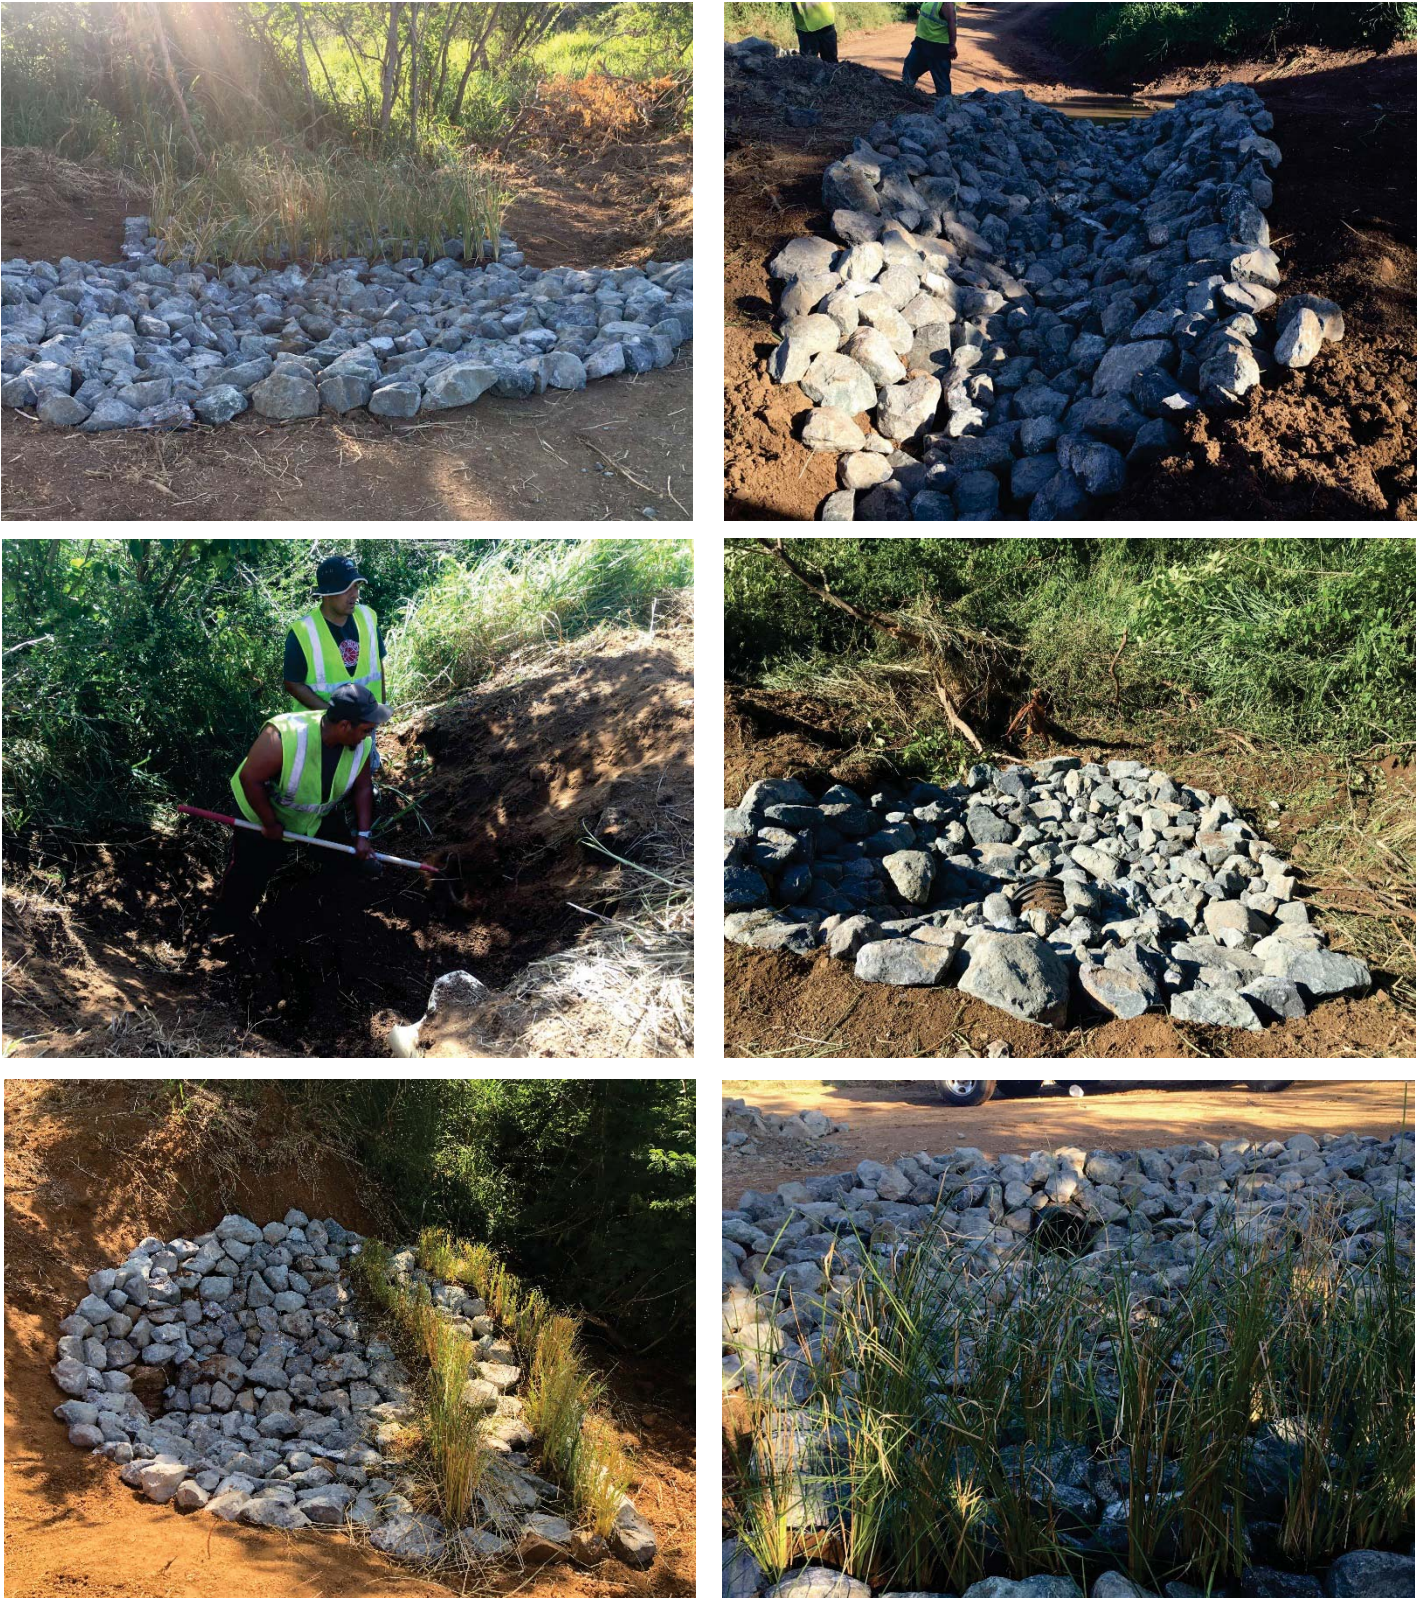
Figure 8. Installation of rip-rap and Vetiver on the outfalls of crossing pipes.

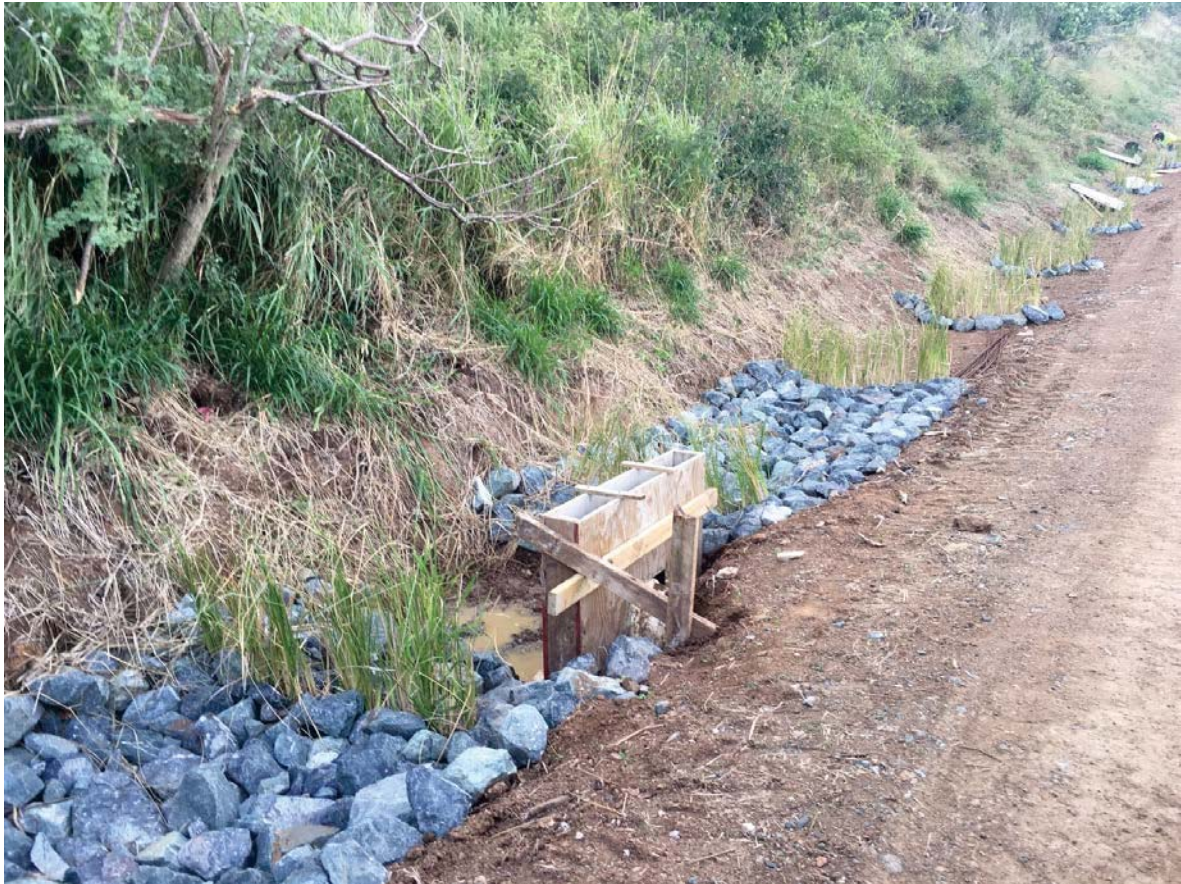
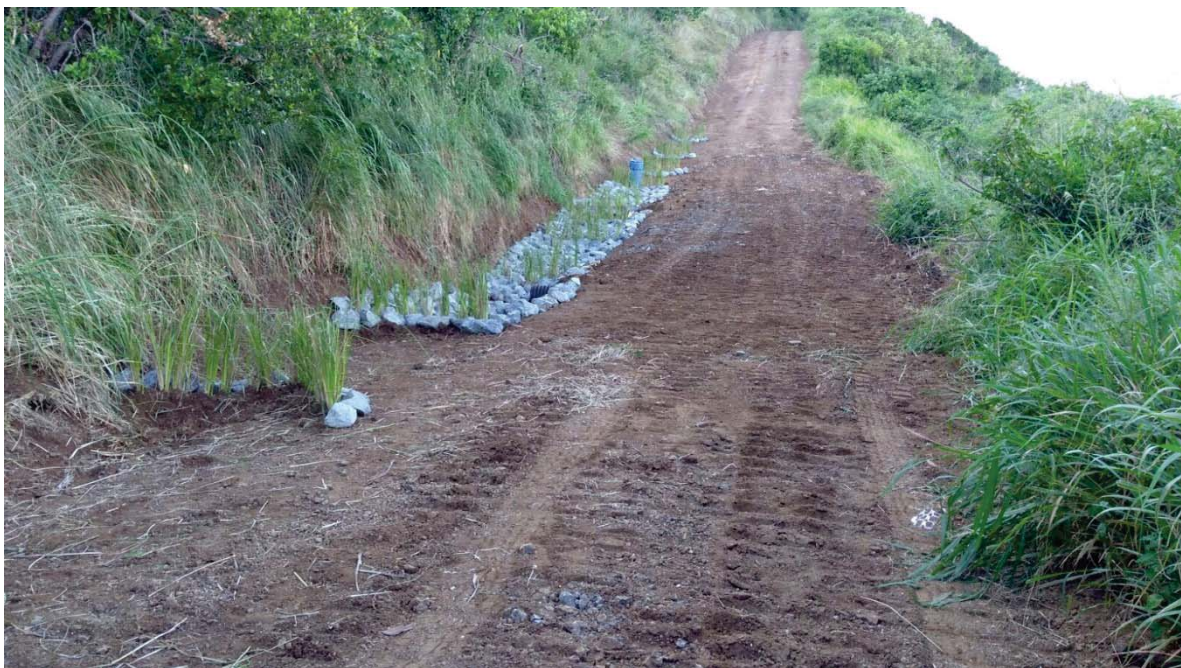
Figure 9. Installation of rip-rap terraces.

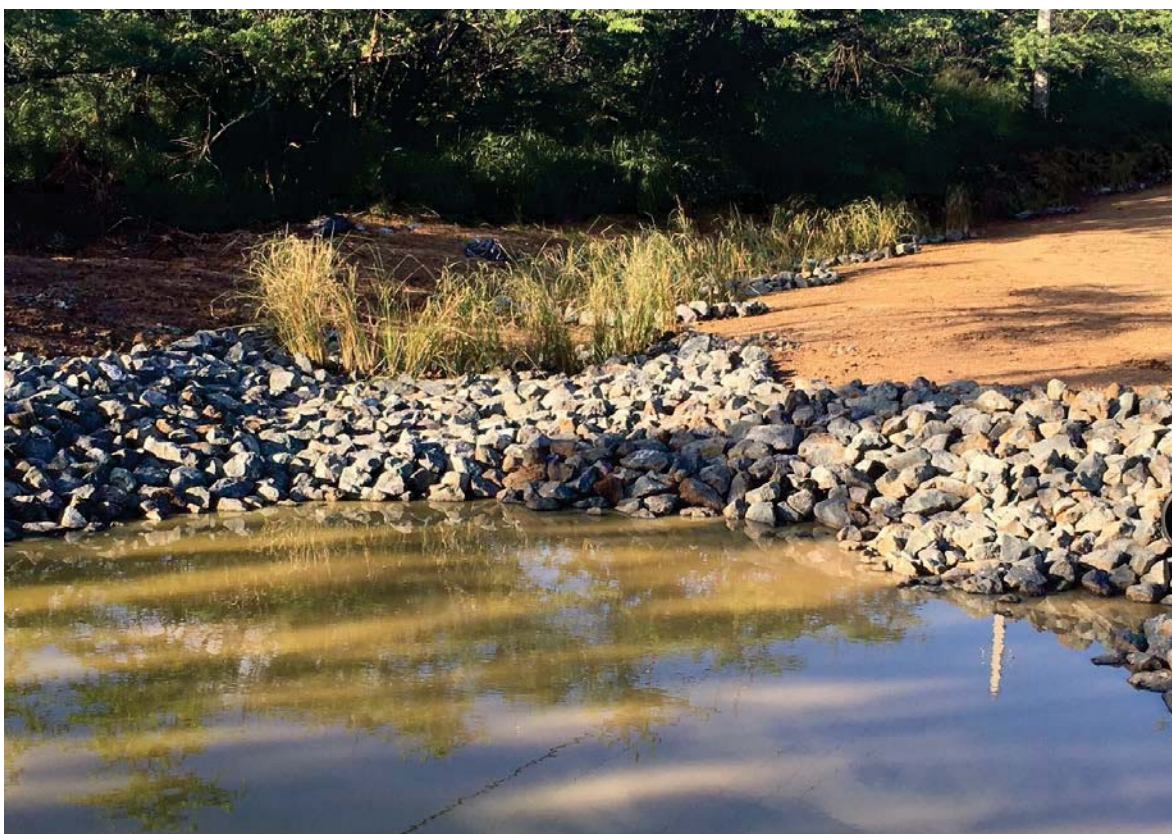
Figure 10. Example of one of the sediment traps constructed.

A total of three sediment traps were constructed to help filter stormwater that was causing erosion problems and discharging sediments (Figure 10). The traps were formed by excavating an area across a low portion of drainage swale, and berms were constructed and compacted with the small compacting roller. After compacting, the sediment traps were covered with 4-12" stones as rip-rap to prevent erosion from the berms, the bottom was punched through with the backhoe to promote infiltration, and Vetiver grass half-moons were planted to help trap sediment and promote infiltration and evapotranspiration. A rip-rap overflow was constructed with bigger 1-2 ft. stones to reduce energy of the water (Figure 11). Sediment traps are excavated as a first step because they serve as a temporary sediment control measurement if unexpected rain events happen during work implementation (Figure 12).

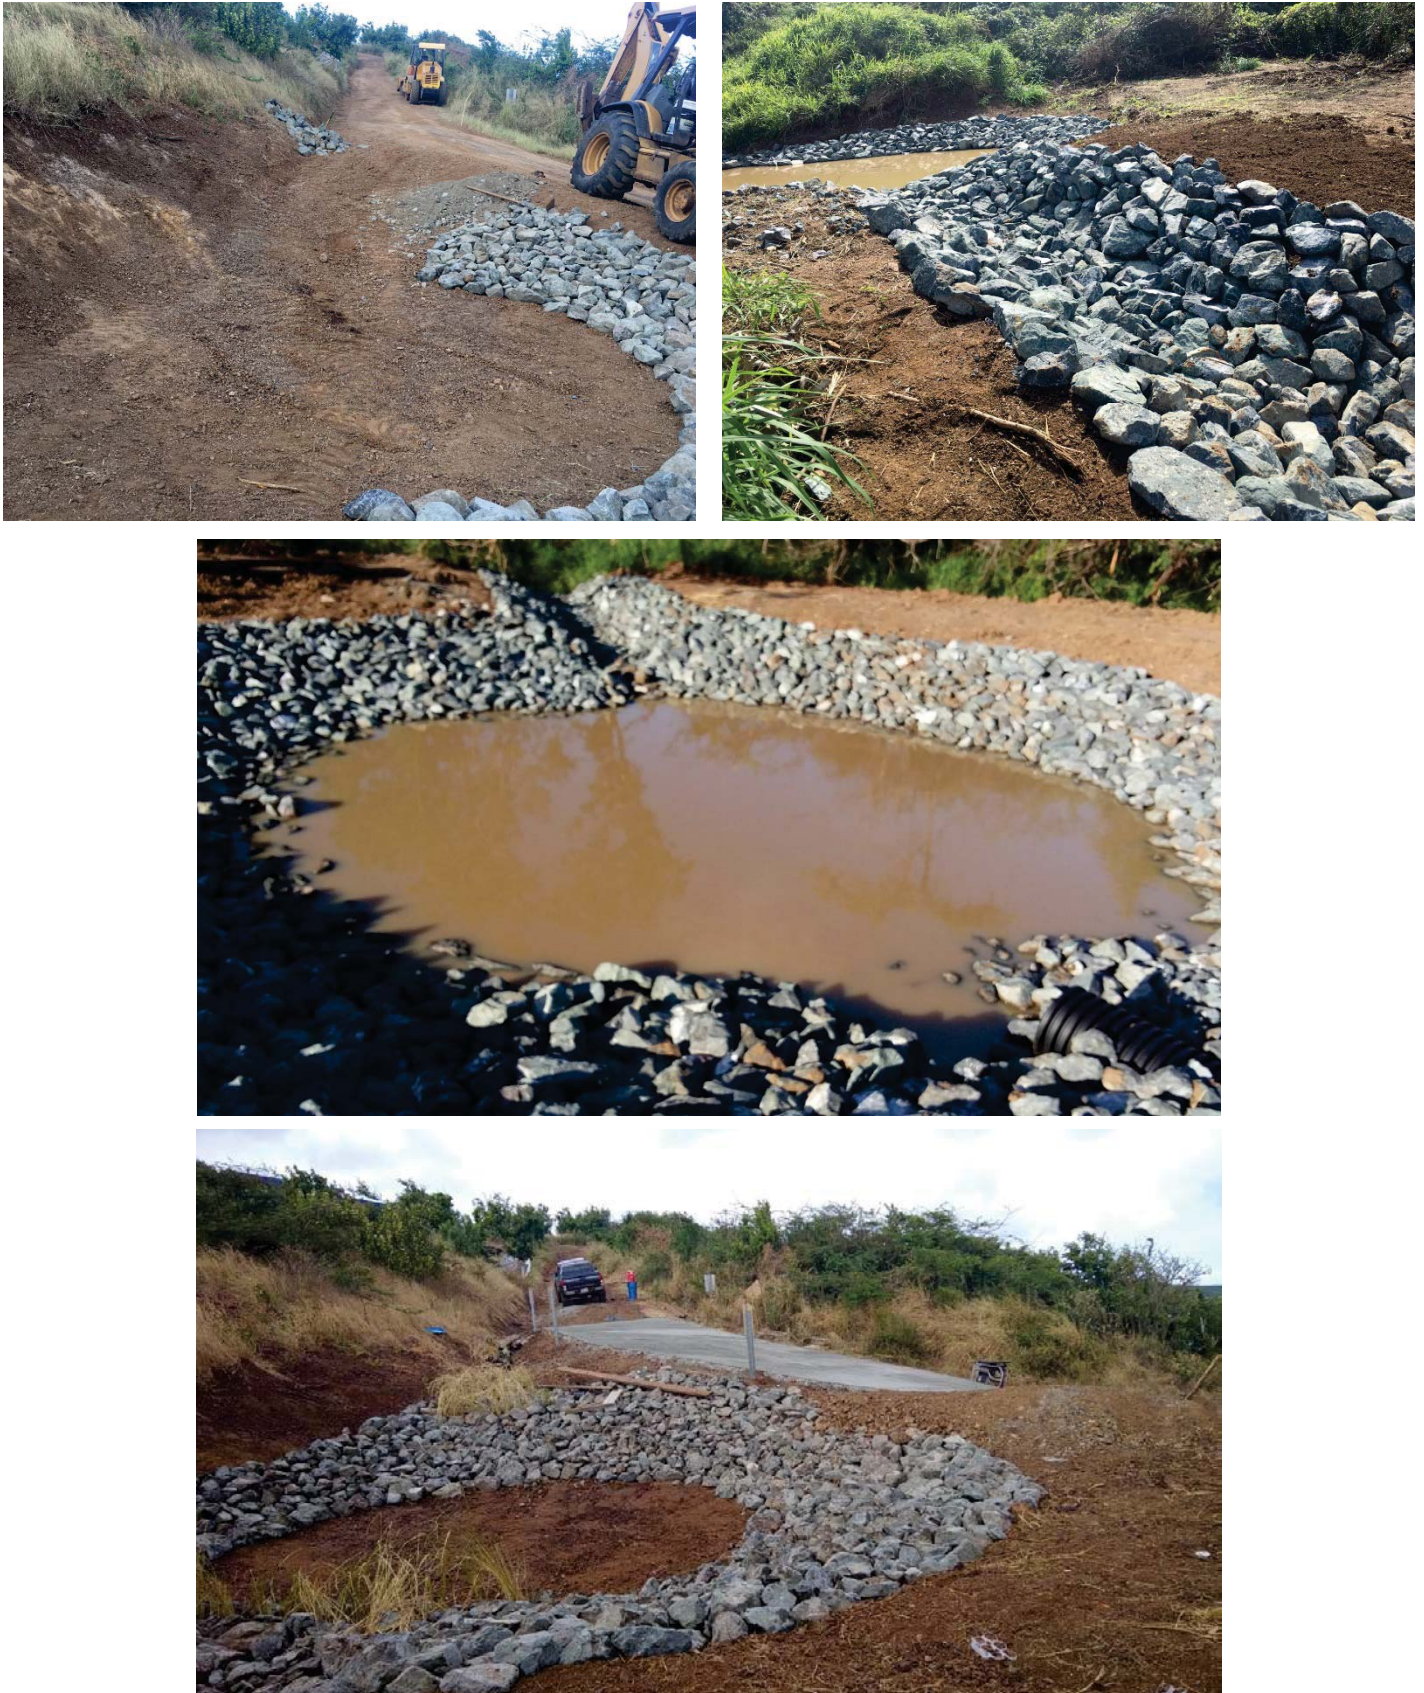
Figure 11. Process of constitution of the sediment traps.

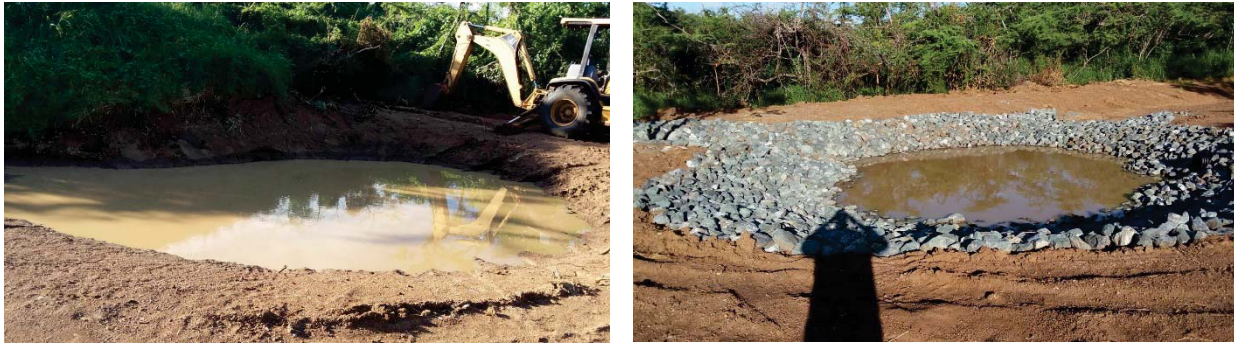
Figure 12. Example of a rain event captured by the sediment traps during project implementation.

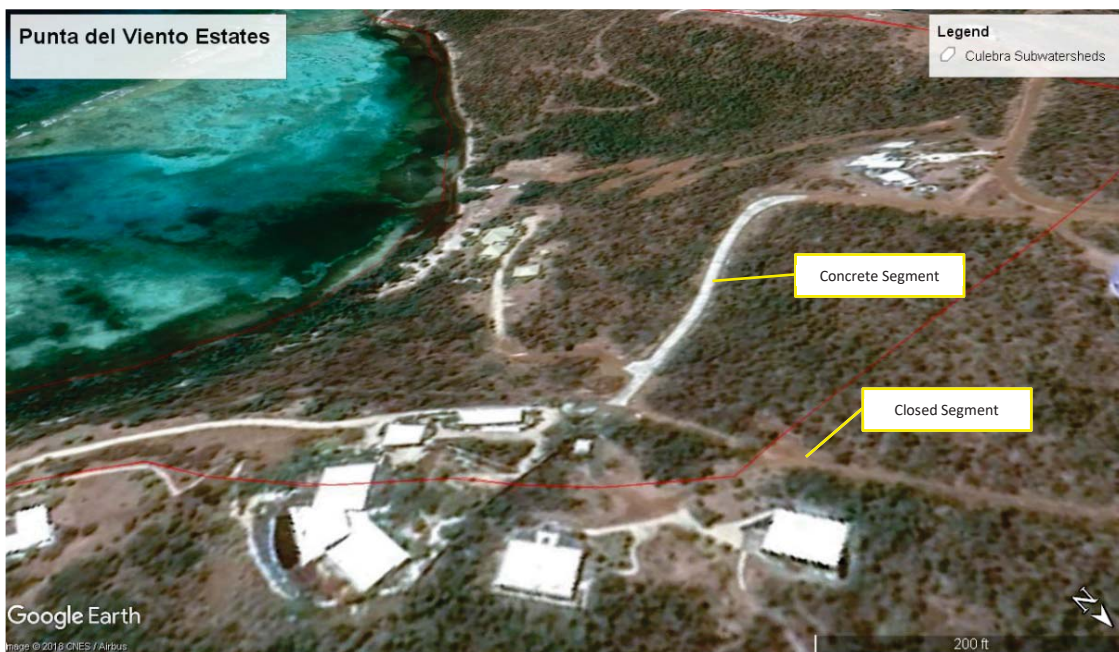
Figure 13. Aerial image of the project site area showing the concrete pavement and part of the closed dirt road segment.

A segment of the dirt road that was very steep and had very limited areas for BMPs establishment was stabilized by using concrete pavement. The total area of concrete is calculated to be of approximately 150 meters long by 4.5 meters wide and 6 inches in depth (Figure 13). The paved segment was regraded and compacted prior to concrete installation (Figure 14-15). The homeowner association paid for the concrete segment as a matching contribution. A total of 110 cubic yard of concrete was used. Rebar #3 was used to reinforce the concrete slab and every 100 ft a deeper trench was established of 1ft x 1ft to ensure concrete strength on the slope if heavy vehicles are used (Figure 16).

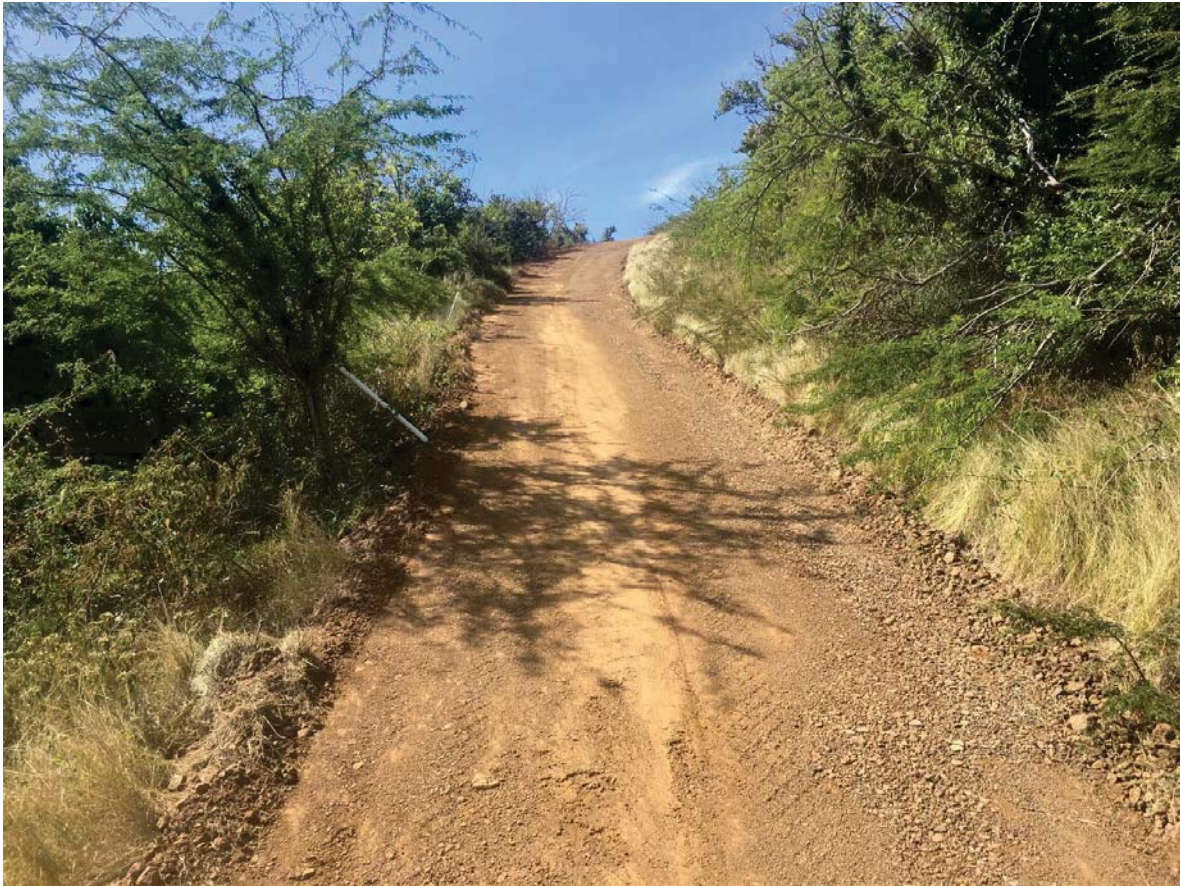
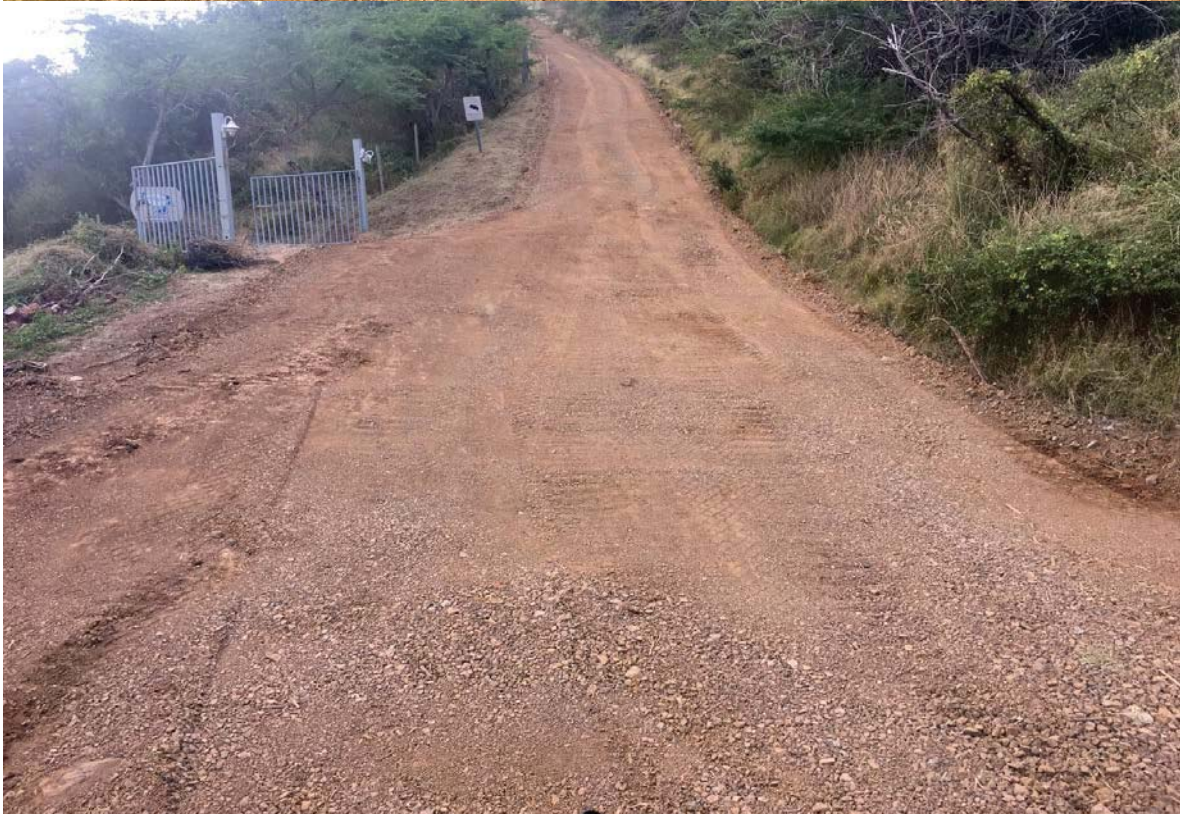
Figure 14. Regrading and compaction process prior to concrete paving.
