Reduction and control of sediment-laden runoff near critical coral reef and other coastal ecosystems through the implementation of BMPs in Culebra, Puerto Rico FY-2016

FINAL REPORT
August 2017

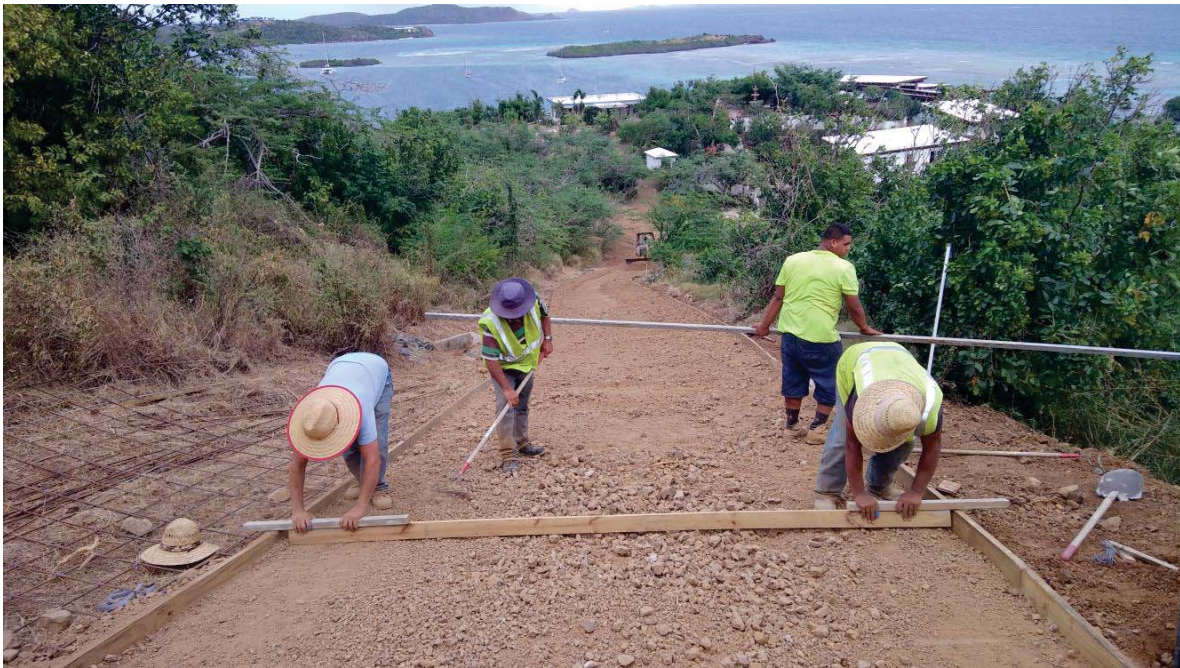
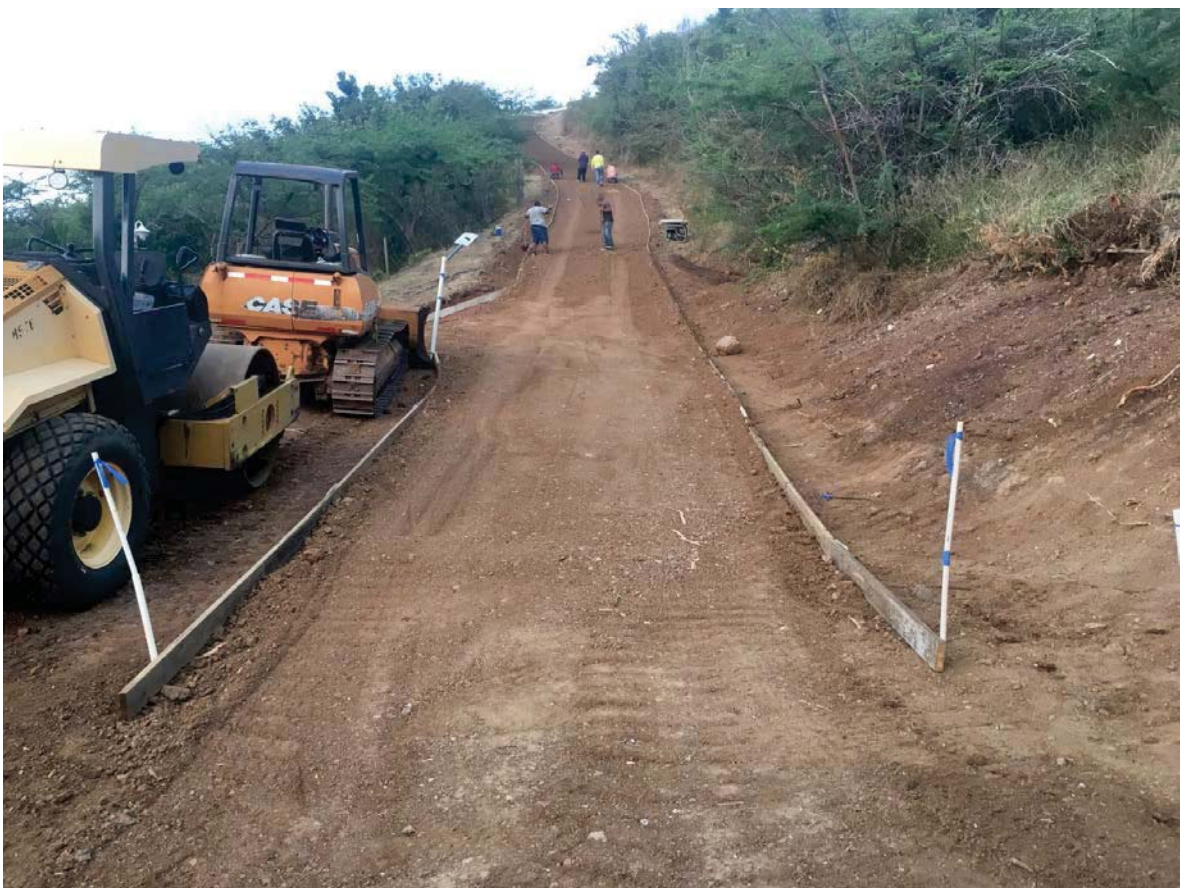
Figure 15. Molding preparation for concrete paving.

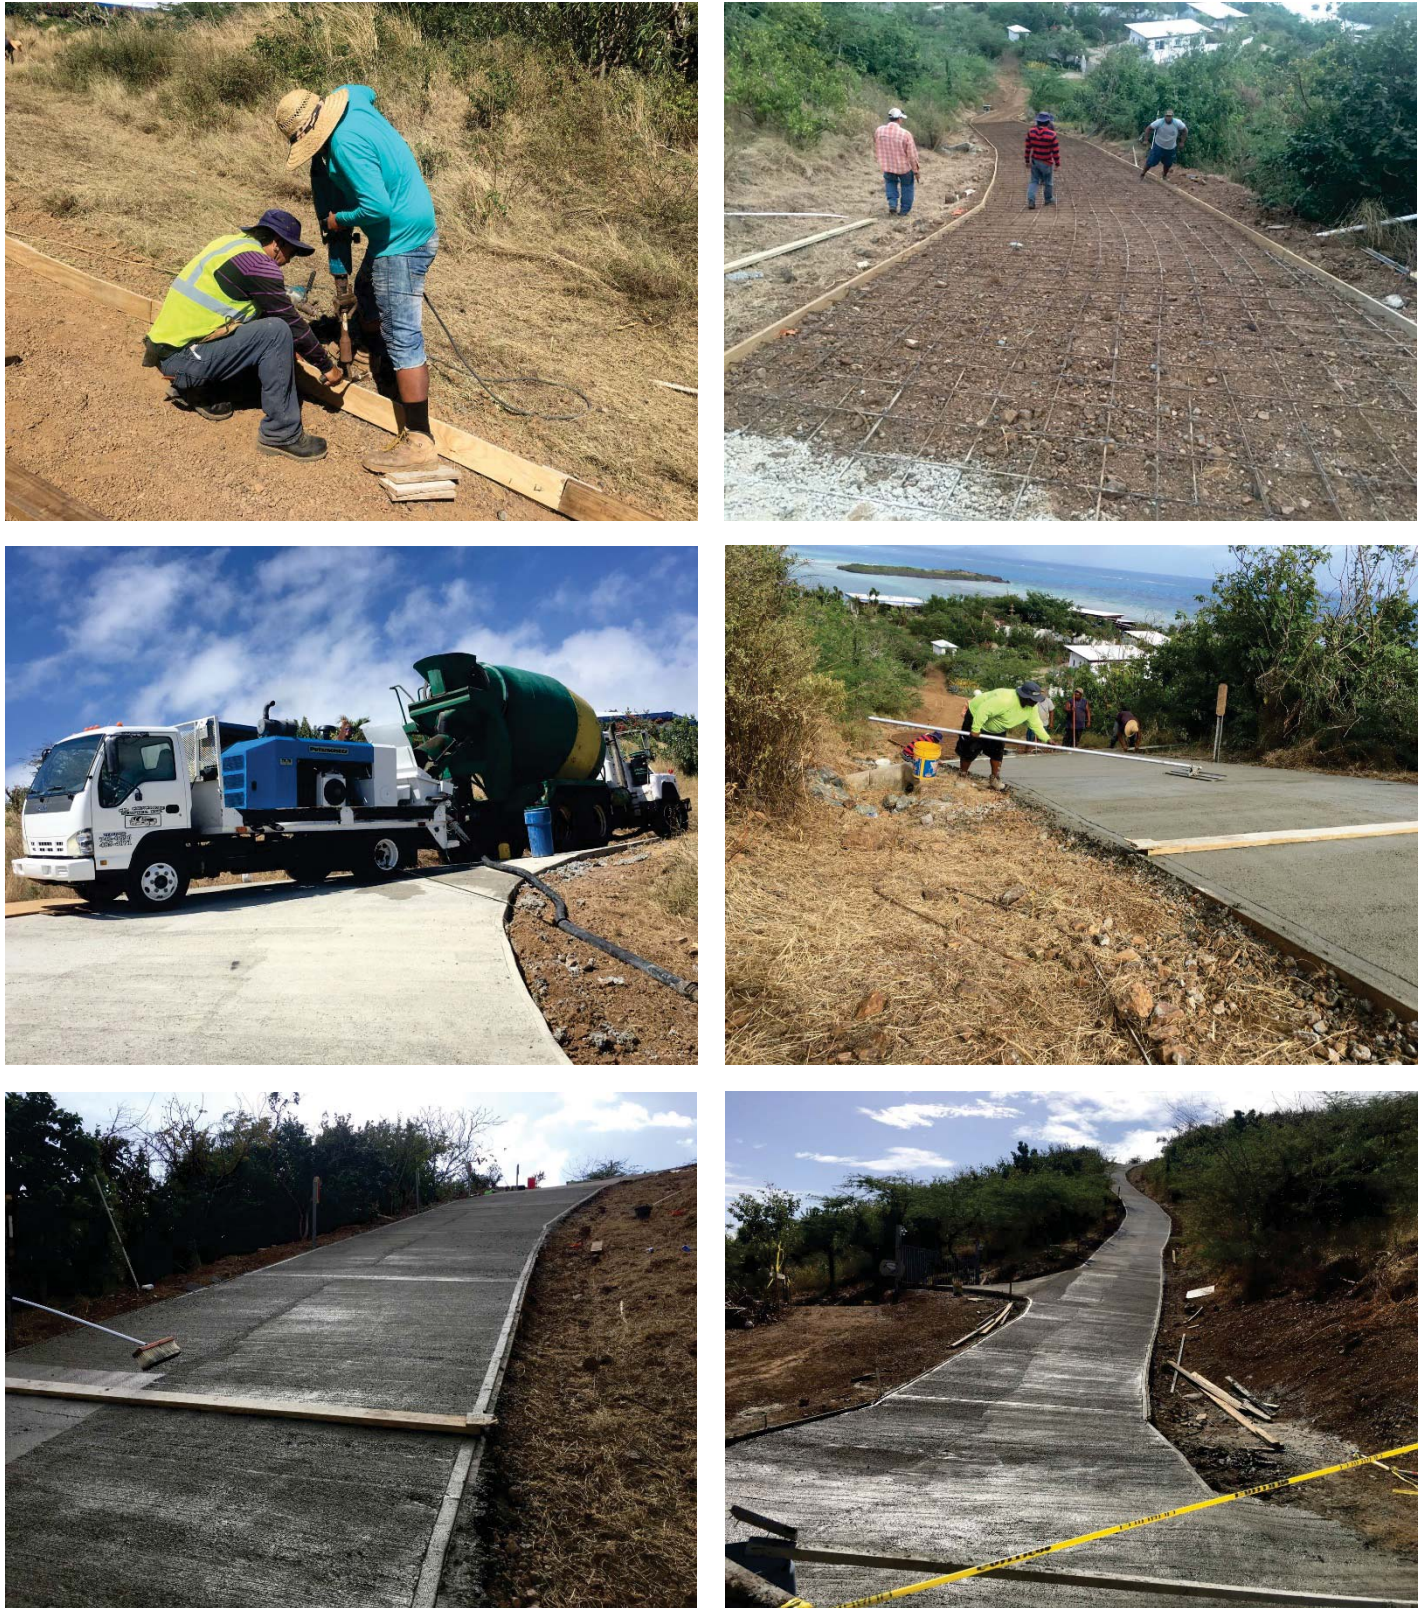
Figure 16. Rebar installation and concrete pouring.

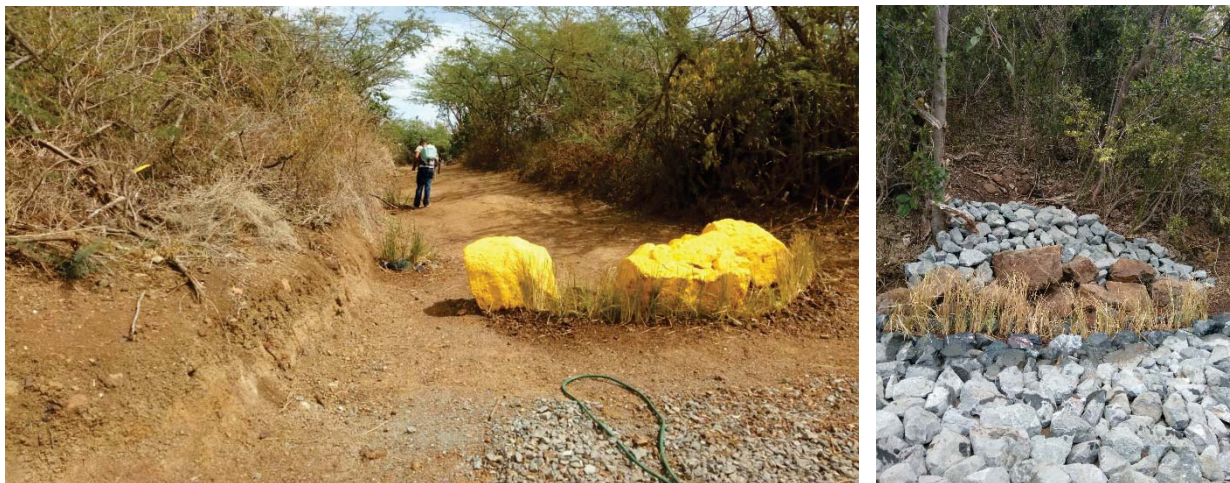
Figure 17. Some of the practices implemented on the closed segment of the road.

Thanks to the concrete pavement the homeowners agreed to close a segment of the dirt road network. This road was used as an alternative to the steep road that was paved, mainly because it was not passable after rain events because of its steepness and it was very dangerous to drive on it. The closed segment of the road was approximately 500 meters in length and was one of the major contributions of sediments to the nearshore as it intersects one of the dry waterways of the subwatershed. The road was stabilized and closed to vehicular access. The expected outcome is that this segment grows back to forest cover (Figure 17).

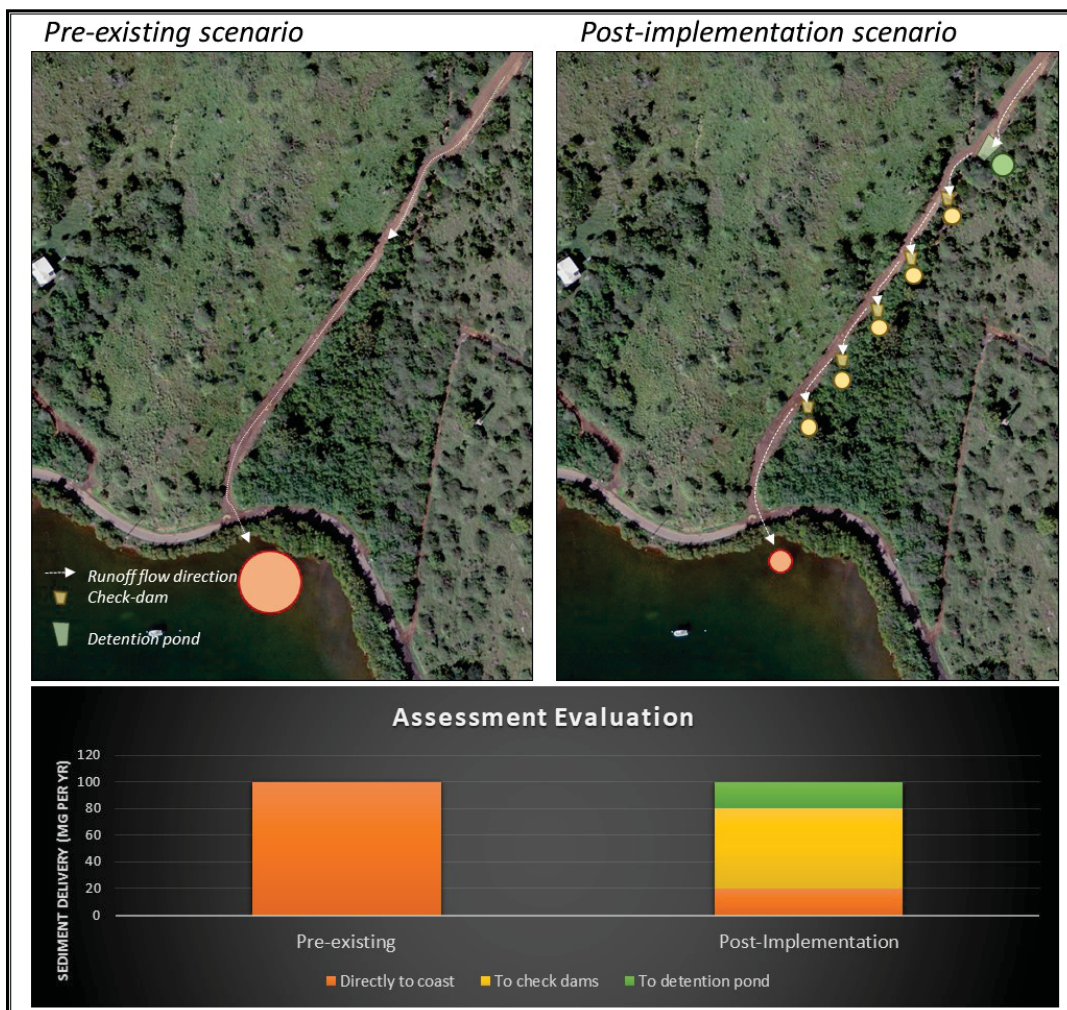
Figure 20. Hypothetical representation of the potential use of the erosion and GIS model to assess the effectiveness of erosion control measures at the road segment scale. The size of the circles refers to the amount of sediment being delivered at each road drain location.

description of how we intend to conduct and present our analyses is shown as Figure 20. Here we display the spatial distribution and total amount of sediment being delivered from the road to the coastline and to specific erosion control practices. In the hypothetical case shown in Figure 20, direct sediment delivery to the bay from that unpaved road segment was estimated to have been reduced from 100 Mg per year to 20 Mg per year. The remaining 80 Mg per year are being treated by several practices before being delivered to the coastline.

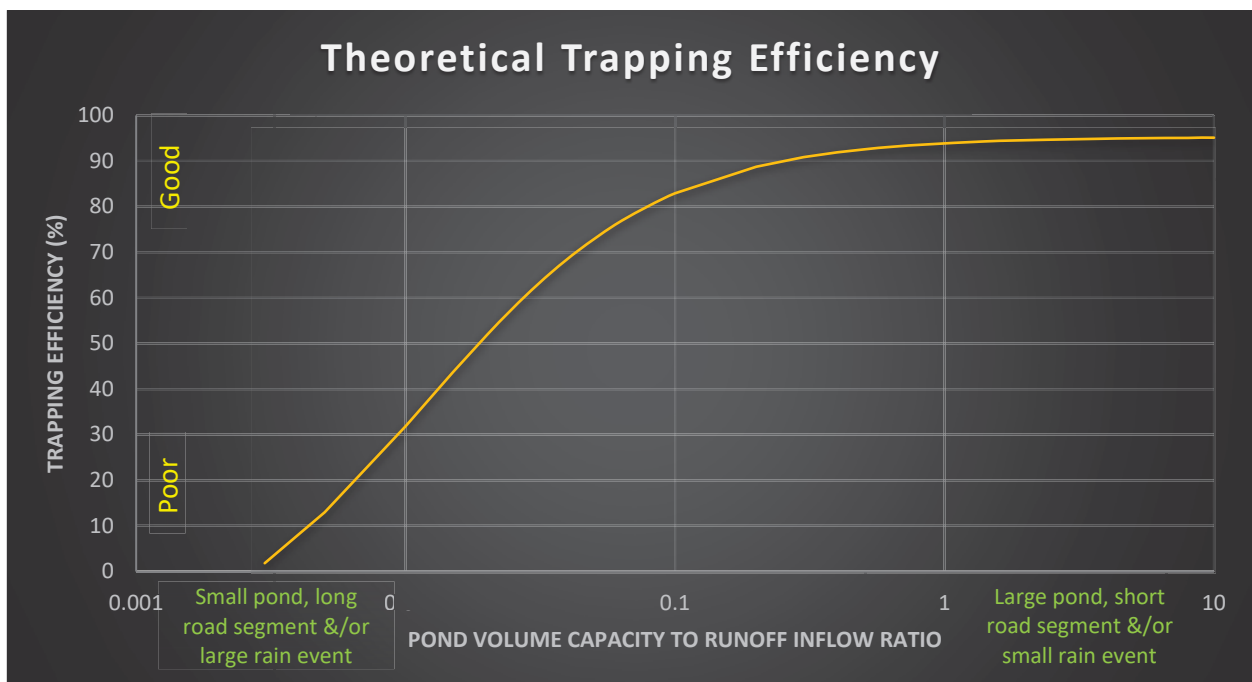
Figure 21. Theoretical relationship between the ratio of detention pond size and incoming runoff against the trapping efficiency of the pond (percent of incoming sediment retained). The figure suggests that the trapping efficiency increases when the size of the pond is high in relation to the incoming runoff. Graph taken from Ref. 11.

trap efficiency metrics developed elsewhere to determine the expected percentage of sediment reaching the traps that is expected to be retained. Trap efficiency (the percentage of delivered sediment that is actually retained by the trap) has been found to be a function of the ratio of pond volumetric capacity to incoming runoff (Brune, 1953; Verstraeten and Poesen, 2000). Once runoff generation models have been developed, we will use observed rainfall data from Culebra to make estimates on the rate and total amount of runoff reaching each of the built ponds on a storm by storm basis. These estimates will be compared to the volumetric capacity of each pond (established from detailed topographical surveys) to determine the expected trapping efficiency of all ponds for rainstorms in Culebra.

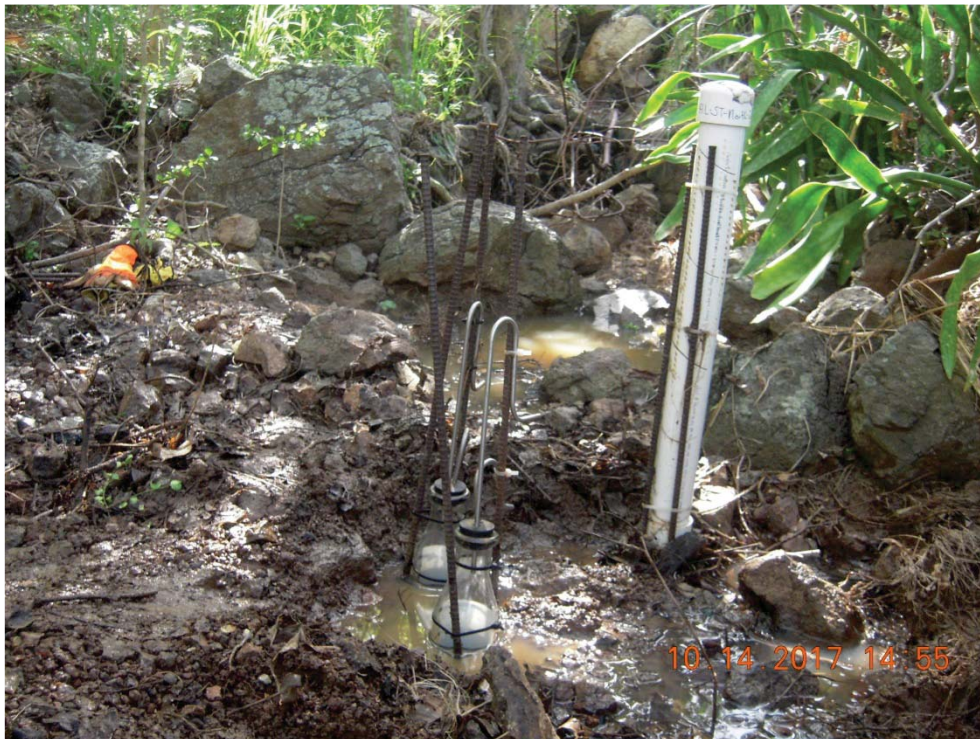
Figure 24: A peak crest gauge and single stage samplers in Punta Aloe North Stream

Three streams draining to Fulladosa Bay are being monitored for water level and sediment concentration using water level recorders, peak crest gauges and single stage samplers (Figures 24-26). The three streams are *Punta Aloe North* and *Punta Aloe South* (which drain the unpaved road that was treated by PDC in 2016), and *Fulladosa* which drains an unpaved road that PDC started to treat during March 2018. As the majority of the streams in Culebra, these three streams are ephemeral and remain dry during most of the year. During our field visits, streamflow has been observed only twice.

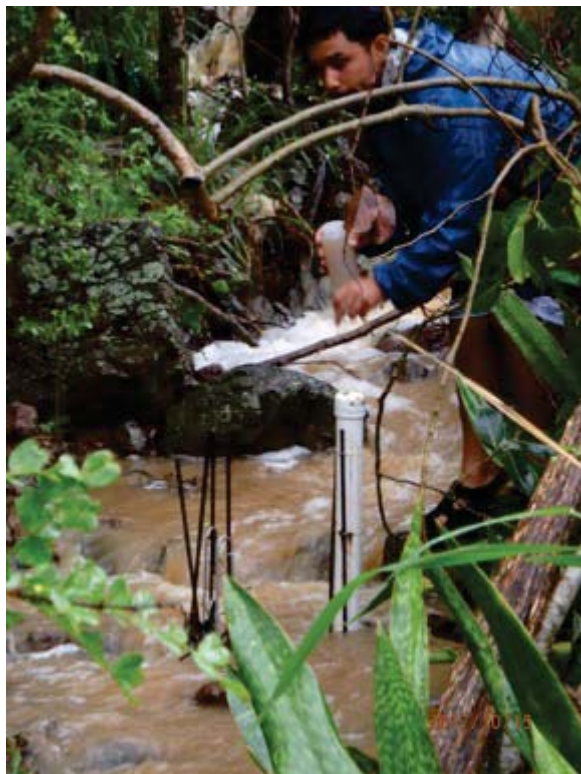
Figure 25: Grab sample collection in Punta Aloe North Stream during 15 October 2017 storm

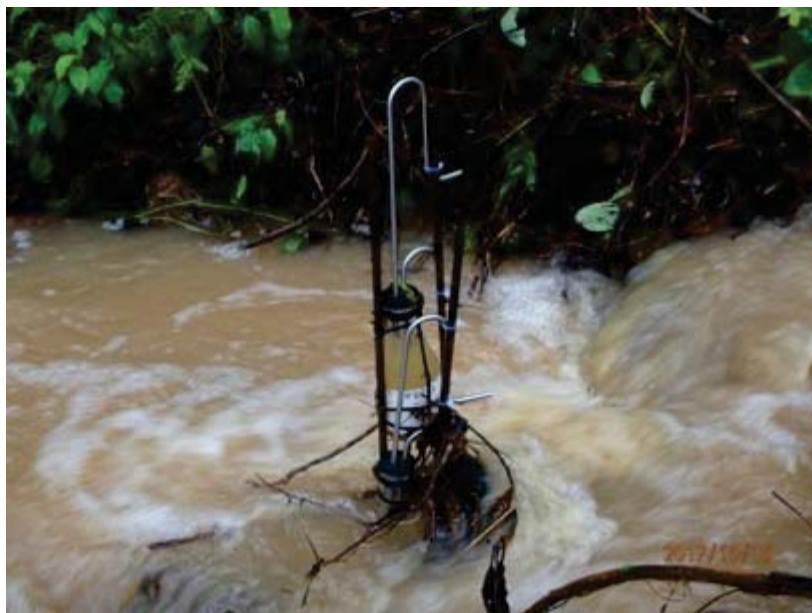
Figure 26: Single Stage Samplers in Punta Aloe North Stream during 15 October 2017 storm

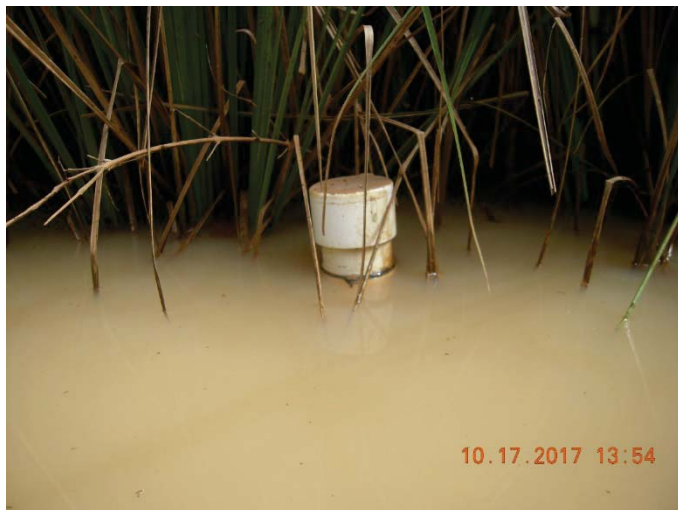
Figure 27: Water level recorder installed at the detention pond in Punta Aloe

Two detention ponds in Punta Aloe and one in Punta Del Viento are being monitored with a Hobo water level recorder (Figures 27-29). This data has not been examined at this point.

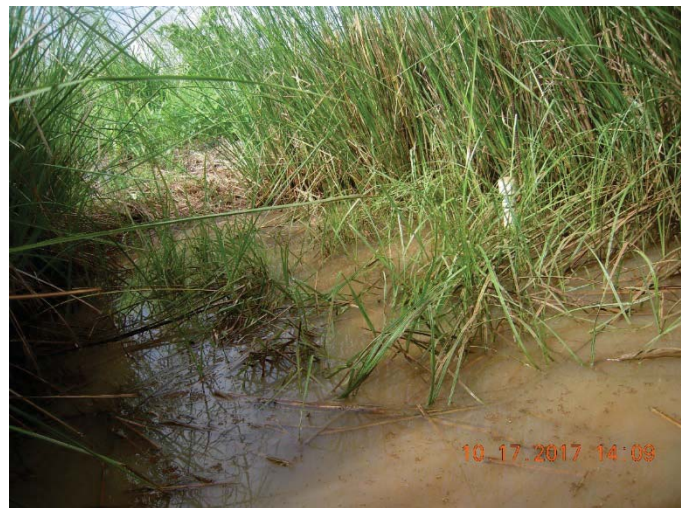
Figure 28: Detention Pond at Punta Aloe

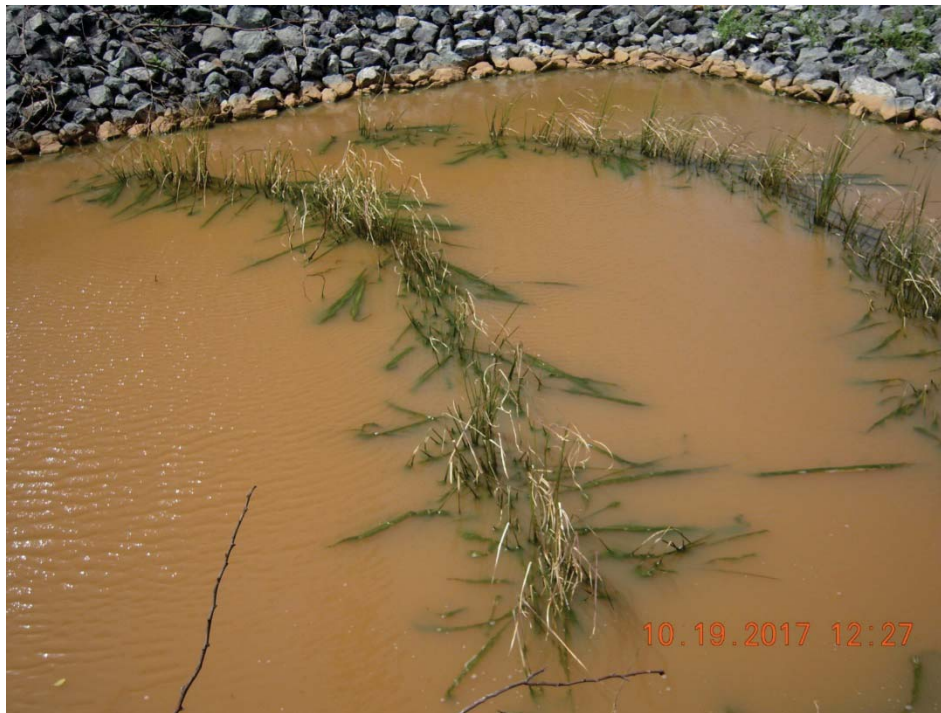
Figure 29: Detention Pond at Punta del Viento

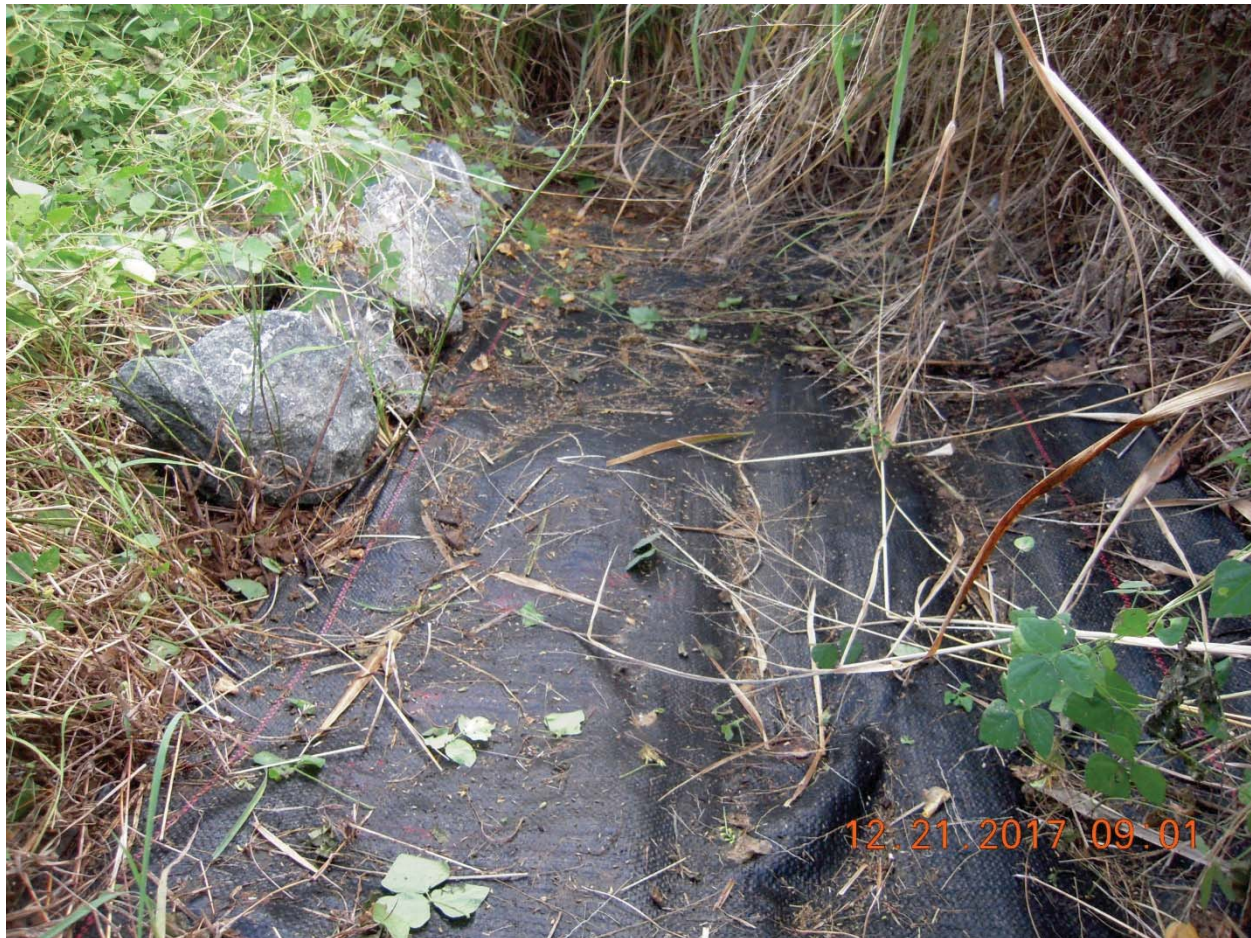
Figure 30: Sediment apron at a check dam in Punta Aloe

Silt-fence aprons were installed at the 23 energy dissipating structures (i.e., check dams along ditches or road drains) that were constructed by PDC in Punta Aloe during an earlier erosion control project. The purpose of these is to quantify the mass of sediment retained by these structures. The sediment traps consist of silt fence fabric nailed to the ground within the area occupied by the energy dissipating structures (Figure 30). These have been measured six times between August and March. The collected soil samples are being processed in the laboratory, but results are still not yet available. As of September 2018, a similar monitoring approach is now being followed at all of the 171 check dams built in Punta del Viento.

achieved during road improvements. Therefore, runoff along these road segments continues down the road and is therefore not being directed towards the traps (Figure 30). Traps 11-15 drain to the lower pond, located about one-third of the way up into Punta Aloe. These are some of the most effective traps due to the depth of the ditch and the effective road inslope tilting in this road section (Figure 31). Traps 16-23 receive the greatest amounts of runoff and sediment, but these were destroyed during the two hurricanes and have lost their trapping efficiency (Figures 32 and 33). Maintenance is required for these traps to perform at an acceptable level. Overall, the energy dissipating structures trap some sediment but periodical maintenance is required to sustain its effectiveness.

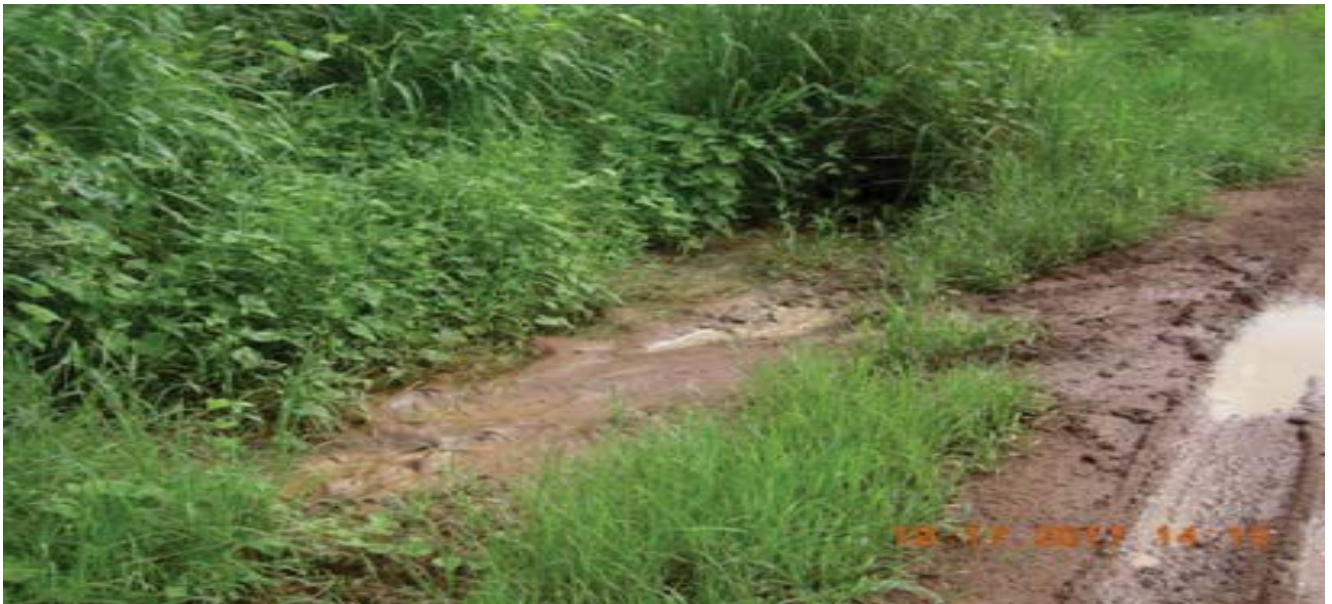
Figure 31: Sediment trap 1 at Punta Aloe

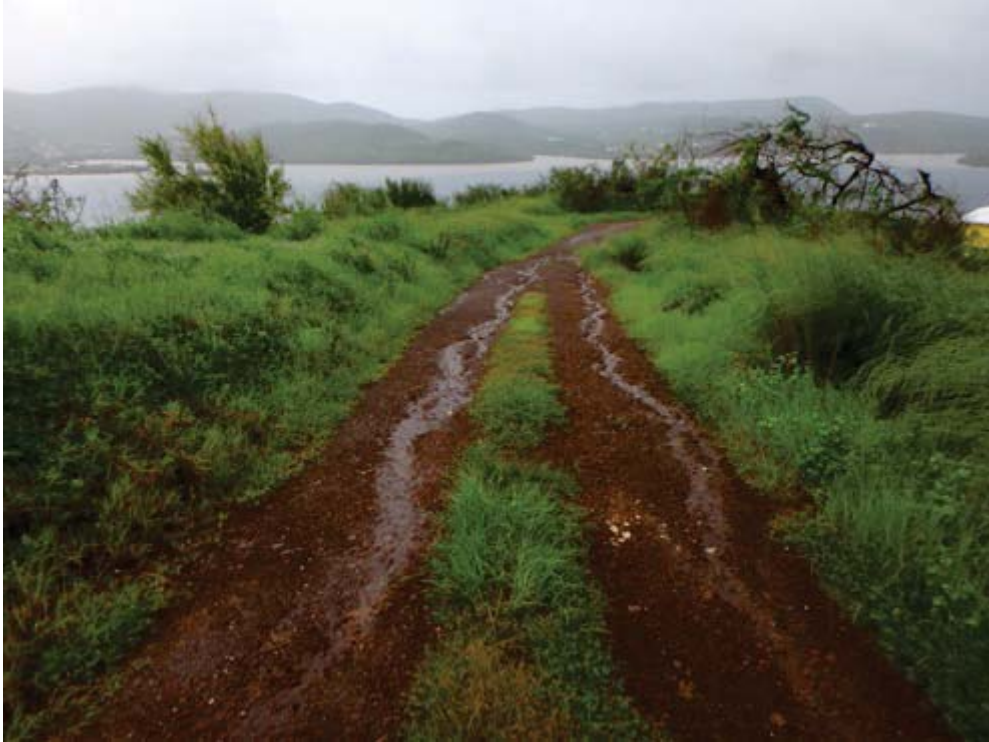
Our current appreciation is that the performance of the energy dissipating structures (check dams) in trapping sediment along Punta Aloe varies significantly among the 23 monitored sites in Punta Aloe. Traps 1 and 2 serve as road drains directing runoff towards detention pond 1 near the top of the main access road. Traps 1 and 2 consistently have had significant amounts of sediment during all the visits (Figure 26). Traps 3-10, all located on road segments below the top detention pond, rarely collect significant amounts of sediment, mainly because the road has lost the insloping grade (i.e., inward tilting) that was originally

Figure 32: Runoff flowing through the center of the road and not being delivered to the ditch on the right were the sediment traps are located

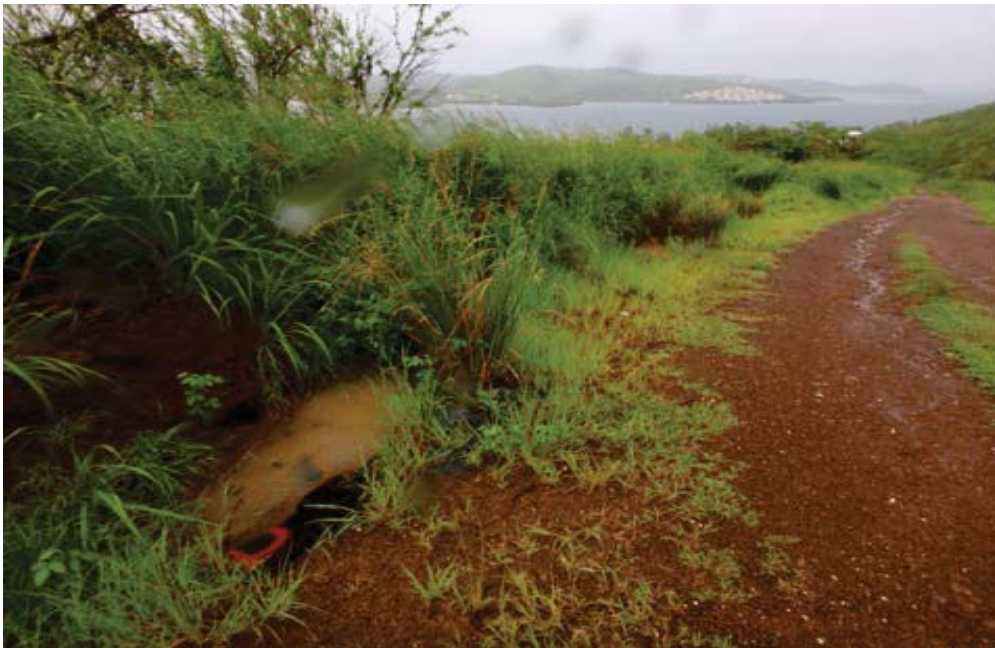
Figure 33: Traps 11-15 are located on the ditch on the left.

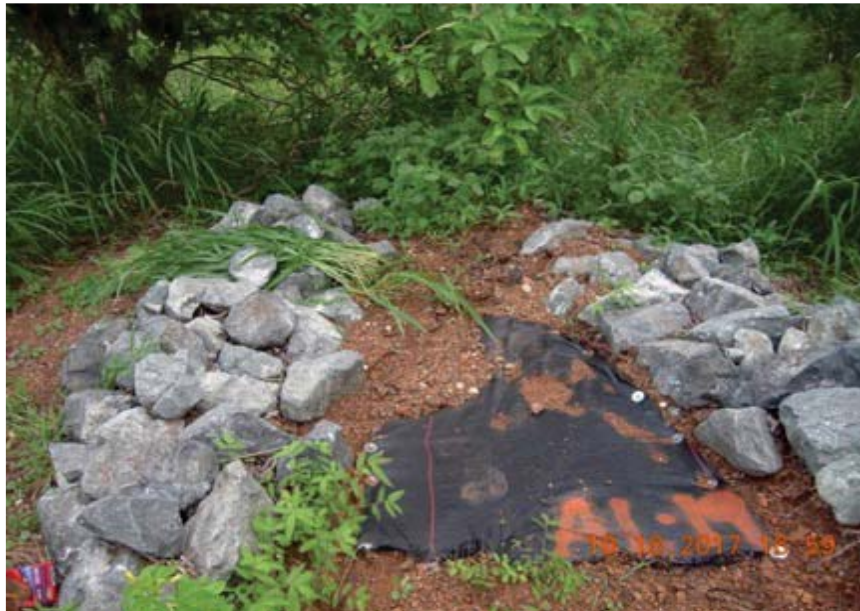
Figure 34: Trap 19, note how the sediment goes over the energy dissipating

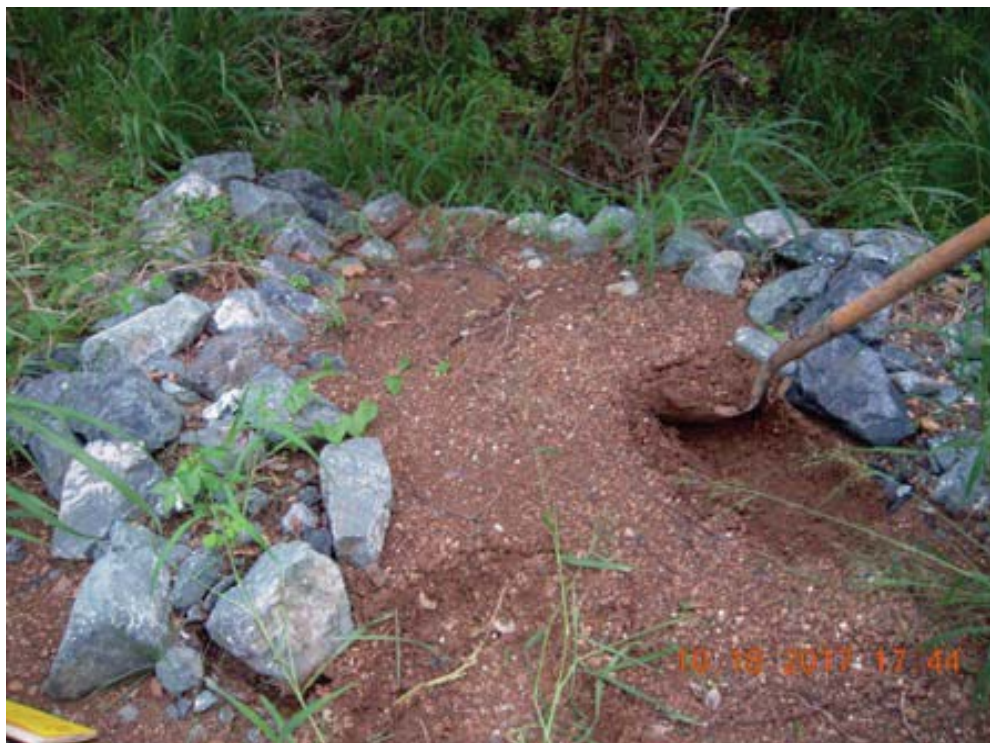
Figure 35: Damaged sediment trap
