Talakhaya Watershed Soil Loss Assessment Phase II Stream Monitoring Report

July 31, 2017

Prepared for:
NOAA Coral Reef Conservation Program

Report Prepared by:
Horsley Witten Group, Inc. and Malcolm Johnson

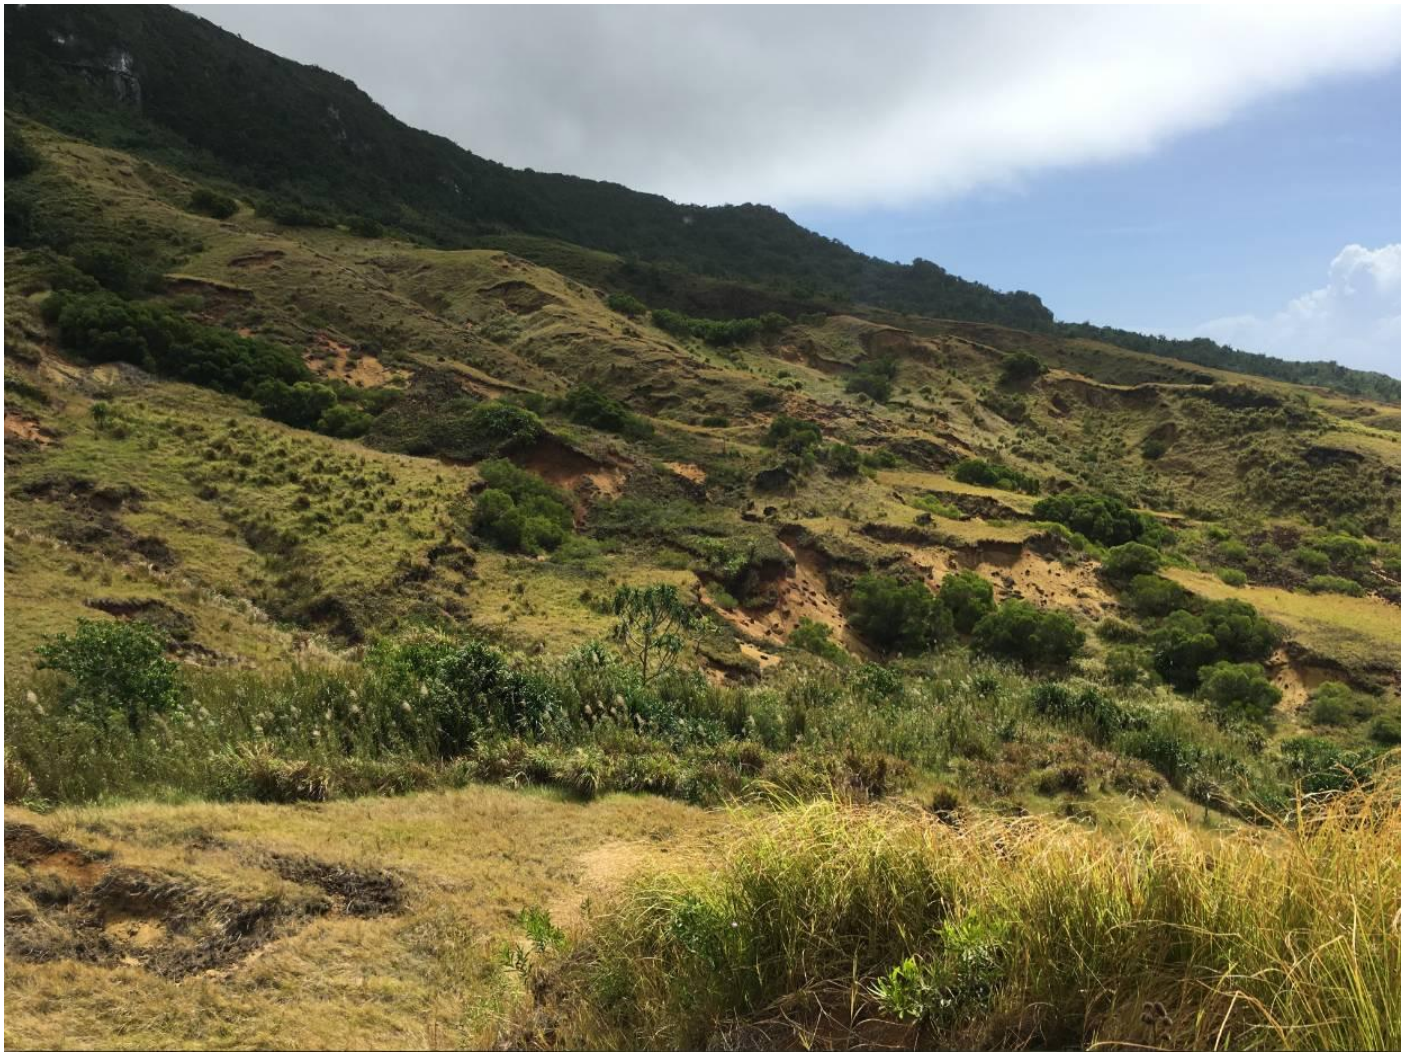
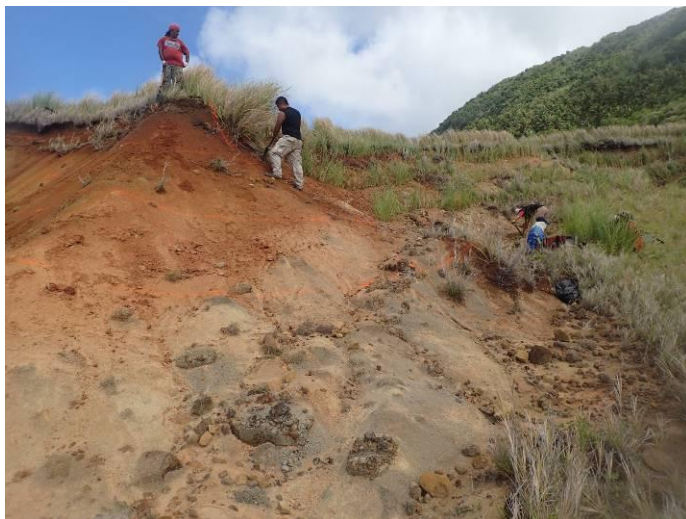
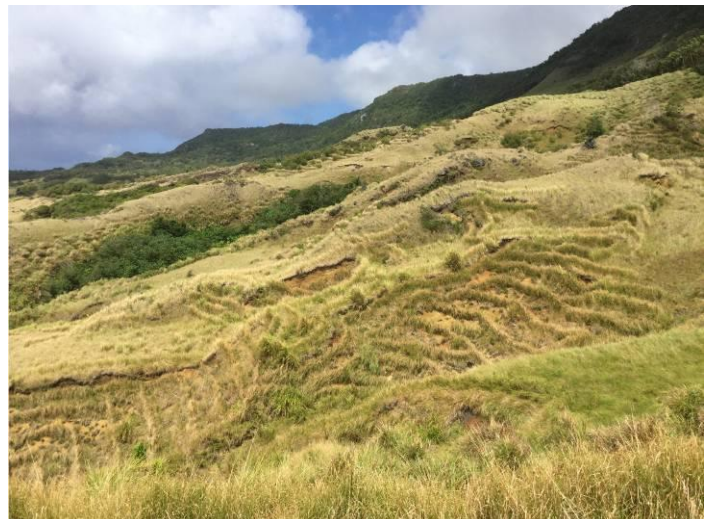
Figure 2. (Top) Steep limestone cliffs leading from the Sabana plateau, into the eroding, grassed slopes of Talakhaya. (Bottom Left) Active planting of Talakhaya badlands in 2016. (Bottom Right) Rows of vetiver grass and resulting vegetative establishment are clearly visible in previously planted areas.

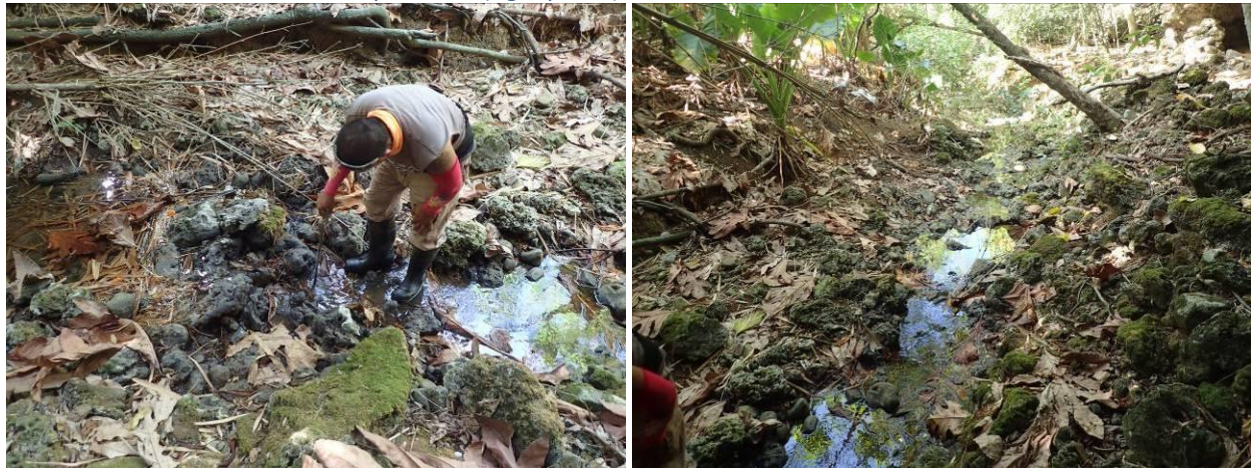
Figure 8. Installation of the new station at TK0-R1 occurred June 15, 2016 (left photo); this subwatershed is similar to TK1 in size and the stream was perennial (right photo).

Station TK0-R1 was added in June 2016 to represent the new “control” subwatershed since revegetation efforts were advanced into the Phase I control badlands starting in July 2016. This new sampling station was added to provide additional data representing a stream with unvegetated badlands. As shown in **Figure 4**, there had been previous revegetation efforts (2007-2010) in this area, but the 2012 fire had recreated badlands. This stream was flowing throughout the Phase II sampling period.

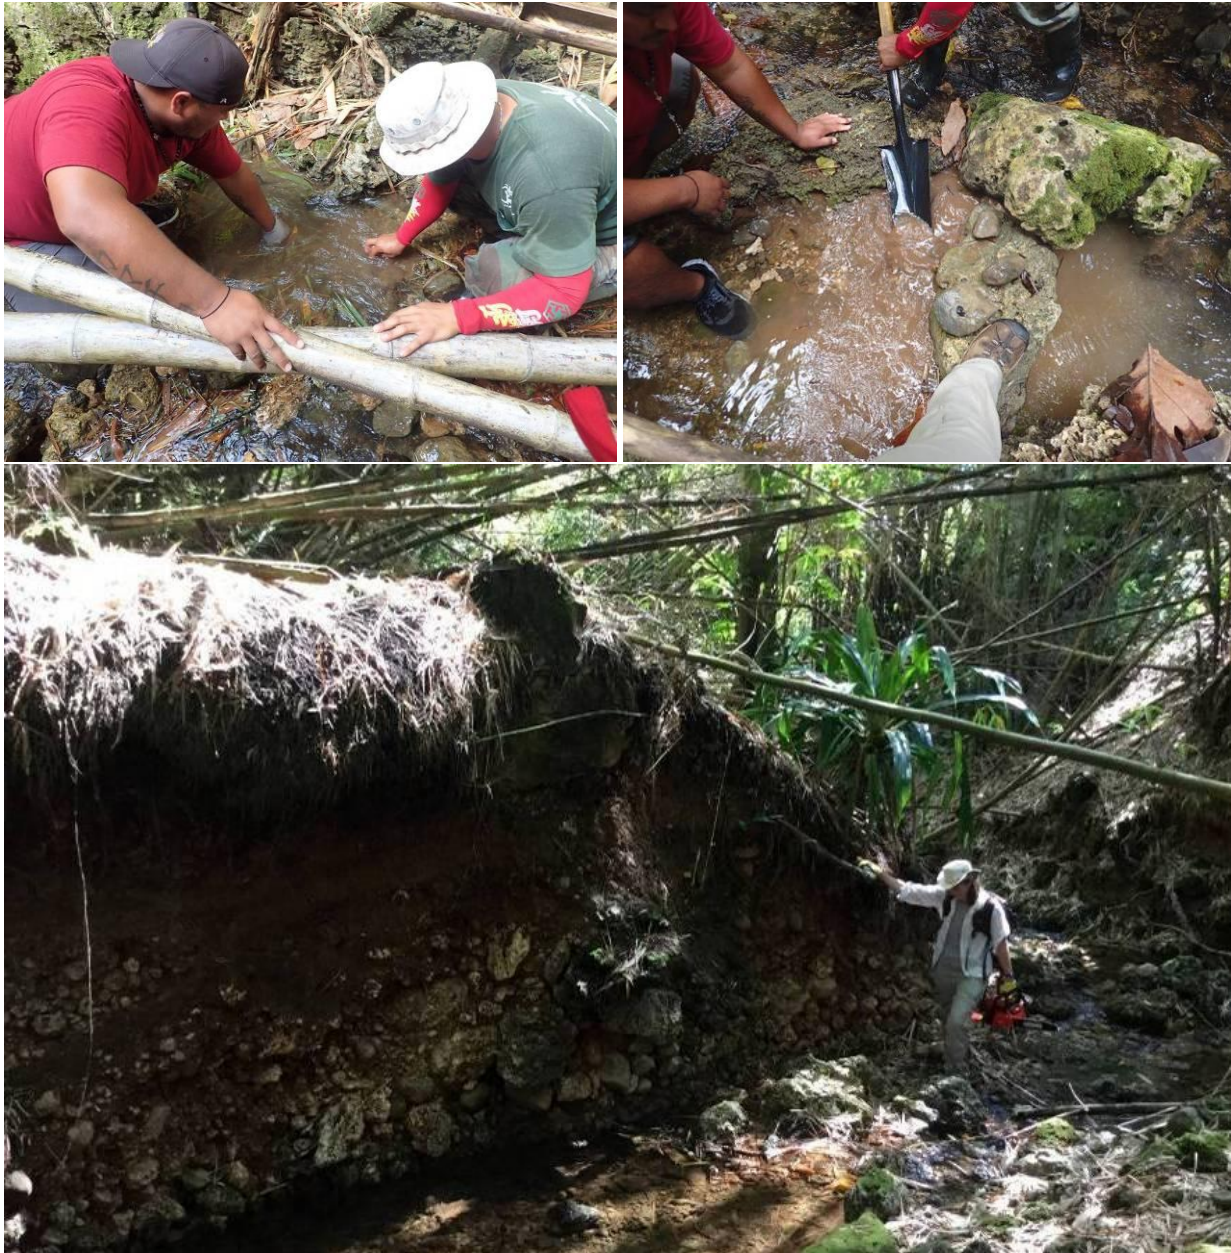
Figure 9. Field team searching for logger under bamboo at TK1-R2 (left); removing sediment build-up at Station TK1-R3; and carrying in a chainsaw to improve access and break-up a debris dam at TK1-R1 (bottom).

The TK1 stream was described during Phase I as most “flashy” or hydrologically dynamic of the sites in Phase I, with widely varying flows throughout the year. Not surprisingly, this stream has had the most data collection issues with debris build-up creating dams and sediment deposits that have buried and even swept away the loggers at the three in-stream stations (**Figure 9**). Access to the stations was dangerous during rain events and occasionally blocked afterwards.

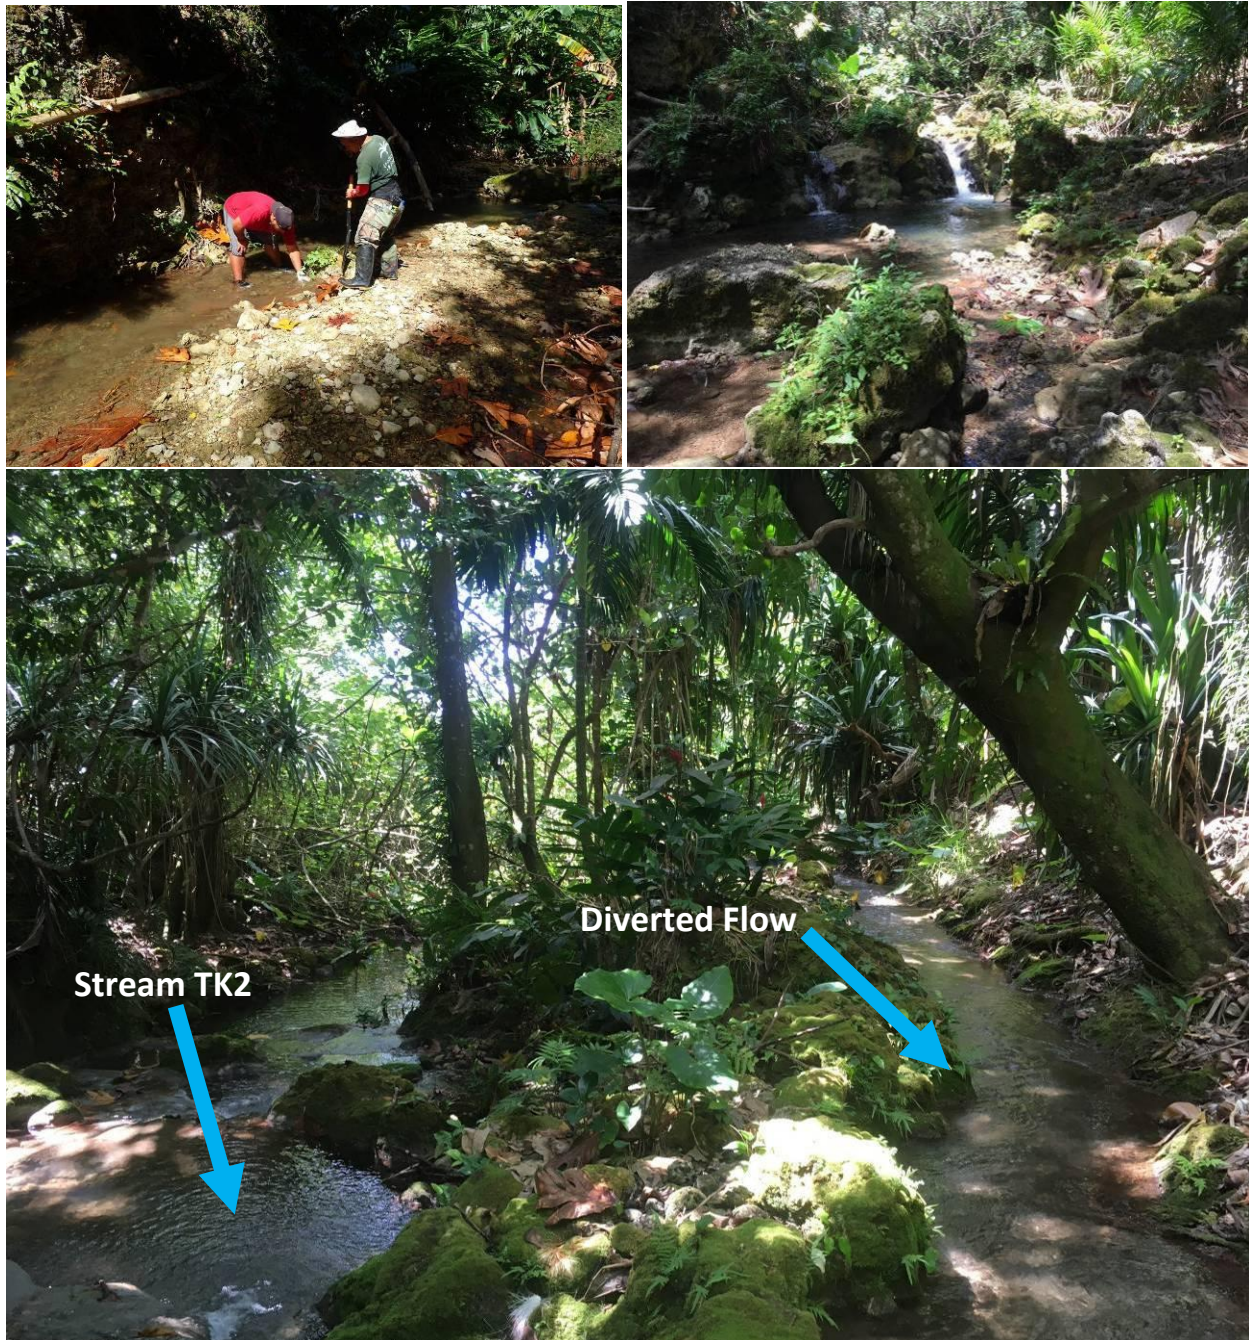
Figure 10. Looking for the logger at Station TK2-R3 (left); waterfall just upstream from TK2-R2 (right); and the flow diversion discovered during Phase II (bottom).

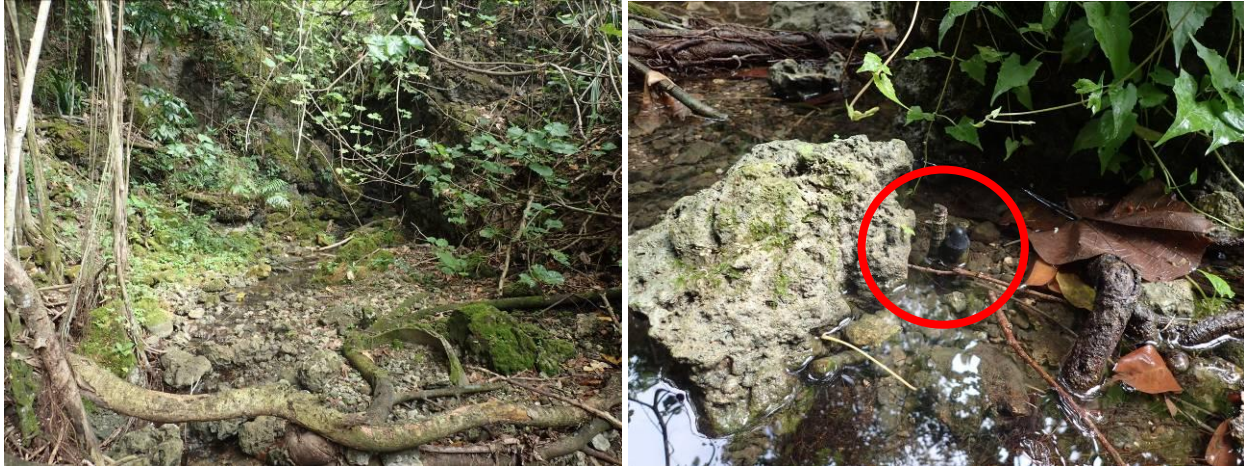
Figure 11. Stream characteristics near station TK3-R1 (left); logger location for TK3-R1 (right).

The one station on stream TK3 was chosen to represent another subwatershed with revegetated badlands in addition to TK2. However, this subwatershed does not include any mapped revegetated areas between 2007-2016 (see **Figure 4**), so it is unknown when revegetation occurred. This stream has the smallest drainage area of the monitored subwatersheds, but the stream is mostly perennial with easy access to the monitoring station (**Figure 11**).

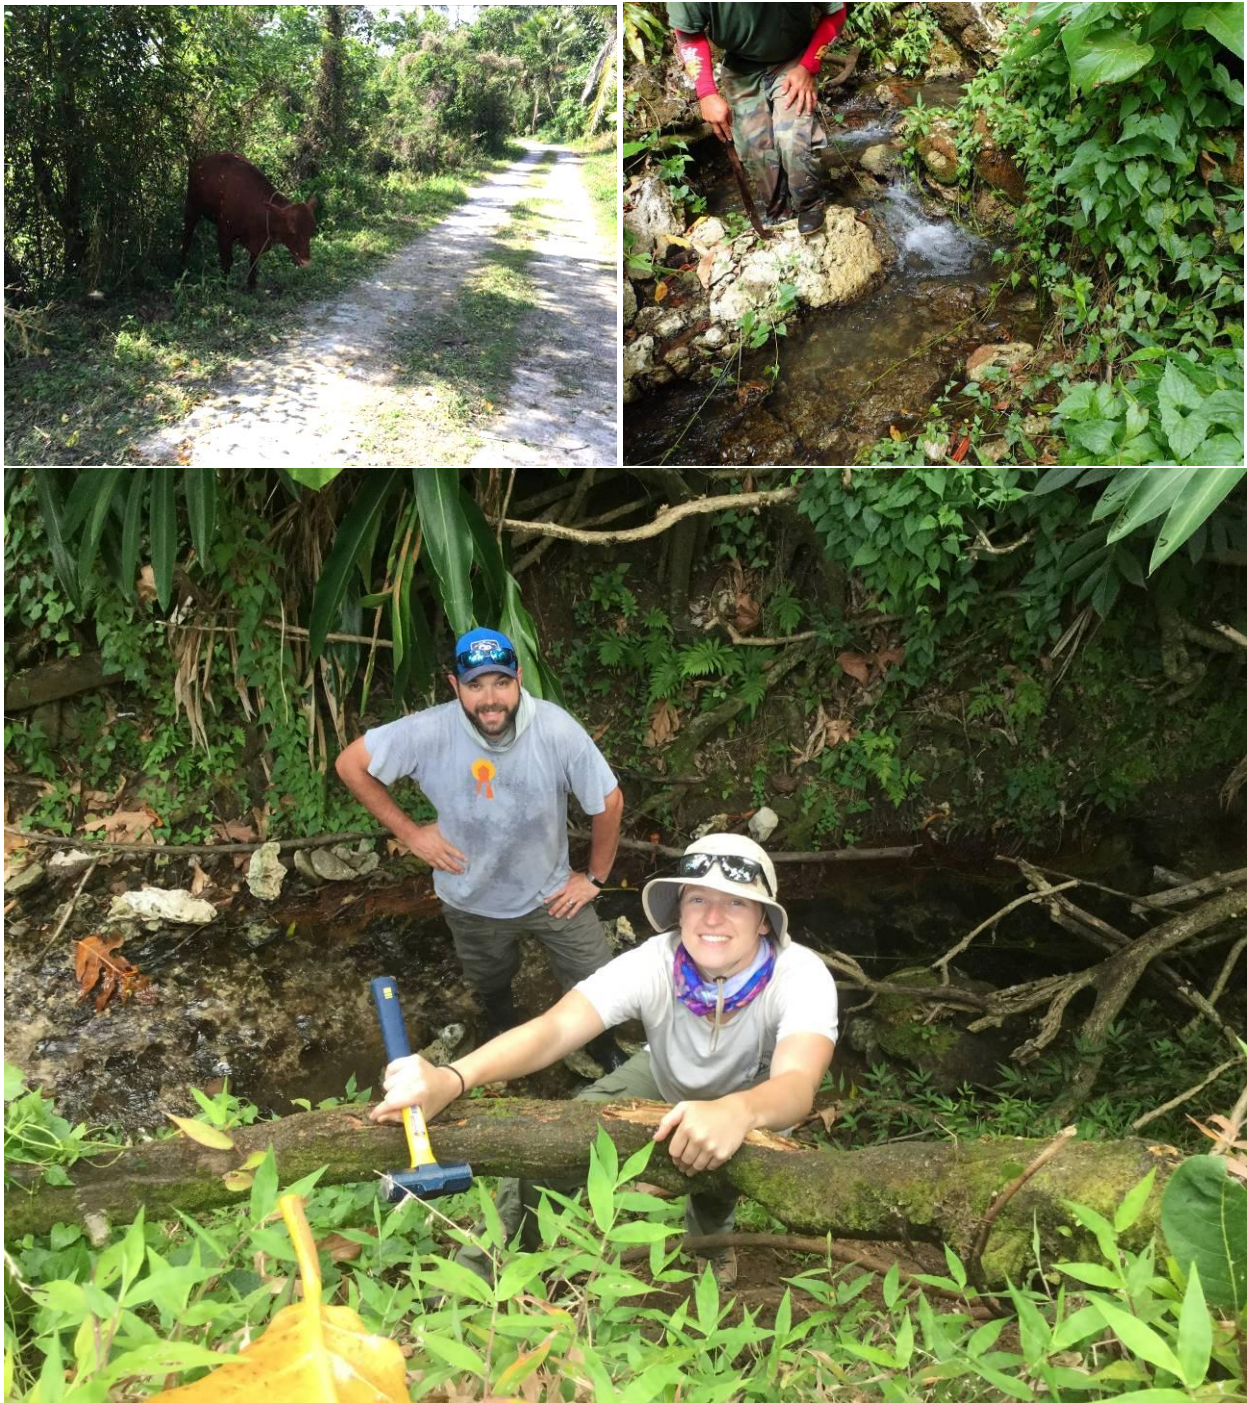
Figure 12. A cow encountered in this subwatershed (left); Stream at TK-R2 (right); and field team climbing out of TK4-R3 before the station was removed.

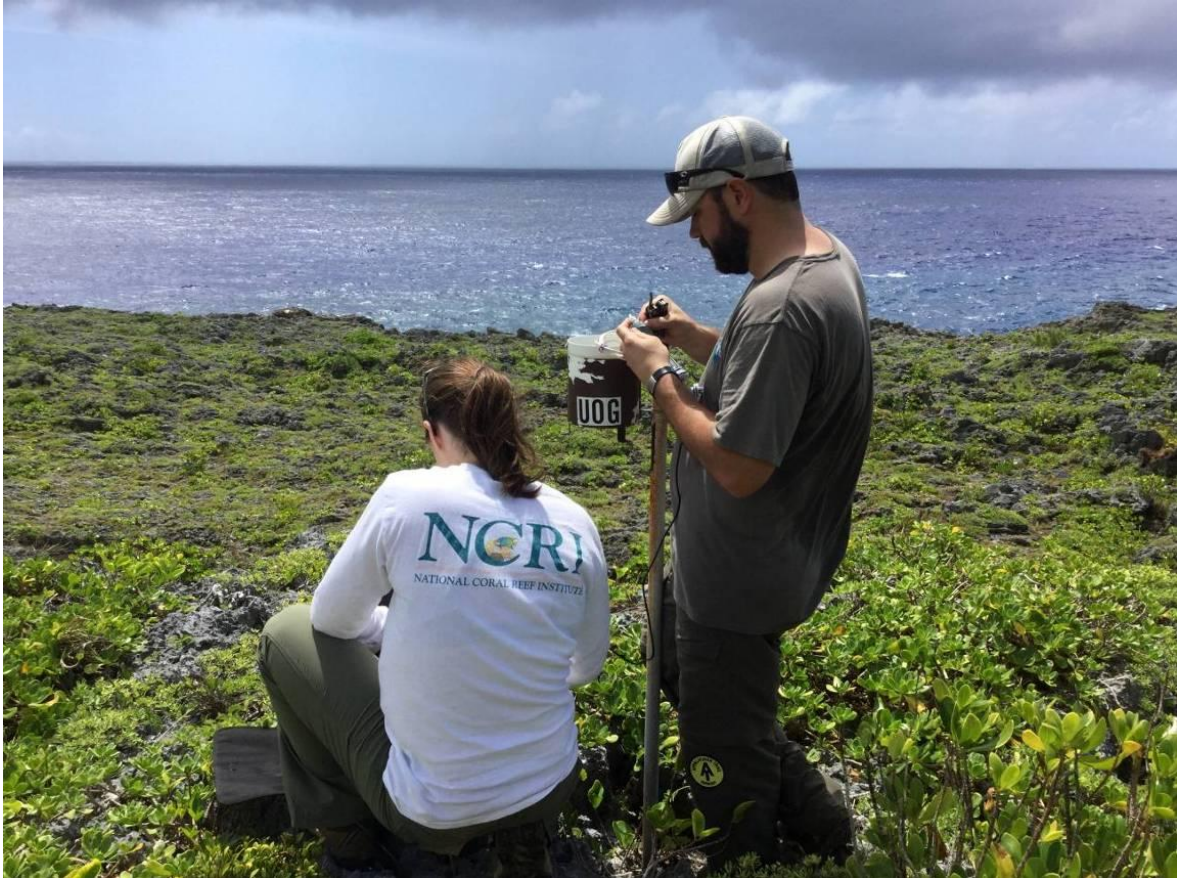
Figure 13. Rain gauge at Pona Point - TKRG1.

The rain gauge at Pona Point is located closest to the coast with the easiest access from the main road (**Figure 13**). This gauge was the most visible to the public, and was removed at one point during Phase II by someone. Luckily, the field team was able to recover the rain gauge, which had been abandoned nearby. Unfortunately, the gauge was later shot and destroyed and had to be replaced with a new unit.

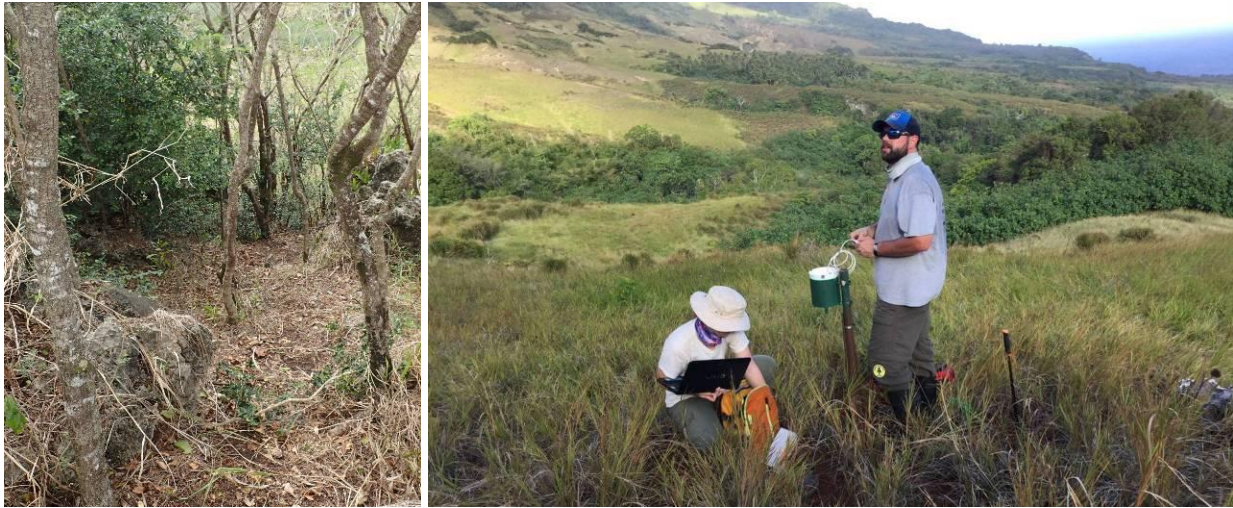
Figure 14. Nearly vertical path to TKRG2 where a rope was installed to help the field team access the site (left); downloading data at TKRG2.

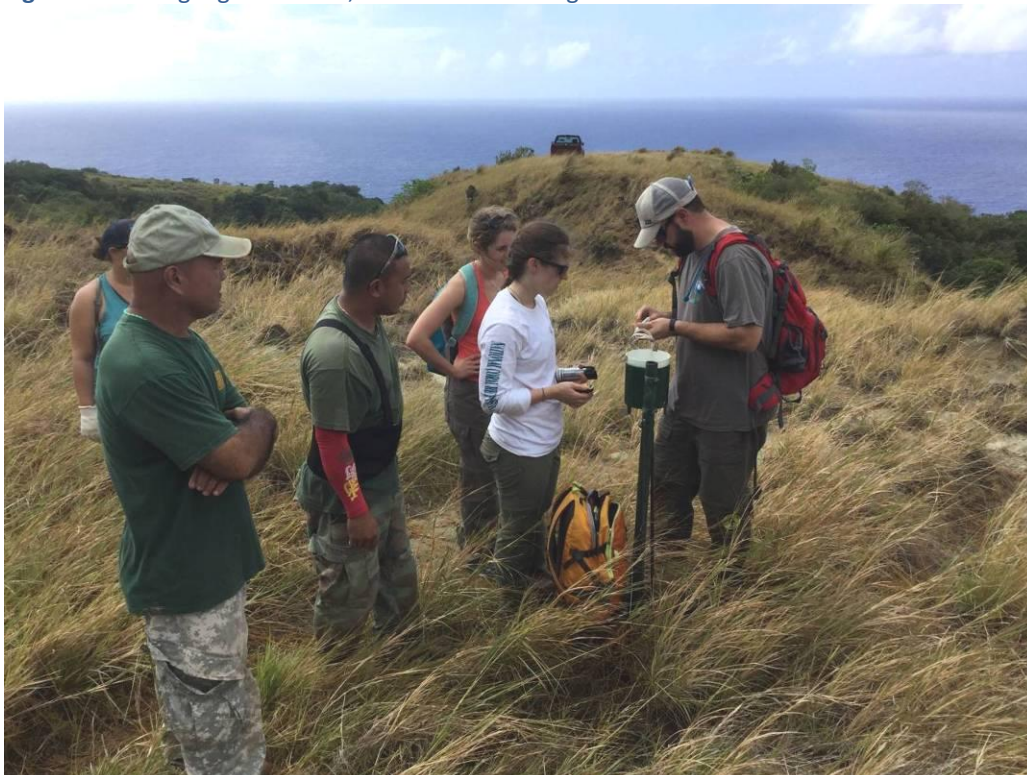
Figure 15. Rain gauge at TKRG3, near the 2016 revegetation site.

TKRG3 was located along the western edge of Subwatershed TK1. The area was mostly open grasslands with some exposed badlands, steep cliffs, and ravines (**Figure 15**). This site was only accessible by an extremely rough road that was barely passable by vehicle; luckily, this location was adjacent to the 2016 planting area, so the field team was able to ride along with DLNR Forestry staff to access the rain gauge. This rain gauge provided the most consistent rainfall data of the four sites.

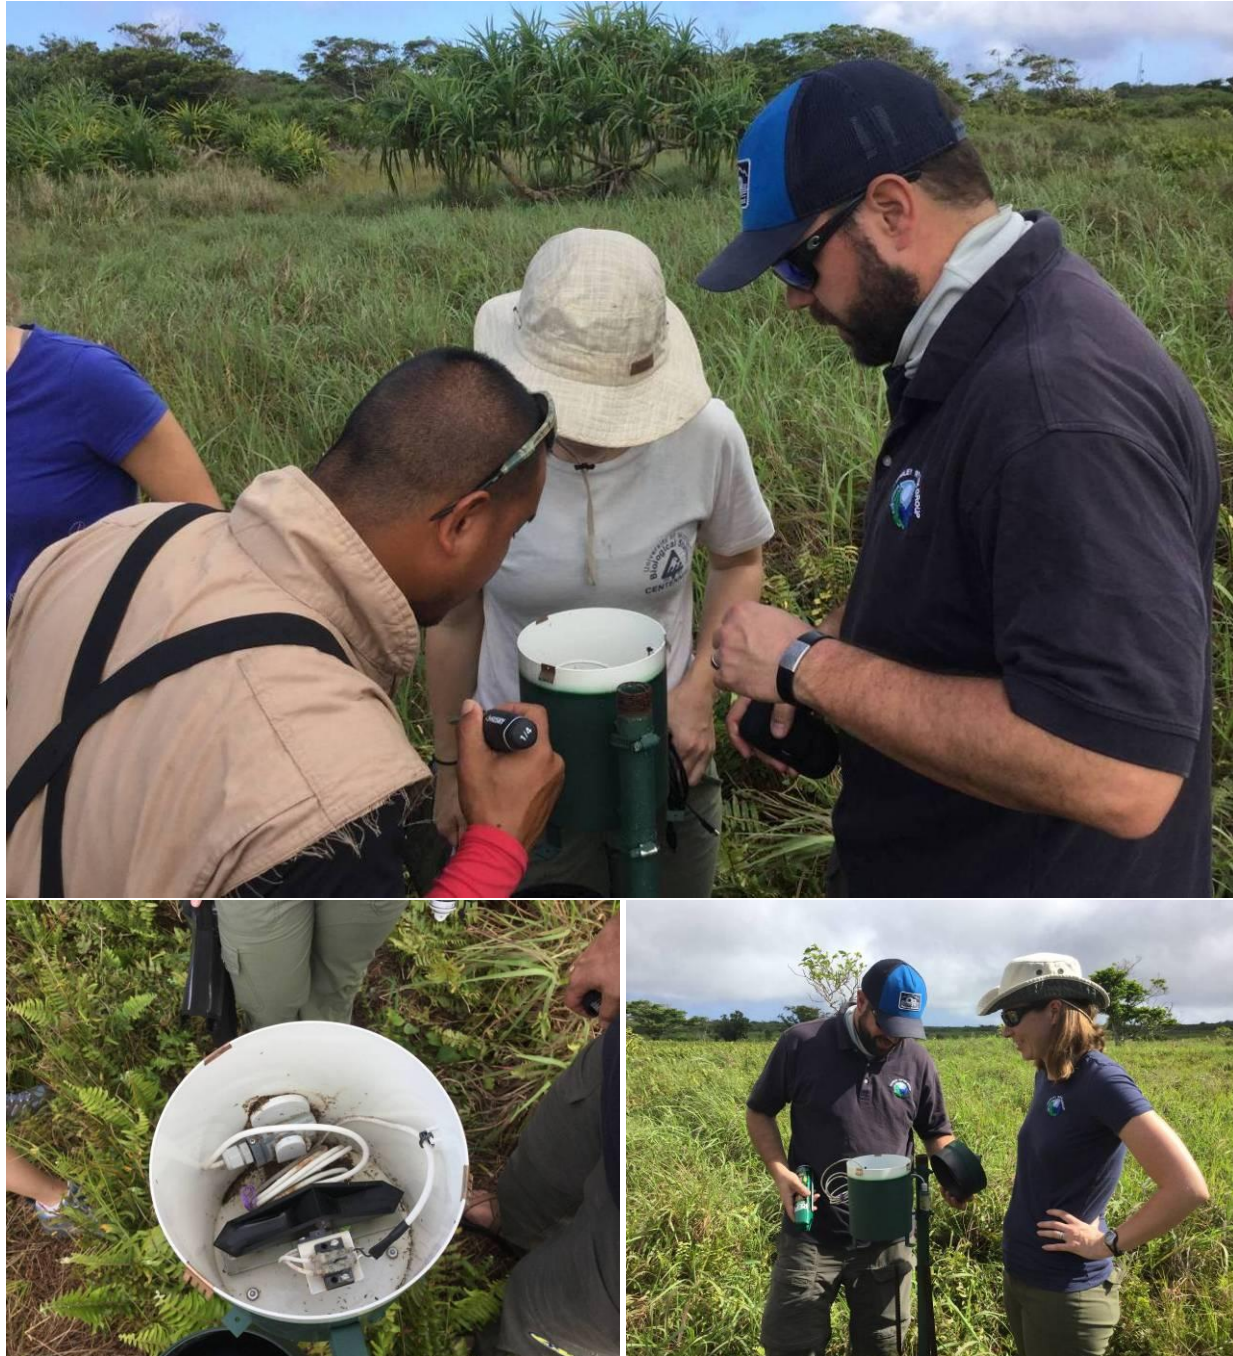
Figure 16. Rain gauge on the Sabana Plateau-TKRG4(top); ant nest affecting the tipping bucket (bottom left); removing ants from rain gauge (bottom right).

This rain gauge is located in the Sabana Protected Area, high on the Sabana Plateau and accessed only from the north (i.e., taking the main road from Songsong rather than the roads near the study area). The Sabana Plateau in this area is a mix of open grasslands and forests, and is protected for threatened and endangered species as well as for the water caves and other local interests. This site had no issues with vandalism, but was occasionally overrun by nesting ants (Figure 16).

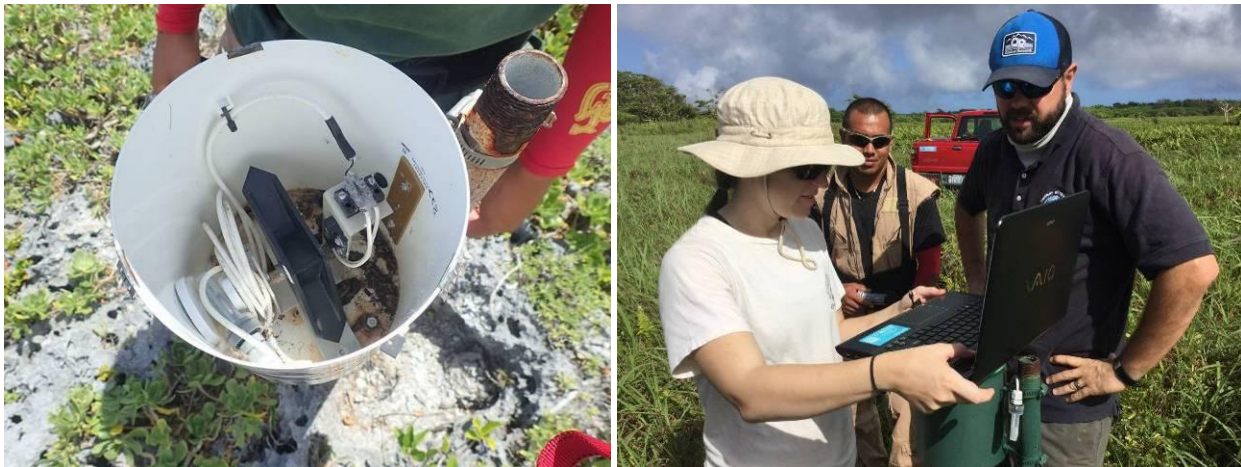
Figure 17. Inside of rain gauge showing tipping bucket (bottom left); Downloading data from the Hoboware Rain Gauge (right).

Rainfall data was collected using HoboWare® rain gauges at four locations in the watershed. Each gauge has a rugged, aluminum housing with a funnel on top that directs rainfall into a tipping bucket that measures and records every 0.01” of rainfall (**Figure 17**). The gauge is battery powered, and the data is downloaded via USB cord or a waterproof shuttle. The rain gauges were installed with couplers onto a metal post. The rain gauge at TKRG2 was replaced in March 2016 due to cracked housing, TKRG4 was replaced in August 2016 when it failed for unknown reasons, and TKRG1 was replaced after it was shot.

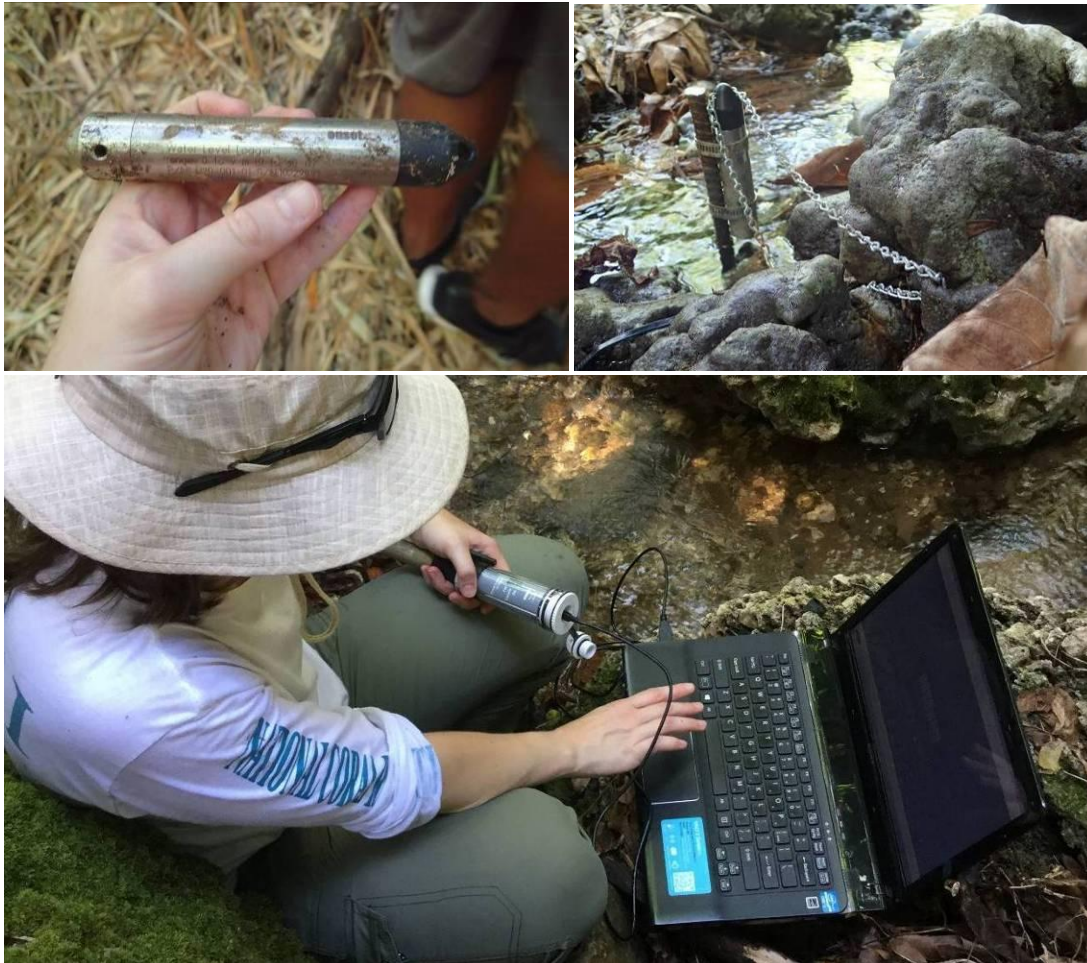
Figure 18. HOBO level loggers were used for determine barometric pressure ("air" loggers; left photo); stream depth (attached to rebar in stream; right photo); and downloading logger data onto laptop in the field (bottom).

Stream water level, also referred to as “stage,” was collected with HOB0® Level Loggers placed in the stream bed at each in-stream station to record water pressure, as well as somewhere near each stream to record atmospheric (i.e., air) pressure (**Figure 18**; **Figure 19**). These loggers

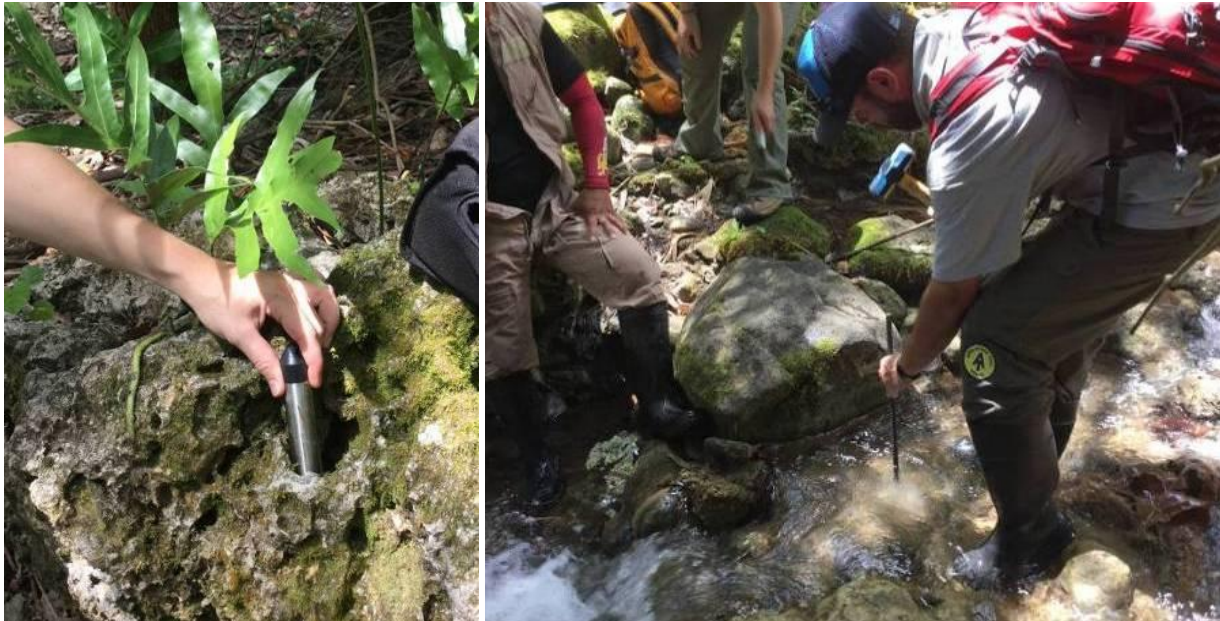
Figure 19. Placement of data logger for recording atmospheric pressure near in-stream station (left); installing rebar for in-stream level logger (right).

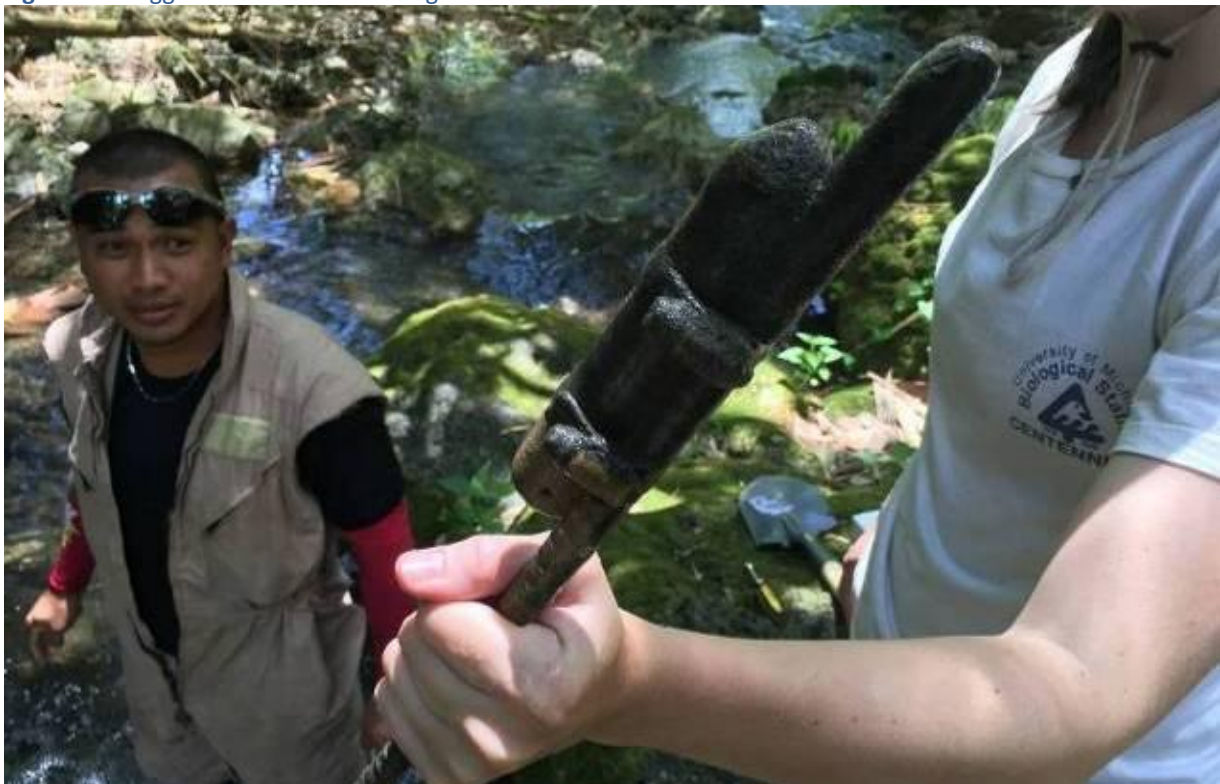
Figure 20. Logger and rebar melded together.

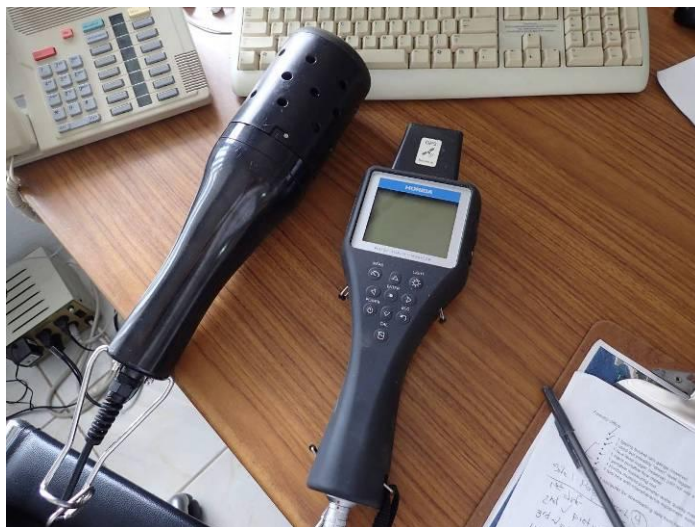
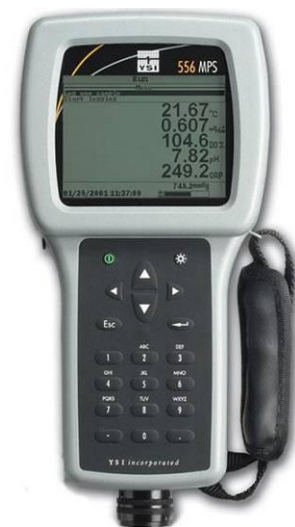
Figure 21. HORIBA multiple parameter meter used in Phase I (left); YSI 556 MPS meter used in Phase II (right)

Stream water quality was measured at least monthly when the streams were flowing using a multi-parameter water quality meter (see **Figure 21**: Phase I – HORIBA meter; Phase II – borrowed BECQ’s YSI® meter, with a separate Hach® meter for turbidity) to collect data on: acidity (pH), dissolved oxygen (DO), turbidity, total dissolved solids (TDS), and conductivity. Water quality data were recorded by hand on field data sheets for entering into a spreadsheet back in the office. For the purpose of this Phase II report, only turbidity data were analyzed and discussed in Section 3. The meters were calibrated when possible to try to maintain level of accuracy.

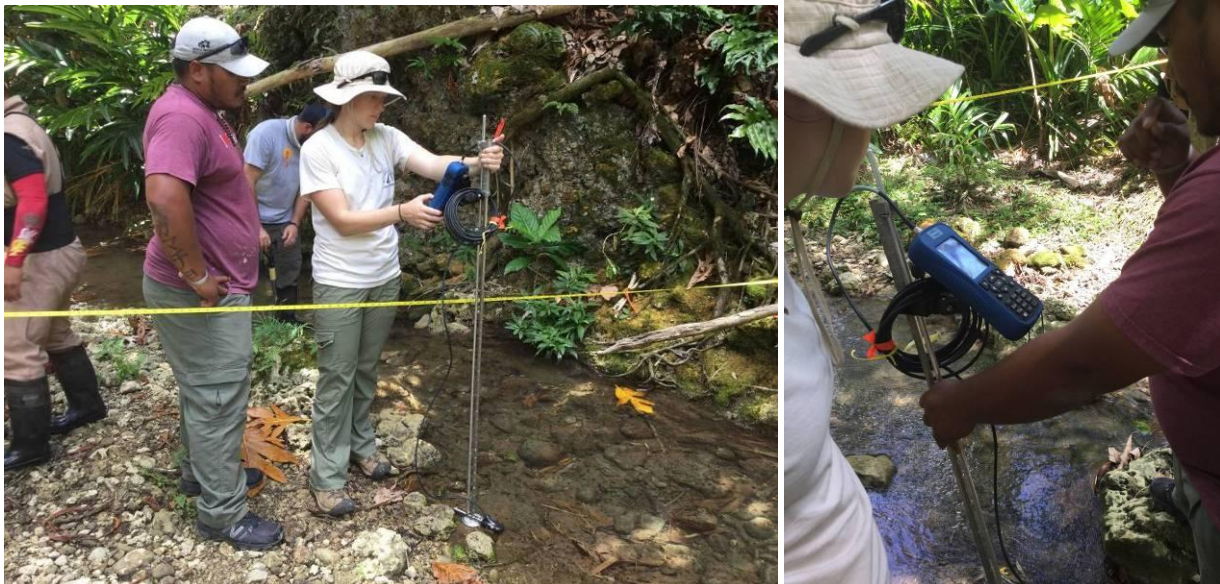
Figure 22. Using the HACH portable flow meter in the field.

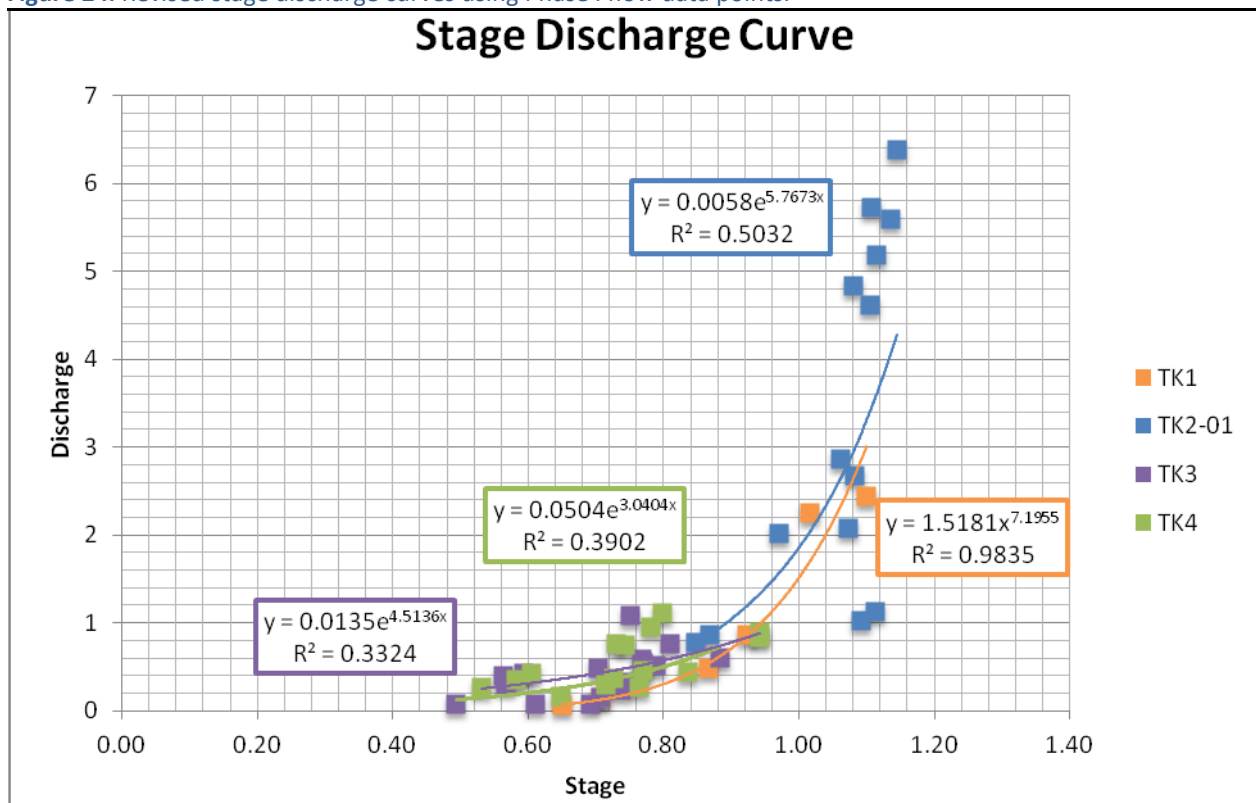
Figure 24. Revised stage discharge curves using Phase I flow data points.

Figure 24 shows the revised stage-discharge curves for Phase I data, which differ from the curves reported by Golabi and Manibusan (2014) as discussed in Section 2.4. The amount of flow data collected during Phase I and Phase II is inadequate to develop high-quality stream stage-discharge relationships. Therefore, results presented are preliminary, and should be seen as the initial step towards establishing such curves. Please note that no stream flow data was collected for stream TK0 during Phase II, and because it is a new station, there was no stage/discharge relationship established under Phase I. Without flow data, the water quality information collected here cannot be analyzed in the context of flow. **Figure 25** compares stream flow to hourly rainfall for each of four streams, showing both Phase I and Phase II calculated flows. Flow is represented on a base-10 log axis due to high data variability.

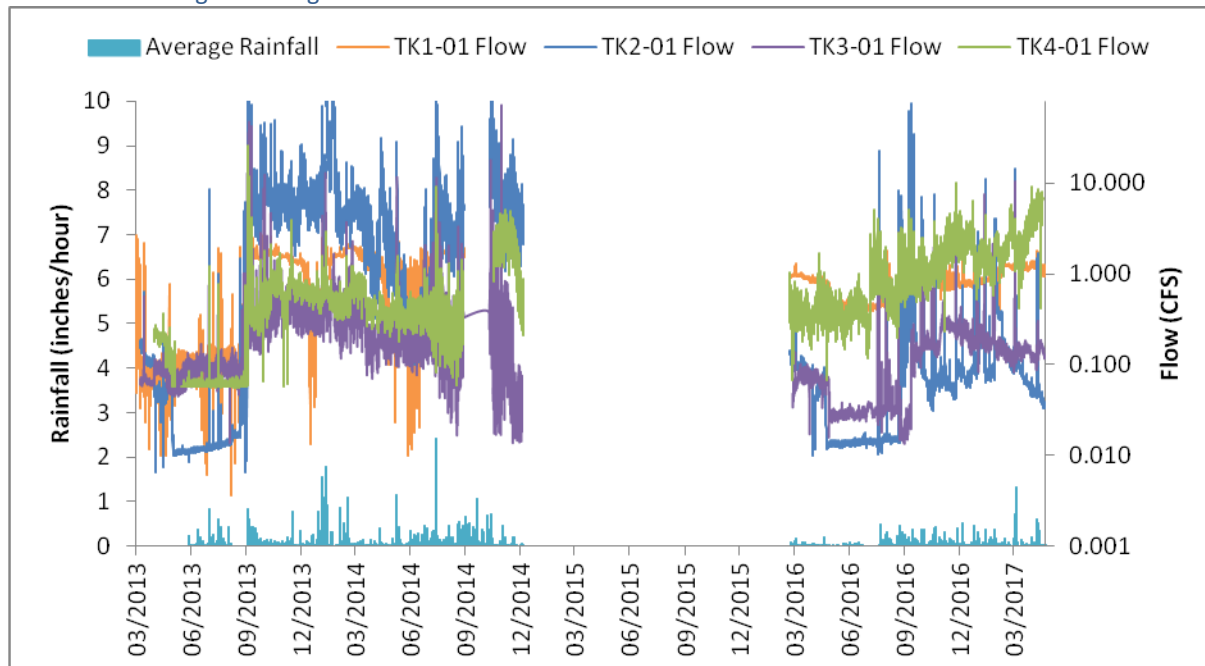
Figure 25. Calculated flow for streams TK1, TK2, TK3, and TK4 vs. rainfall for Phases I and II of the study based on each stream’s stage-discharge curve.

As expected, TK1 is the most hydrologically dynamic with the most widely varying flows during and after rain events. In general, this graph follows the same trends as the stream level graph, which is expected since these data are calculated flows from the stage-discharge relationships rather than measured flows.

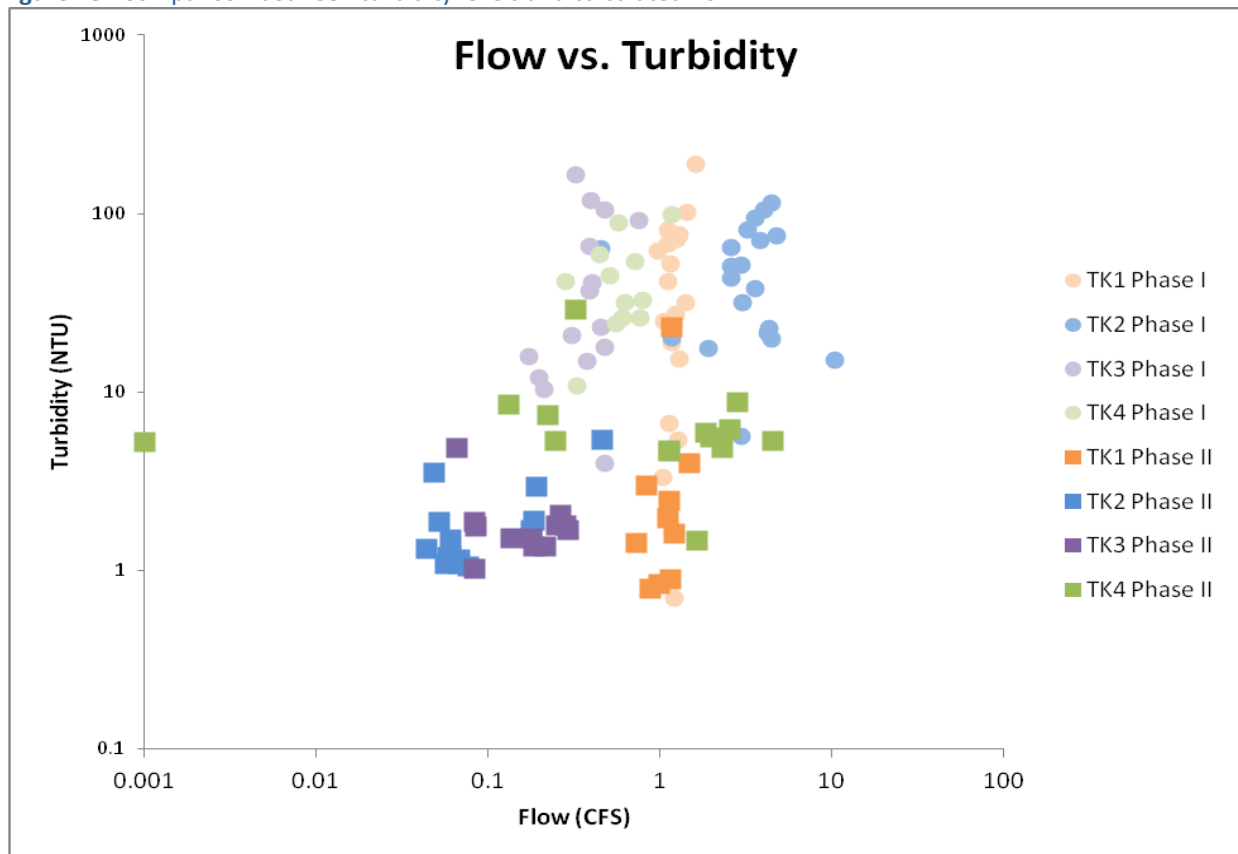
Figure 28. Comparison between turbidity levels and calculated flow.

Figure 28 looks at the relationship between calculated streamflow and turbidity levels at each stream. Comparison between turbidity levels and calculated flow indicates a positive correlation for TK2 and 3, with no correlation for TK1 and 4.
