# St. Thomas East End Reserves Watershed Management Plan

May 2013

Horsley Witten Group, Inc.

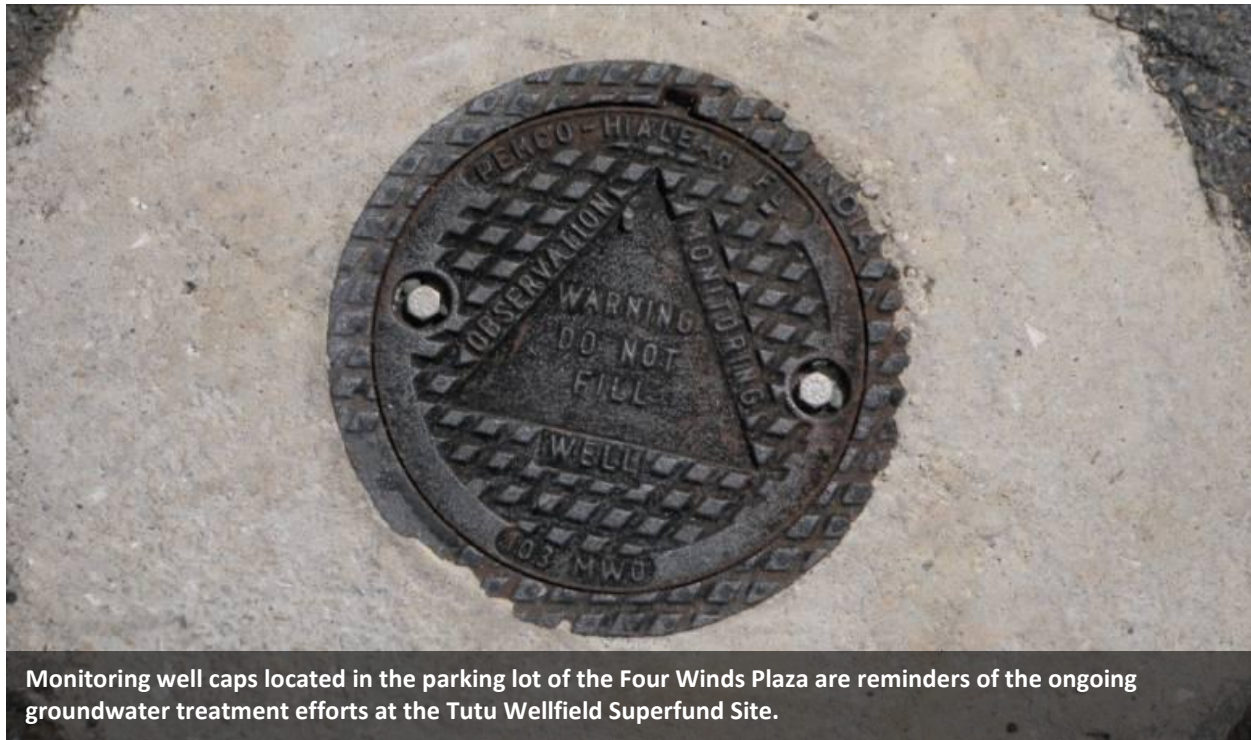
Monitoring well caps located in the parking lot of the Four Winds Plaza are reminders of the ongoing groundwater treatment efforts at the Tutu Wellfield Superfund Site.

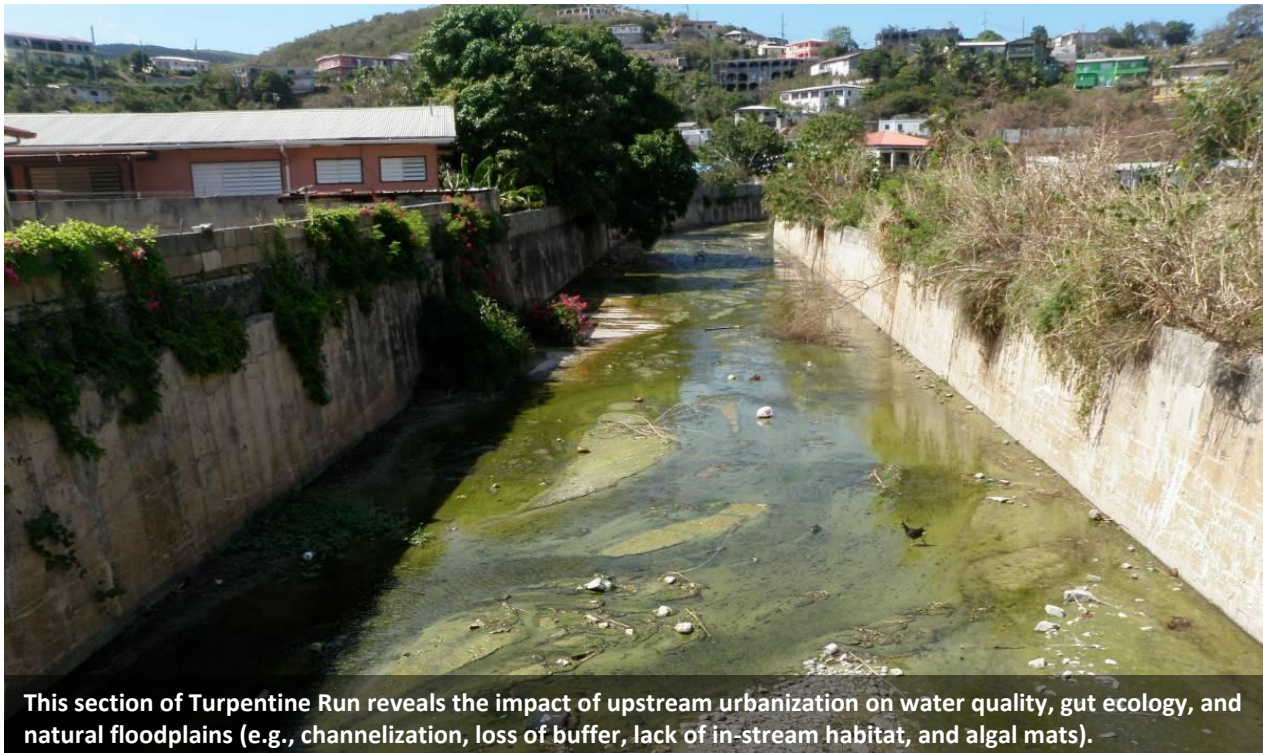
This section of Turpentine Run reveals the impact of upstream urbanization on water quality, gut ecology, and natural floodplains (e.g., channelization, loss of buffer, lack of in-stream habitat, and algal mats).

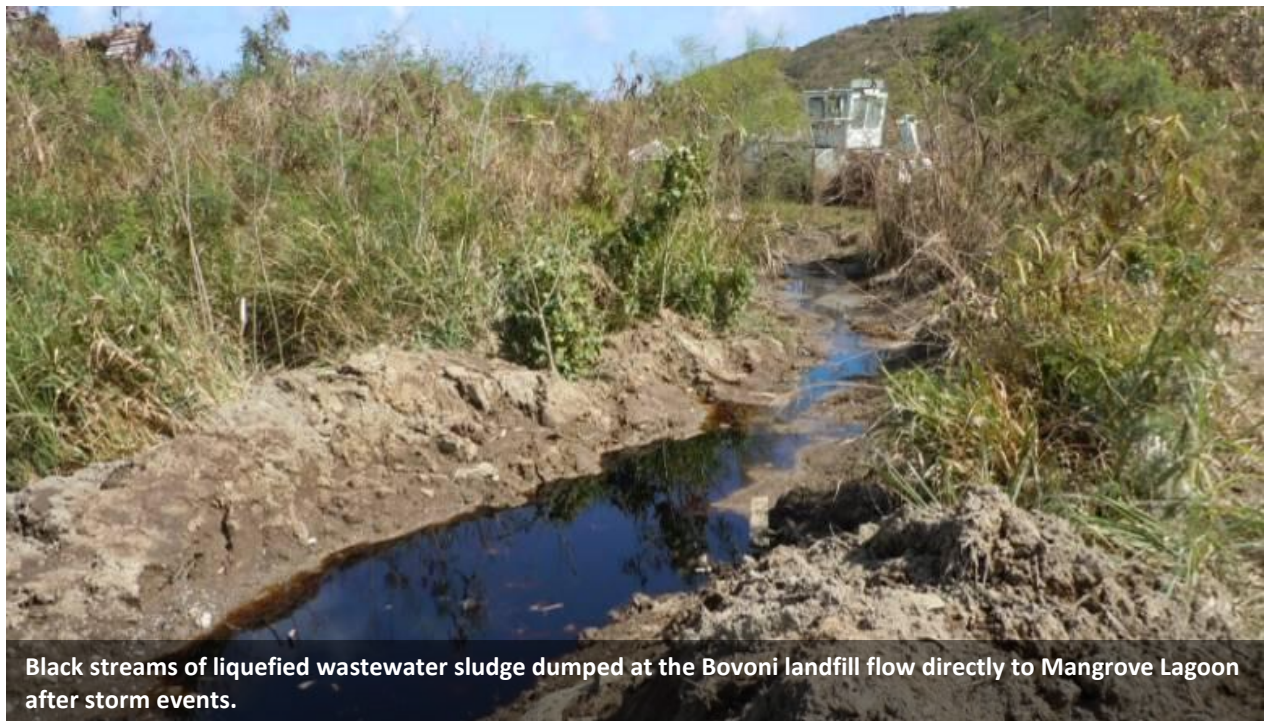
Black streams of liquefied wastewater sludge dumped at the Bovoni landfill flow directly to Mangrove Lagoon after storm events.

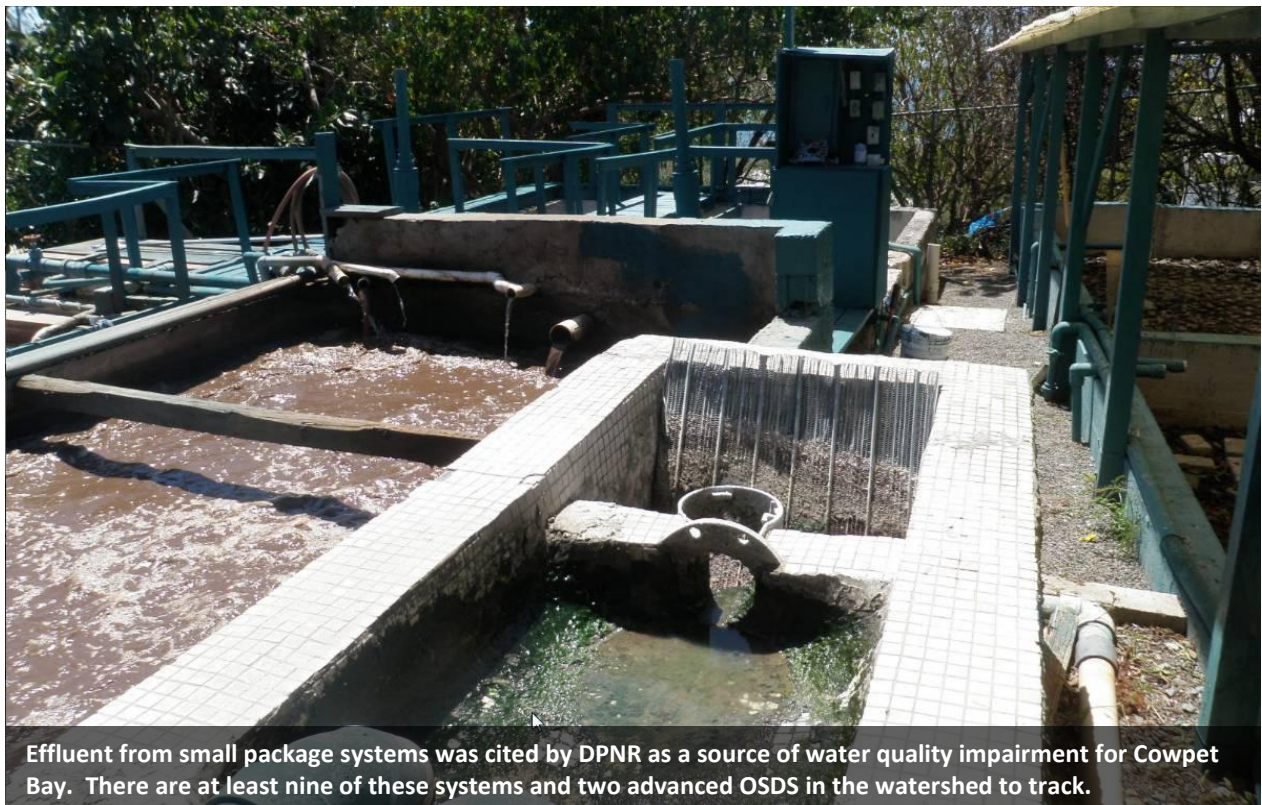
Effluent from small package systems was cited by DPNR as a source of water quality impairment for Cowpet Bay. There are at least nine of these systems and two advanced OSDS in the watershed to track.

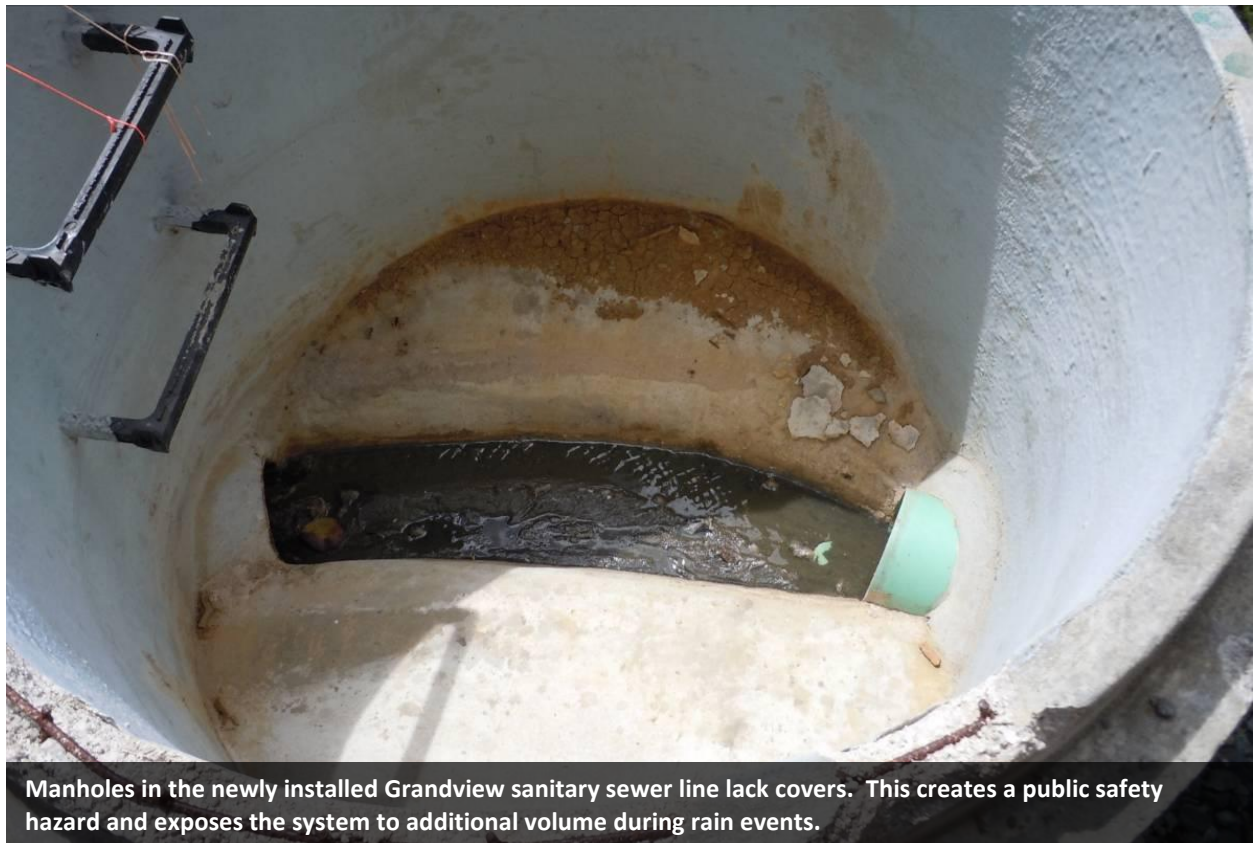
Manholes in the newly installed Grandview sanitary sewer line lack covers. This creates a public safety hazard and exposes the system to additional volume during rain events.

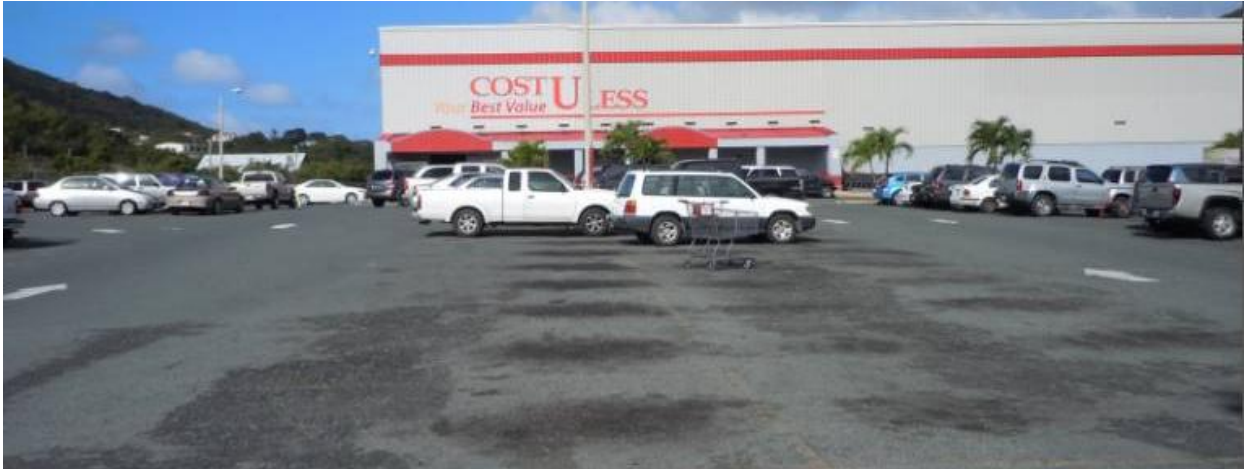
The oil stains seen here are one of a number of pollutants collecting on impervious surfaces throughout the watershed that are washed into Turpentine Run and discharged into Mangrove Lagoon when it rains.

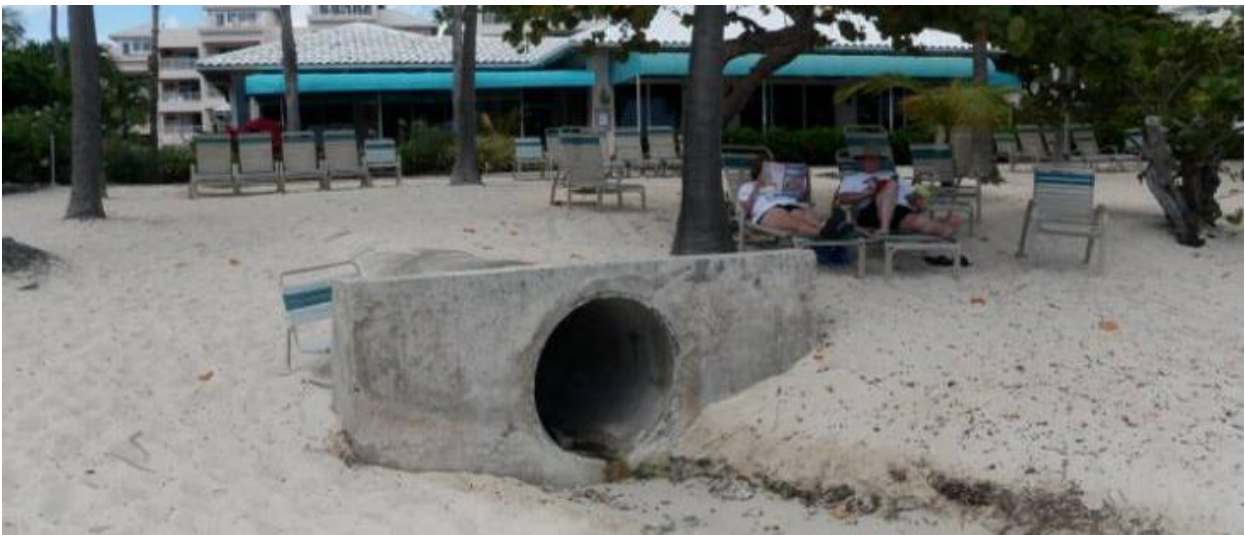
Discharge pipes visible on the beach drain parking lots, roads, and other developed areas in the watershed. In most cases throughout STEER, this runoff is not cleaned prior to discharge.

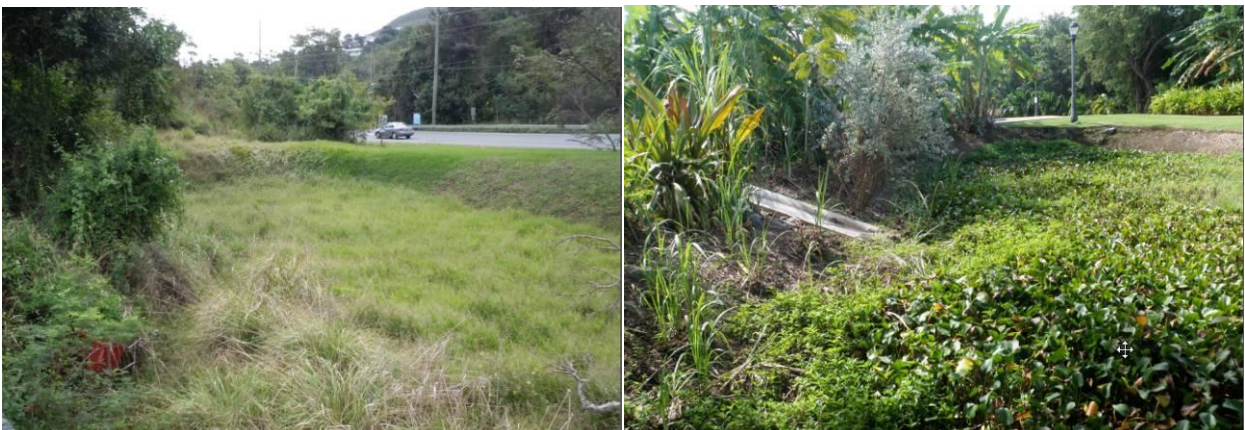
Two examples of existing stormwater management facilities are the dry detention basins at Cost-U-less and the wet basin at the Ritz Carlton.

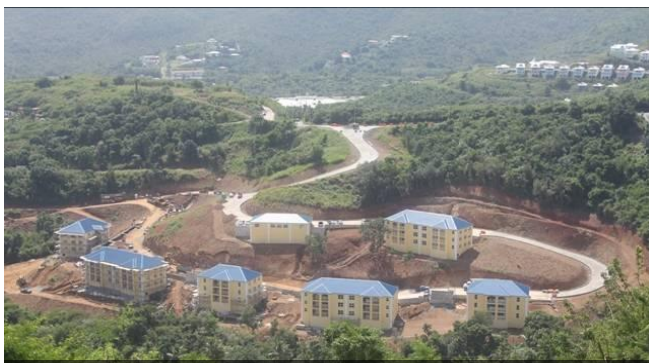
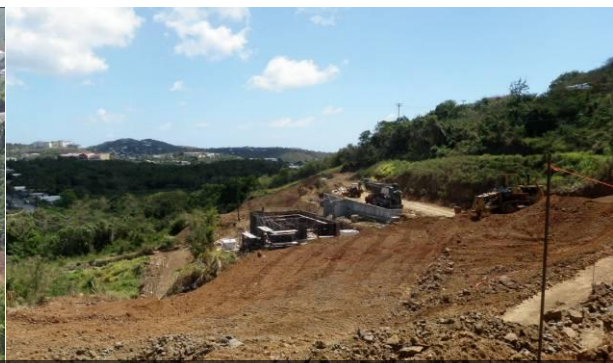
Grandview uses erosion control blankets and riprap to stabilize some slopes, but there remain acres of exposed soils and failing perimeter silt fencing that result in sedimentation downstream.

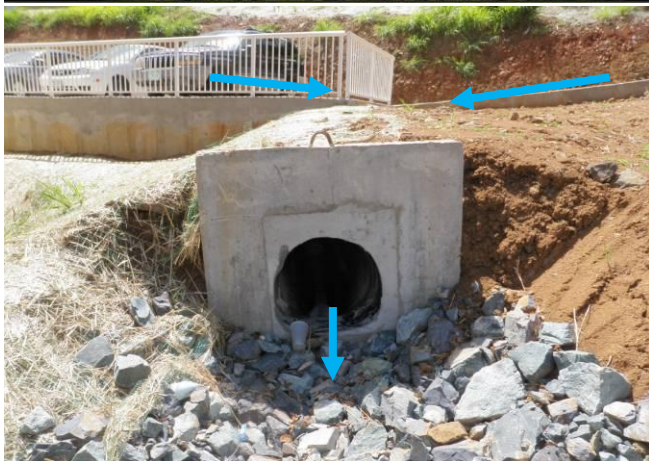
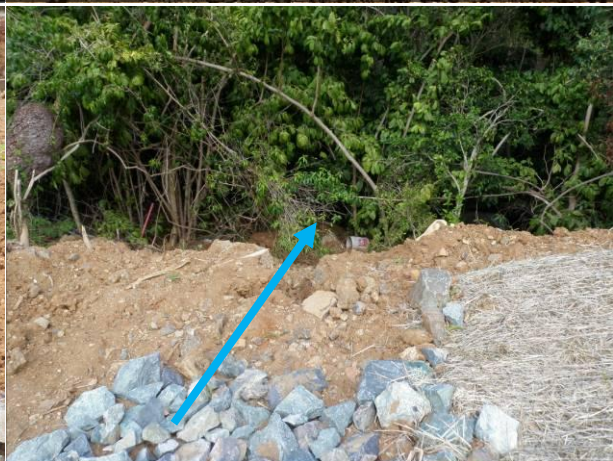
Outfalls discharge stormwater from Grandview roads and parking lots directly to the gut without any form of water quality treatment or flow detention.

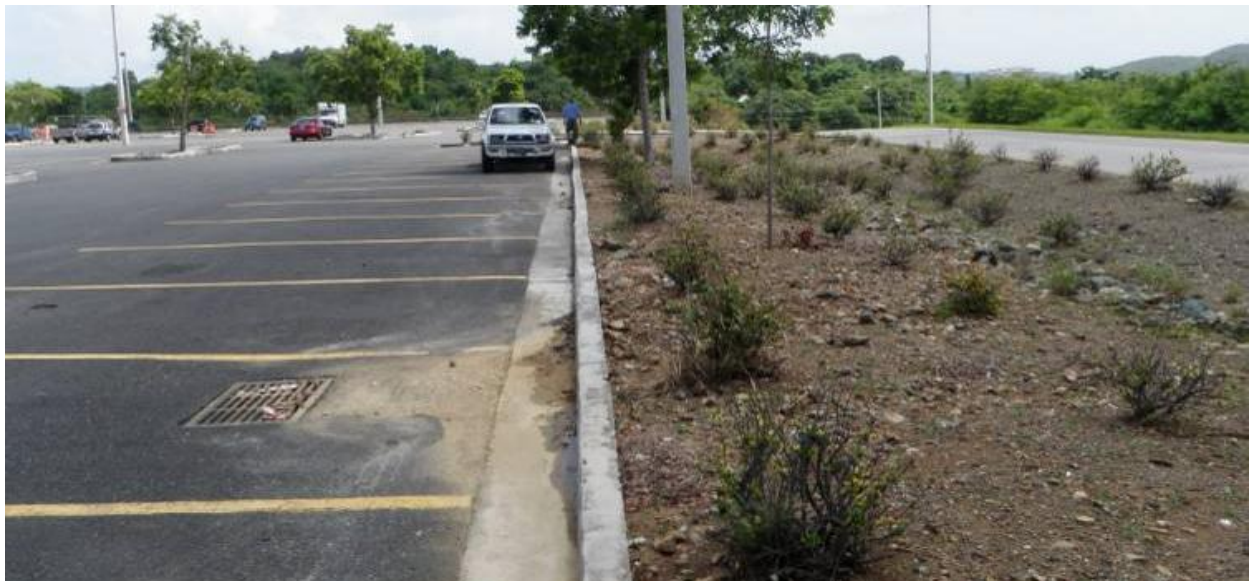
**Retrofitting can help improve existing conditions. An easy fix at Home Depot is to block this inlet and allow parking lot runoff to flow into landscaping via curb cuts, allowing for plant uptake, infiltration, and filtering.**

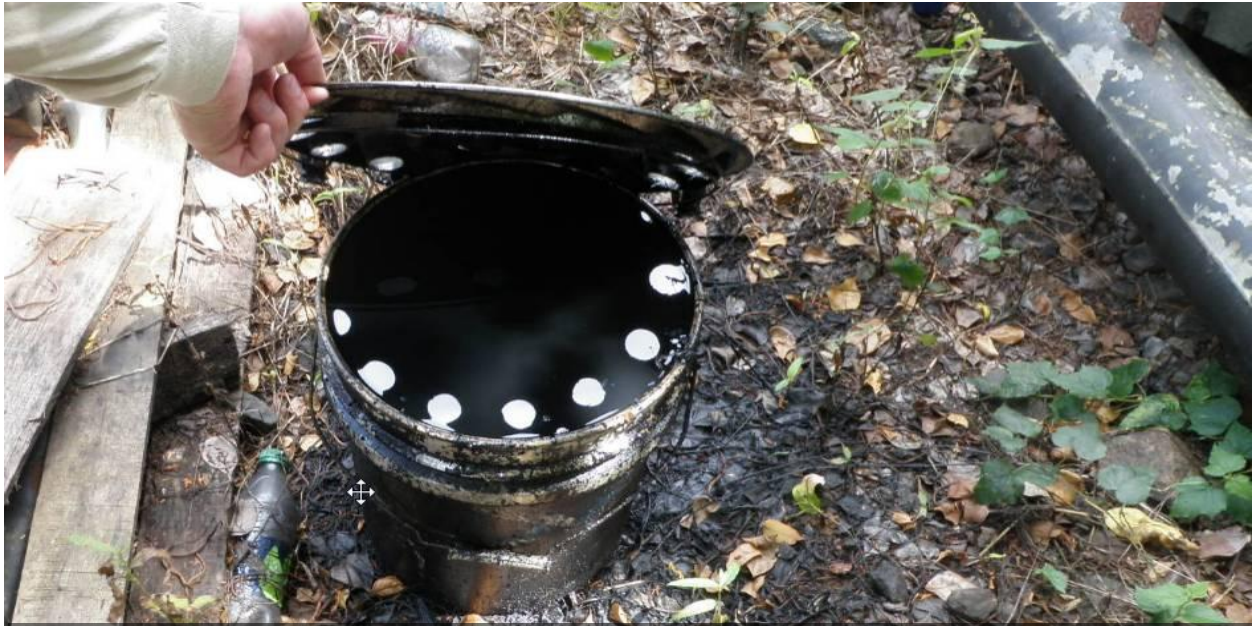
Overflowing buckets of used oil were found along the gut at locations where easy access allows for dumping and the abandonment of vehicular equipment.

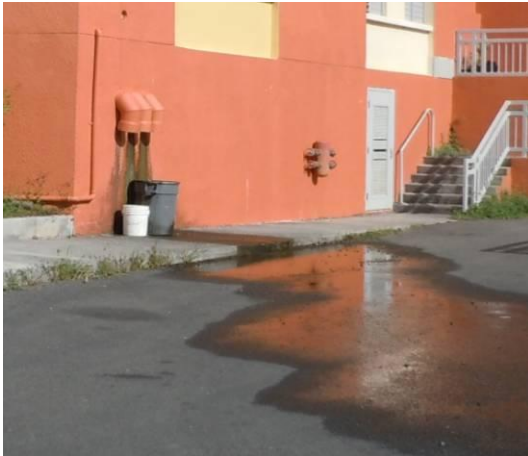
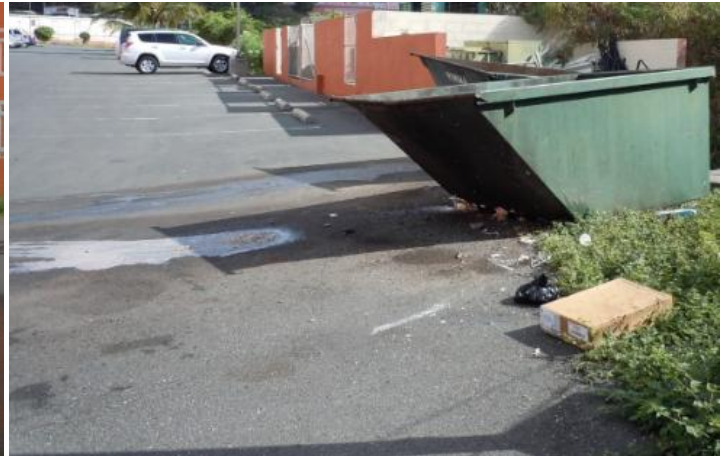
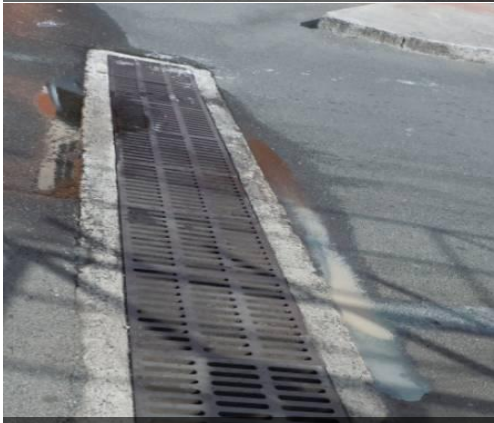
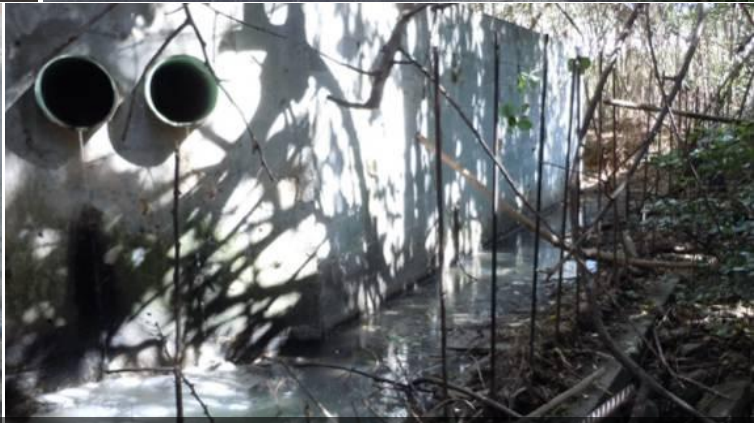
Unused cistern overflows, mop bucket waste, and dumpster juice at this site drain across the parking lot carrying pollutants into the storm drain system and discharging them downstream even when it is not

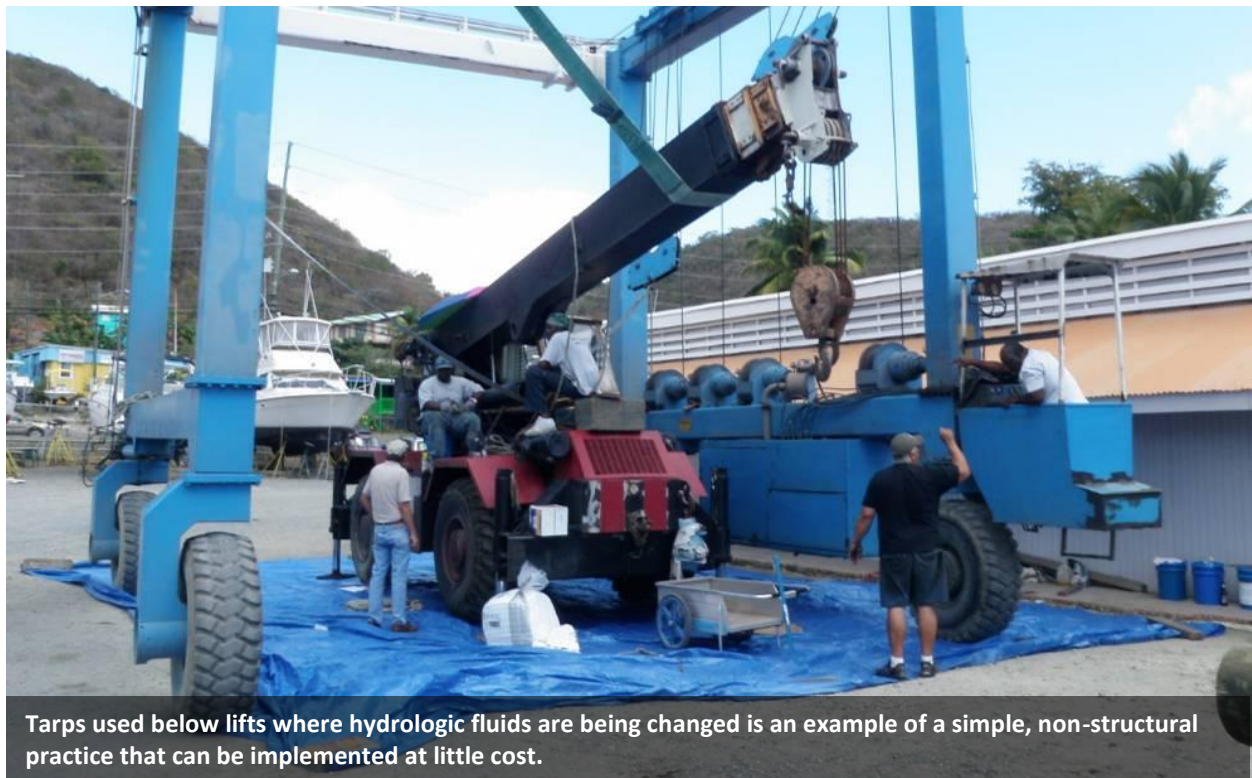
Tarps used below lifts where hydrologic fluids are being changed is an example of a simple, non-structural practice that can be implemented at little cost.

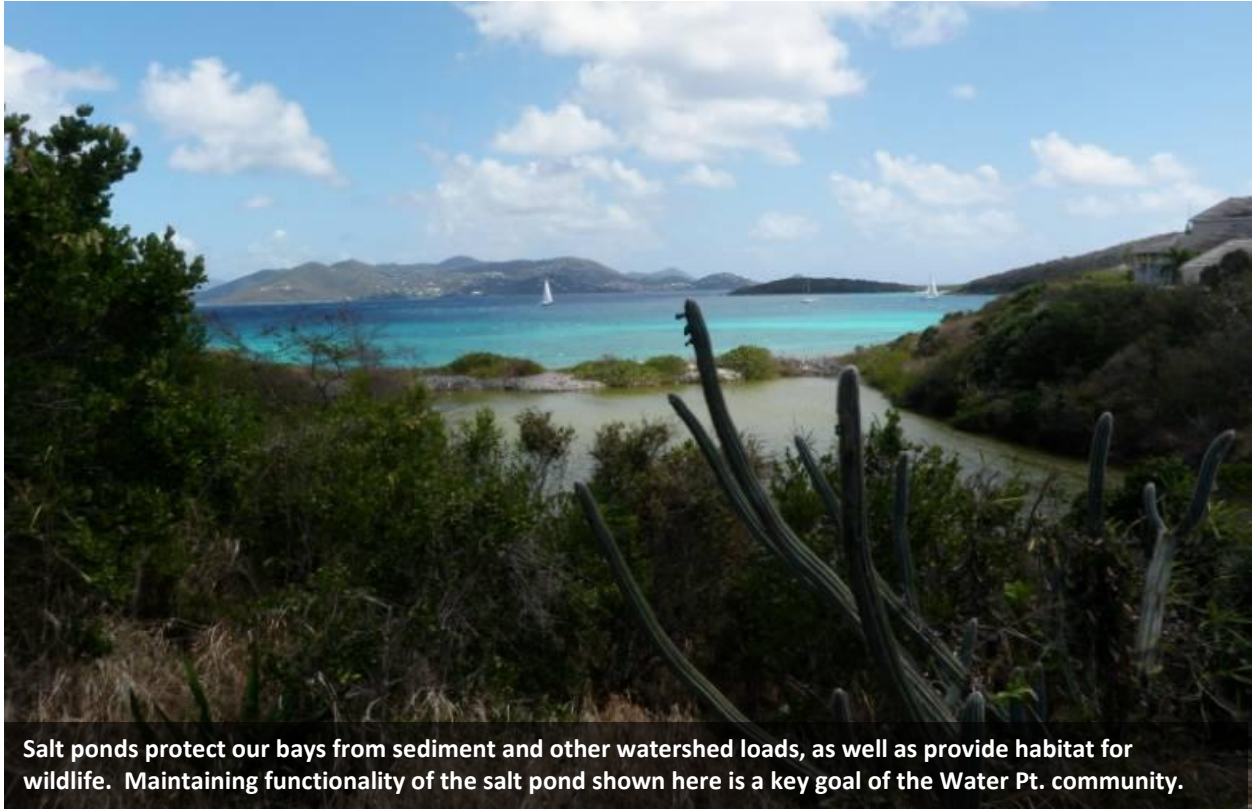
**Salt ponds protect our bays from sediment and other watershed loads, as well as provide habitat for wildlife. Maintaining functionality of the salt pond shown here is a key goal of the Water Pt. community.**

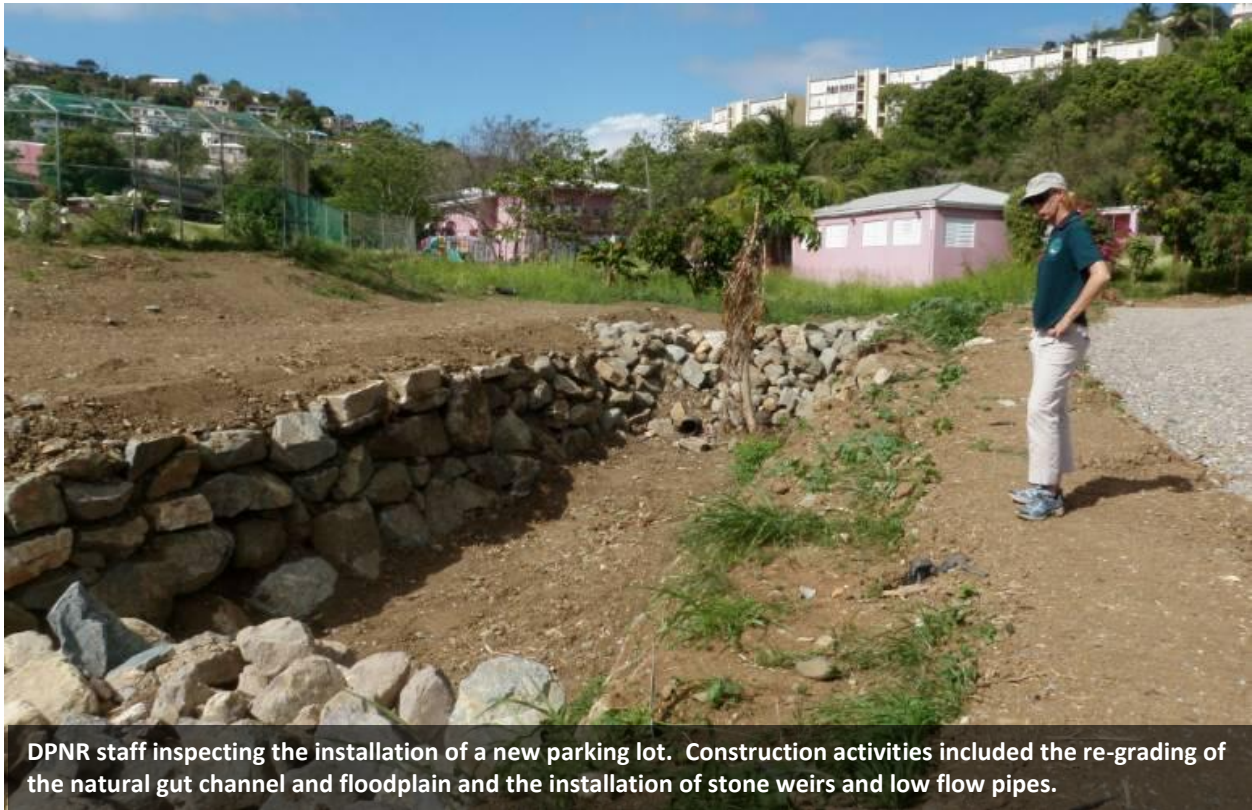
**DPNR staff inspecting the installation of a new parking lot. Construction activities included the re-grading of the natural gut channel and floodplain and the installation of stone weirs and low flow pipes.**

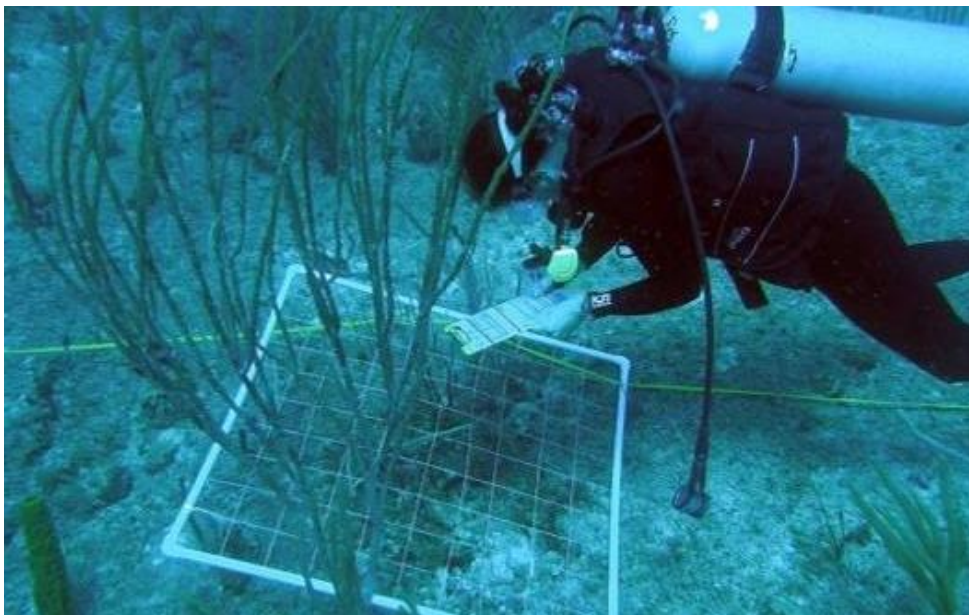
Biological characterizations of STEER included quantifying benthic habitat composition using quadrants (shown here), as well as establishing transects to document the abundance and diversity of fish, debris, and macro-invertebrates.

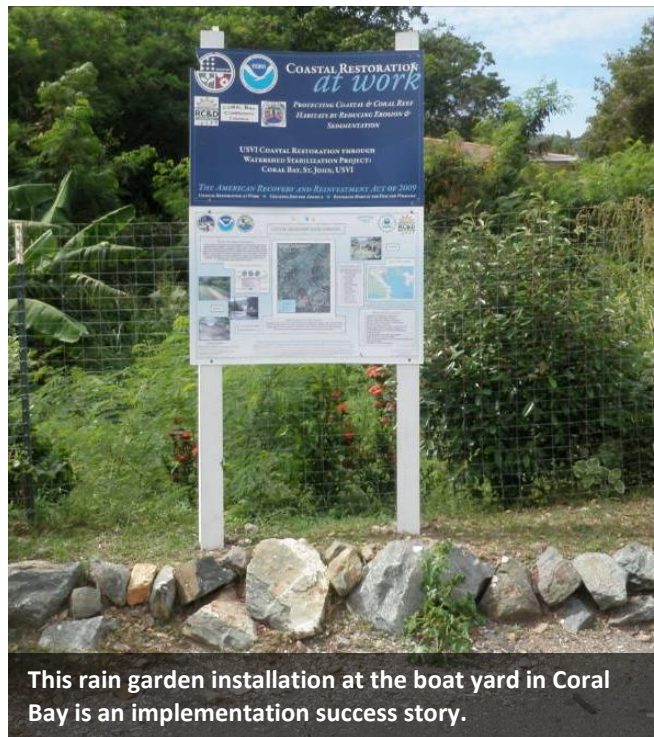
This rain garden installation at the boat yard in Coral Bay is an implementation success story.

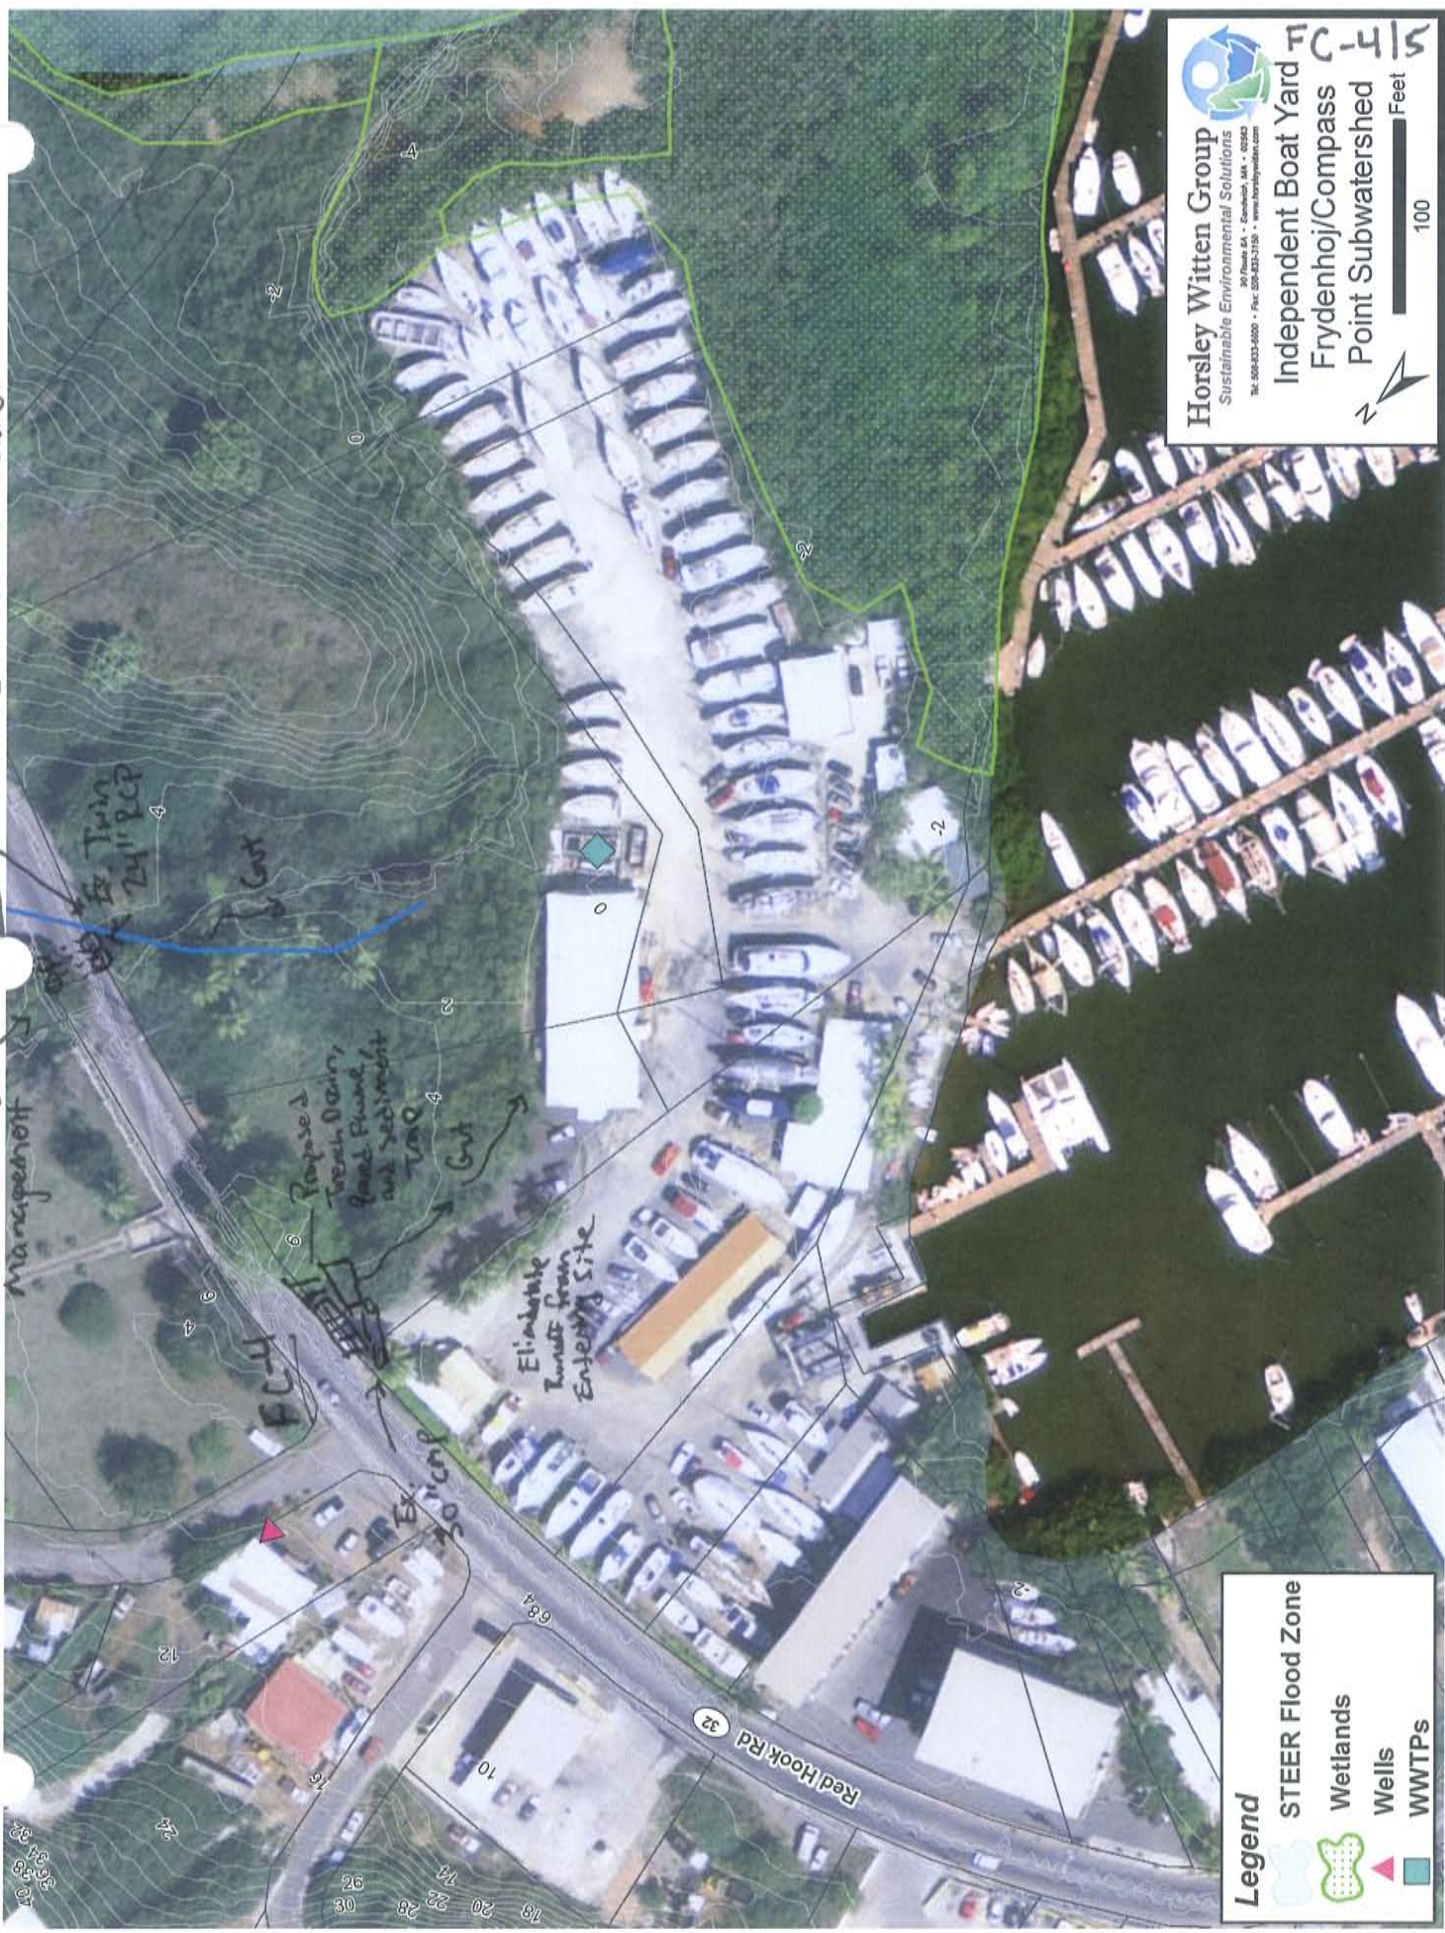
**Independent Boat Yard  
 Frydenhoj/Compass  
 Point Subwatershed**

Sediment, Trash, veg. Management

6-5 Stabilize Erosion Gullies
