NOAA Technical Note NCDC No. USCRN-04-2

Vibrating Wire Fall Protection Device for the USCRN Geonor Weighing-Bucket Precipita- tion Gauge

Vibrating Wire Fall Protection Device for the USCRN Geonor Weighing-Bucket Precipitation Gauge

March 2004

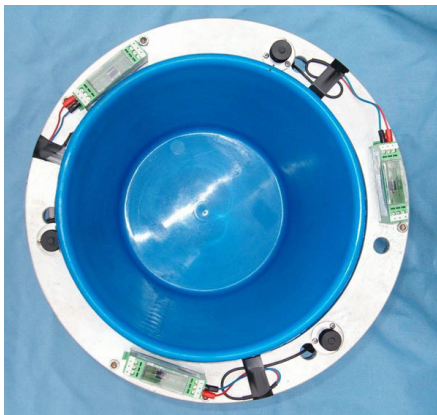
Figure 1: Geonor catch bucket from above.

A photograph of a Geonor catch bucket taken from above (Figure 1) shows the top of the three

vibrating wire load sensors (round, black objects) spaced 120 degrees apart around the collecting bucket, and the transducers' surge suppressors (in turquoise). A side view of the bucket (Figure 2) shows the vibrating wire casing (without the FPD suspending the bucket.) The sensor arrangement allows the weight of the bucket and its contents to be equally suspended by the three wires. The balanced suspension ideally results in an identical signal at all three sensors when the bucket is level. As the suspended weight increases, a corresponding change is induced in the harmonic frequency of each the three wires. A quadratic equation converts frequency to depth measurements⁷. From depth, a corresponding measurement of precipitation contained in the bucket is obtained.

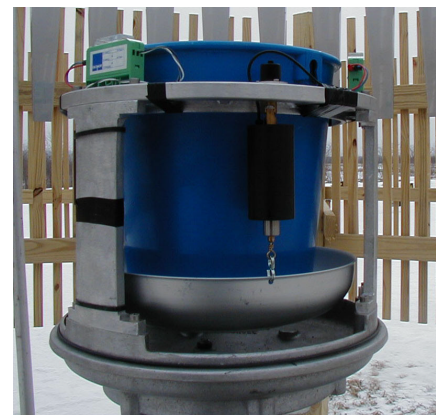
Figure 2: Geonor catch bucket from the side.

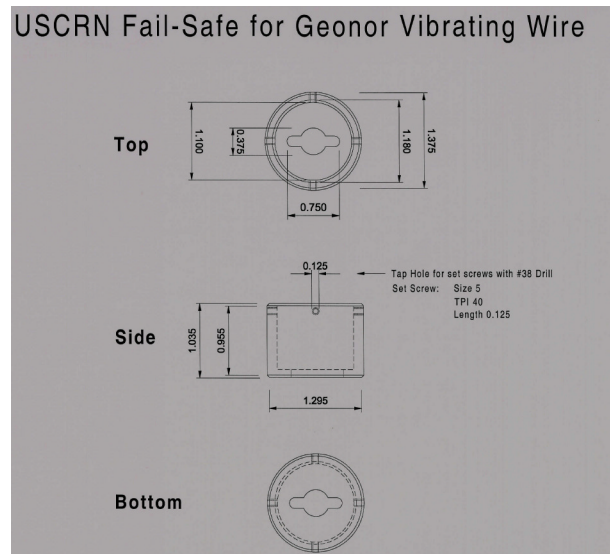
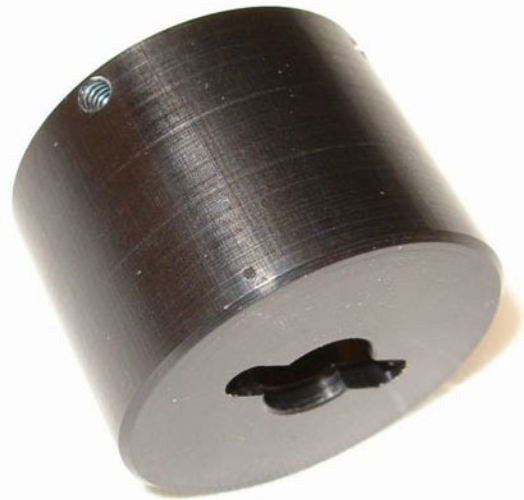
Figure 3: FPD schematic drawing (left) and FPD (right)

A schematic drawing and a photograph of the FPD are shown in Figure 3 (left and right, respectively). It is a simple, lightweight, aluminum collar that is fitted to the vibrating wire casing. The device was fabricated⁸ at a cost of \$10 per piece. In a close-up view of the wire casing, the small silver cylinder that is attached to the end of the vibrating wire is shown without the FPD and with the FPD installed, (Figure 4, left and right, respectively).

When a Geonor sensor wire breaks without the FPD, the cylinder falls, the balance of the catch bucket becomes uneven, and the two remaining sensors fail to accurately report depth. When a Geonor sensor wire breaks with the FPD, the silver cylinder is caught by the FPD. It drops no more than 1.4mm and the bucket tilts by approximately one degree. The FPD allows the two remaining wires to continue operating even if one wire breaks. This results in an accurate report to continue from the two remaining sensors.

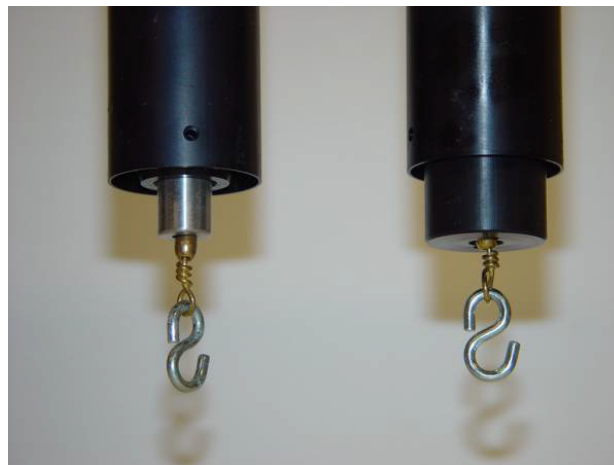
Figure 4: Vibrating wire without (left) and with (right) the FPD

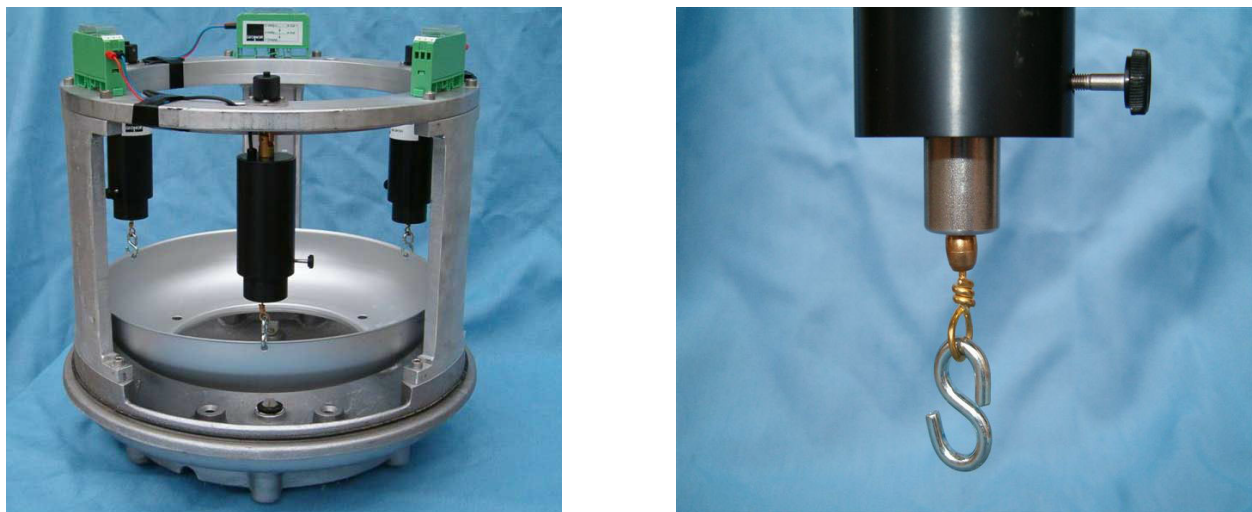
The Geonor gauge was calibrated using precision-machined stainless steel weights that self-center within the collection bucket, allowing for both calibration in the field as well as in the laboratory. Under laboratory conditions, weights were added to a Geonor gauge in 1000 g increments, where 1000 g is equal to 50 mm of rainfall. First, measurements were made while all three wires suspended the bucket normally. The depths calculated from the frequency of vibrating wires two (VW-2) and three (VW-3) were recorded as weights were added to the bucket. Next, to simulate a break in a wire, the adjusting set screw of sensor one (VW-1) was turned two turns counterclockwise, resulting in a 1.4 mm drop, and a bucket tilt of approximately one degree. After the turning of the screw, the two remaining wires suspended the bucket. Depths were again calculated from sensors two and three, taking measurements while adding weights incrementally. See Figure 5 for a view of the three wire suspension (left) and for a view of the set screw placement (right).

Figure 5: Three wire suspension (left) and set screw (left)

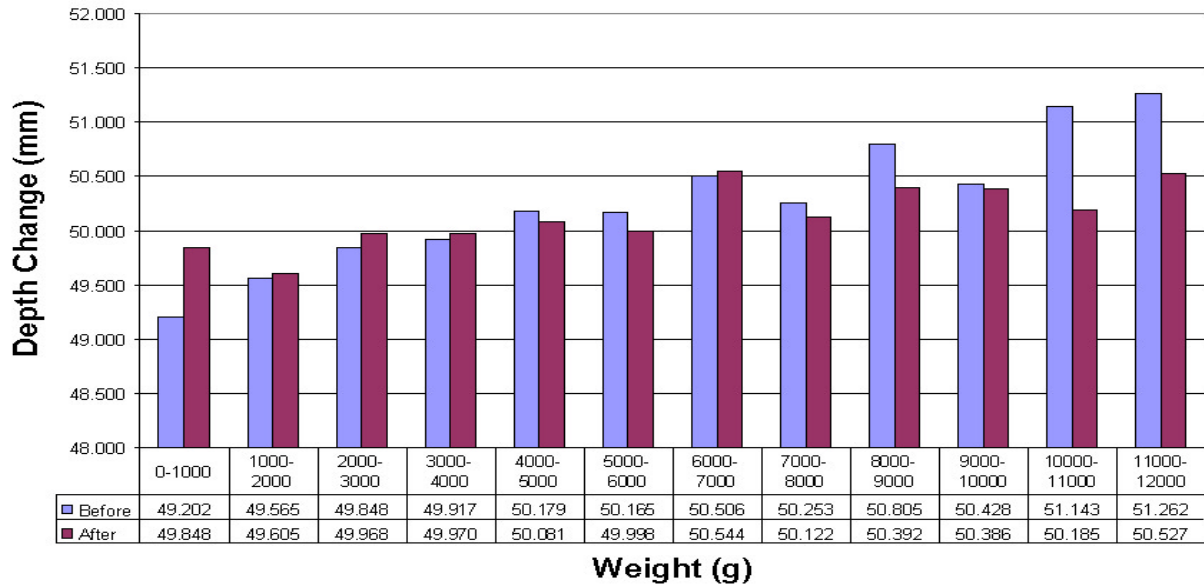
Depth Change Between Weights (Sensor 2)

to the depth change after the simulated break. These values are plotted in Figures 6 and 7 for sensors VW-2 and VW-3 (next page.) The blue bars represent the values before the break, and the magenta bars represent the measurements after the break. From these graphs, it is evident that the actual change in the calculated depth was very close to the theoretical value of 50 mm. This was true for both before and after the simulated break and true for both sensor VW-2 and sensor VW-3.

Figure 6: Sensor VW-2 change in calculated depth before and after simulated break of VW-1

10. USCRN USCRN Functional Requirements Document. NOAA/NESDIS CRN Series X040, NOAA-CRN-20030009R0UD0 (June 27, 2003), 13 pp, Section 3.2.5 page 6 Accuracy of the precipitation measurements, the greater of 0.25mm or 2% of the reported value. Therefore the required accuracy of the depth change at 1000g (the lowest level of the test) is 2.5 mm. At 12000g (the highest weight load of the test) the accuracy of the depth change is 12mm. See Figures 6 and 7.

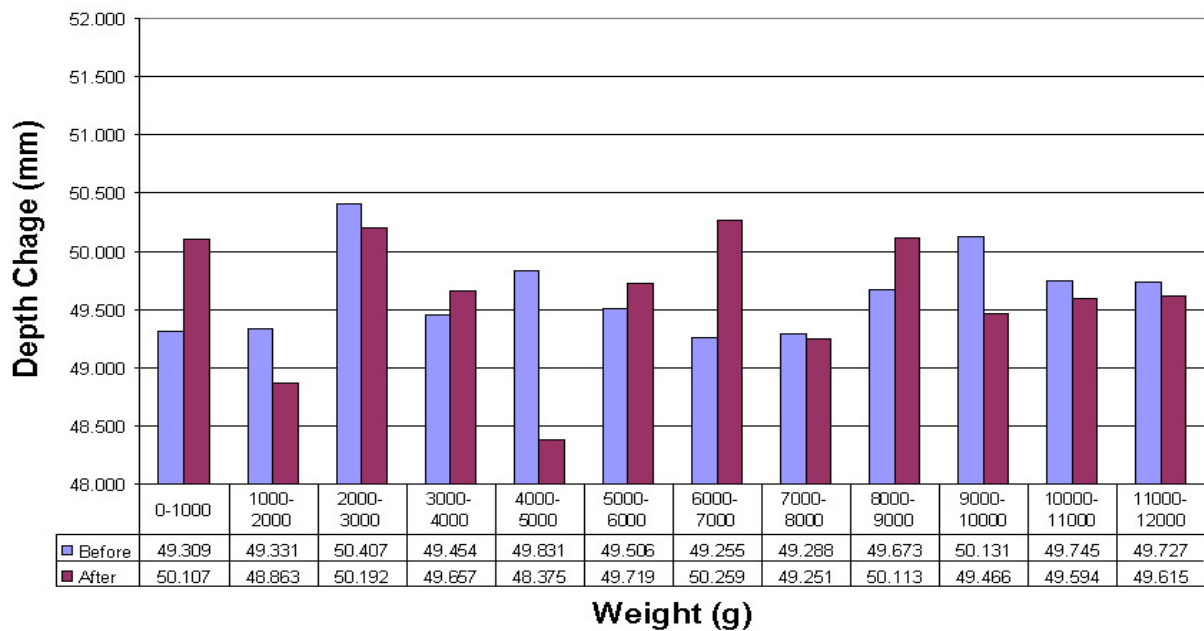
Depth Change Between Weights (Sensor 3)

Figure 7: Sensor VW-3 change in calculated depth before and after simulated break of VW-1

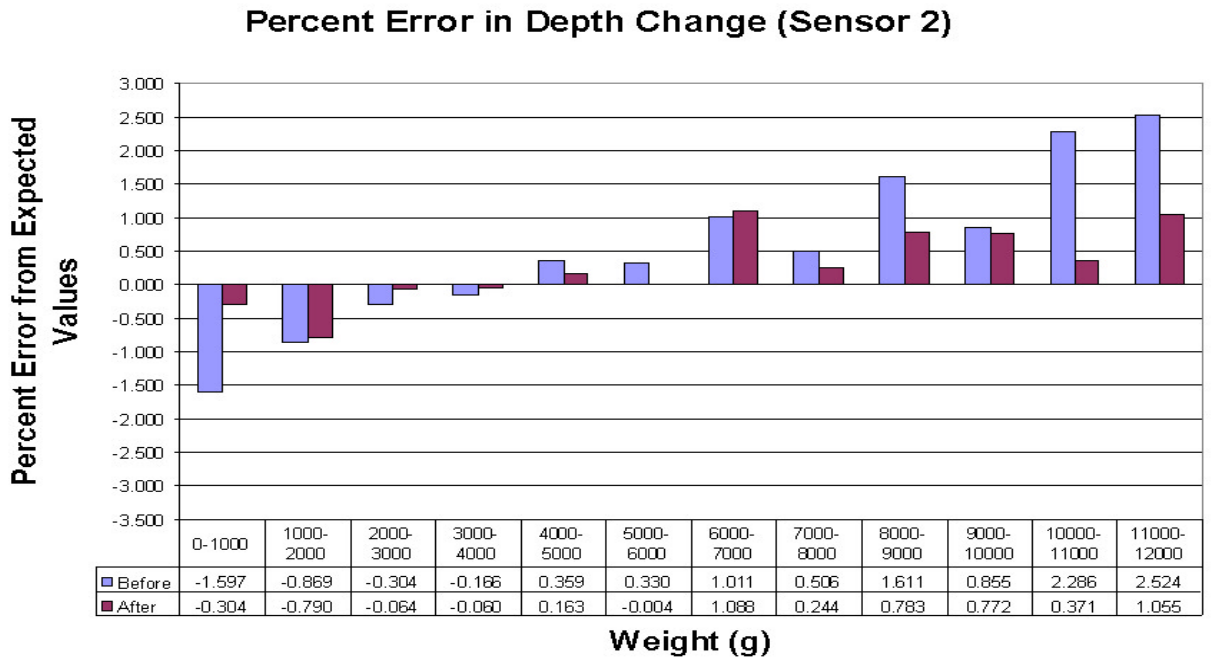
Next, the percent error in depth change was compared to the theoretical value of 50 mm, before and after the simulated break. This is shown in Figures 8 and 9 for VW-2 and VW-3, respectively (next page.) There was an error of less than 1% over much of the range of weights, both for wires VW-2 and VW-3. The error varied randomly with depth and was traceable to noise in the signal.

Figure 8: Percent error in depth change for sensor VW-2

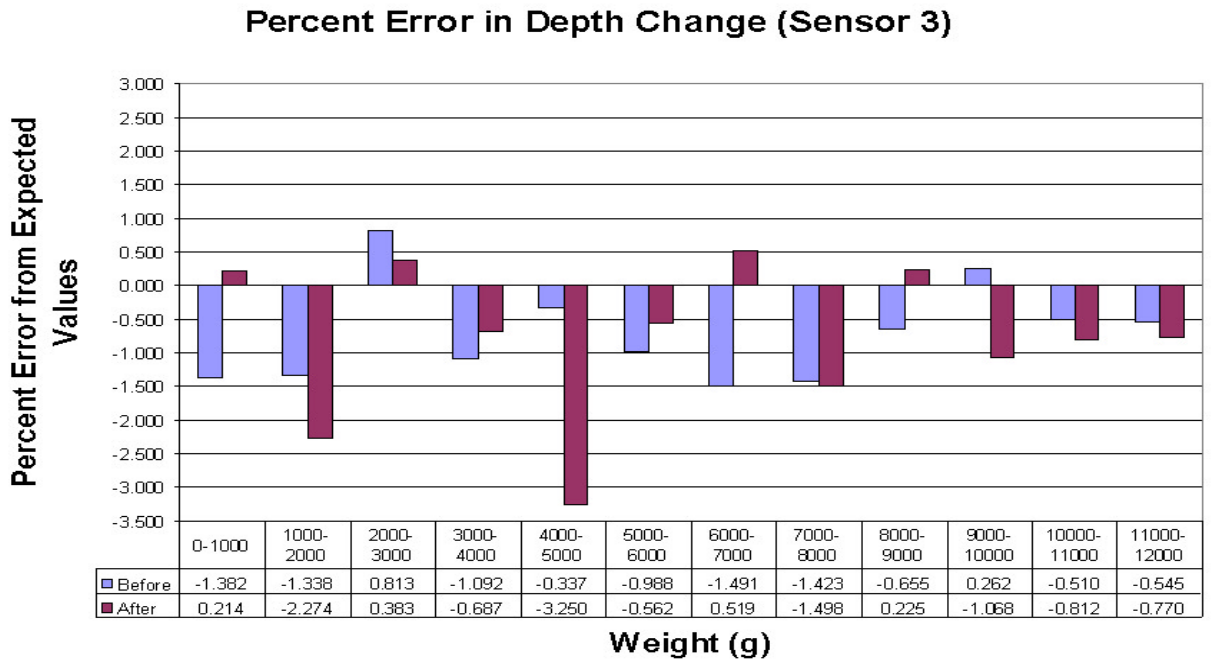
Figure 9: Percent error in depth change for sensor VW-3

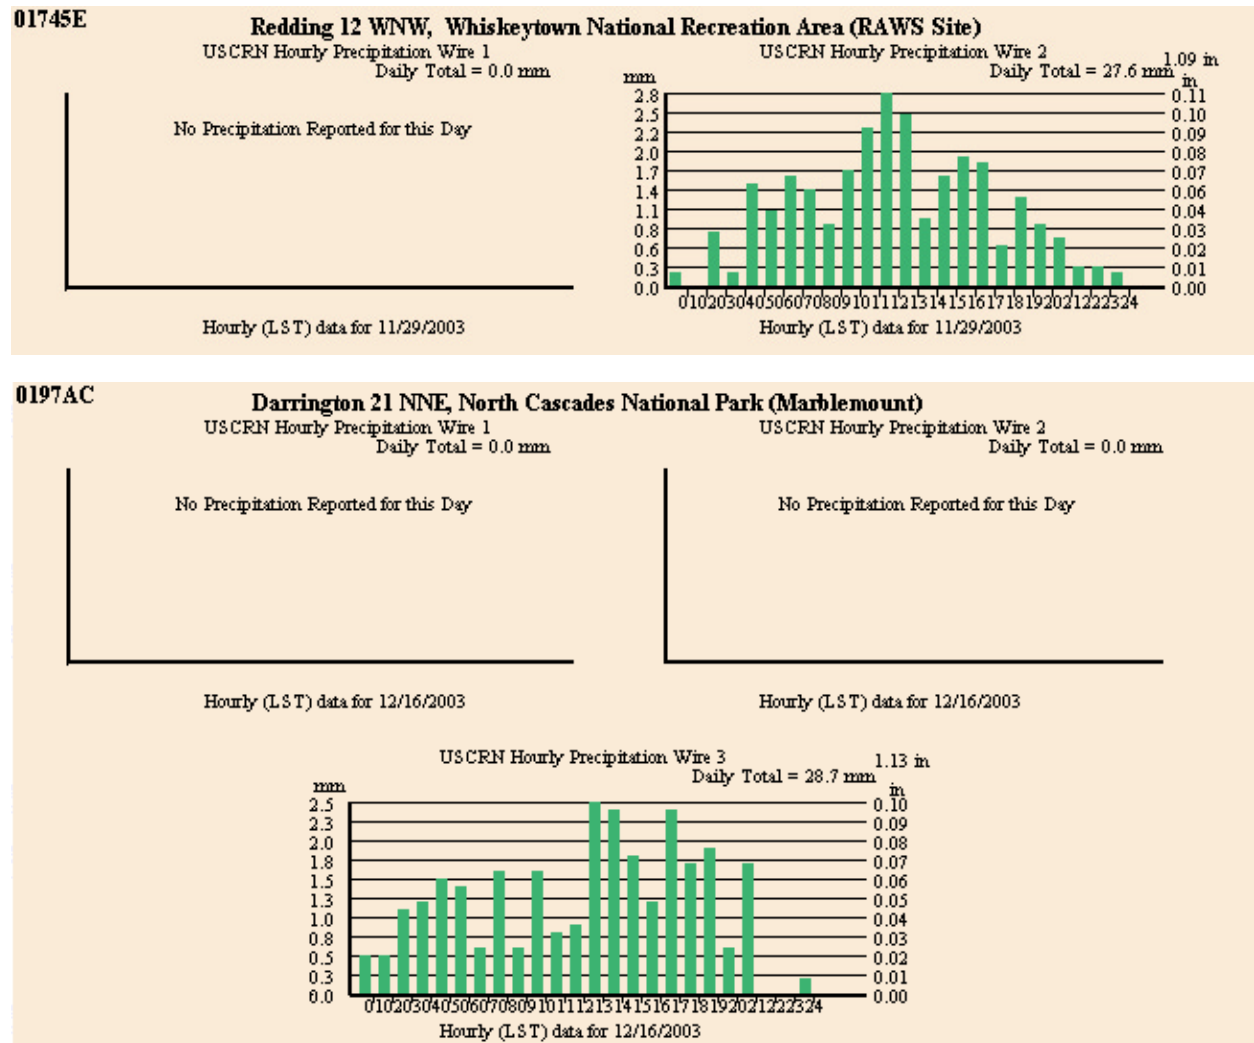
The Redding 12 WNW, CA, site had two broken wires on November 10, 2003, and was not equipped with a FPD. There were no valid precipitation data from the site at this point. The data logger transmitted null depth values (-6999) for VW-1 and VW-3. However, according to maintenance records recorded in the USCRN Anomaly Tracking System¹¹, a technician performed a temporary repair on November 19, 2003. The steel cylinder was re-inserted and the setscrews on each of the two broken wires were tightened (to hold the cylinder in place), and the bucket was leveled. At this point, the sensors were in a configuration similar to the laboratory experiment, although two broken wires had not been tested explicitly in the laboratory. (The factory configuration of the Geonor gauge is to measure with a single wire.) Following the technician's temporary repair, 500 ml of water was added to the gauge to verify that VW-2 recorded the depth changes accurately and that the sensor would record precipitation. Figure 10 (next page) shows the precipitation plot for November 29, 2003, at Redding as calculated from the depth readings of VW-2. Total daily precipitation amounted to 27.6 mm or 1.09 inches. The Redding Airport¹² measured 0.92 inches for the day. The USCRN site is located 12 miles northwest of the airport in the Whiskeytown National Recreation area and is co-located with a RAWS sites. Using ancillary data, such as radar data, it would appear that the one wire at the Redding USCRN recorded precipitation accurately. The sensors were later replaced on December 3, 2003. During this maintenance visit, it was noted that the RAWS station itself was not functioning and was repaired.

The Darrington 21 NNE, WA, site had two broken wires on the morning of December 15, 2003, and was not equipped with a FPD. The depth values on the broken wires went from 155 mm to null (-6999). Later that same day, according to ATS maintenance records, a technician performed a temporary fix, just as was done at Redding. It was further recorded in ATS that the remaining wire (VW-3) was sensing precipitation in a nominal fashion, based on the displayed Seattle radar data. Figure 11 shows light precipitation at Darrington 21 NNE, WA recorded the following day, December 16, by VW-3. 2003. The sensors were later repaired on December 22, 2003.

Figure 10: Precipitation plot for Redding 12 WNW, CA, on Nov. 29, 2003 (top)

Figure 11: Precipitation plot for Darrington 21 NNE, WA, on Dec. 16, 2003 (bottom)

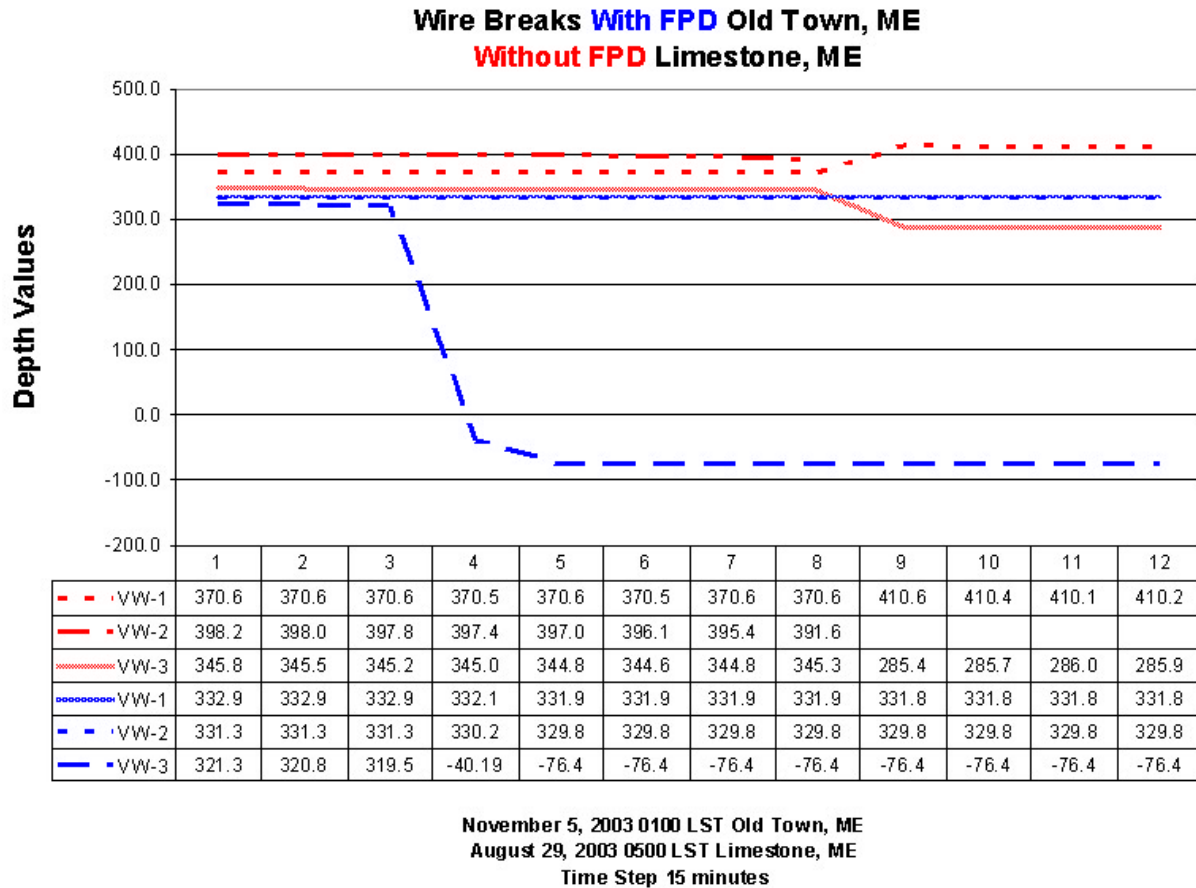
The second analytical step is to examine depth data from two stations having one broken wire, but one station is equipped with the FPD. Depth values reported from each of the three wires at both stations are shown in Figure 12 on the following page. The depth values reported from stations with and without FPDs during a wire breakage are compared. At Limestone, ME, VW-2 broke on August 29, 2003, well before the installation of a FPD. The broken wire reported null values after the break. The depth values from the two remaining wires diverged, reporting erroneous precipitation values as

the bucket tilted out of balance. At Old Town, ME, VW-3 broke on November 5, 2003. The FPD had been previously installed October 18, 2003. The depth values reported from the broken wire decreased rapidly and then leveled off to a constant negative value. The depth values from the two remaining sensors were steady.

Figure 12: Depth values from Limestone and Old Town, ME

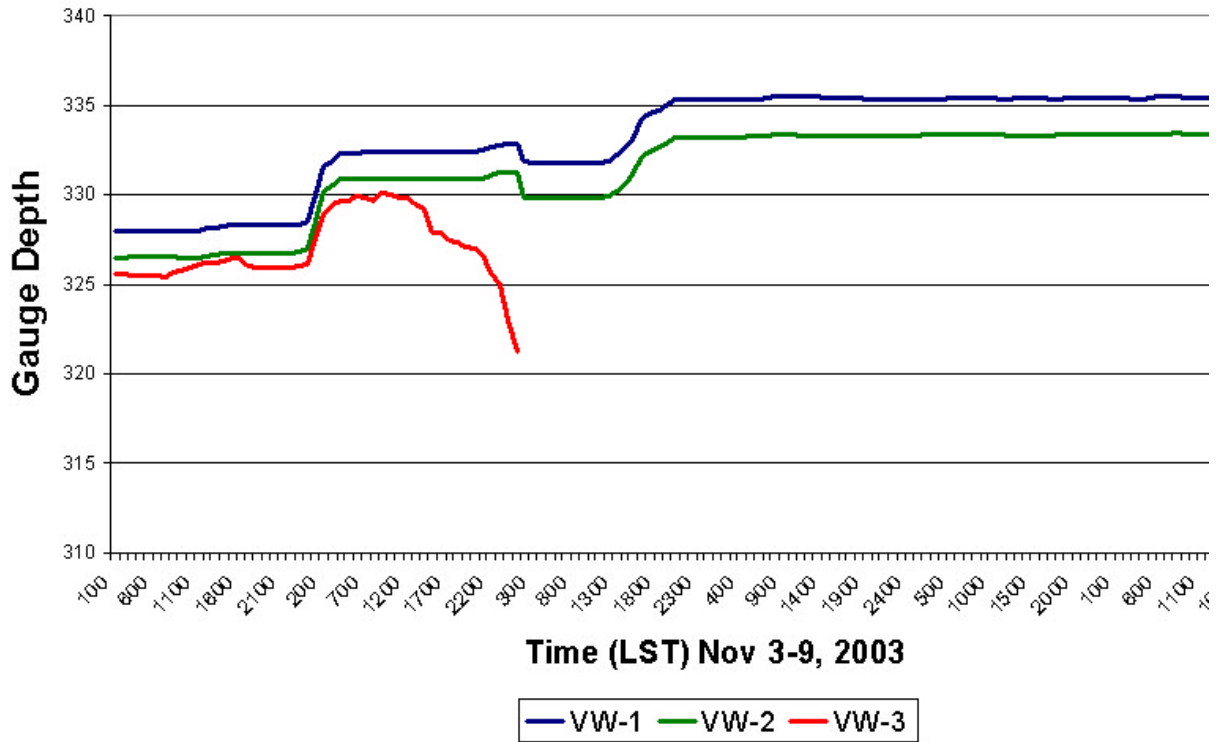
Broken Wire Example Old Town, ME

A zoom view of the depth values at the time of the break at Old Town is shown in Figure 13 (next page.) The values for VW-3 were not plotted after the break in order to keep the graph to scale. Note the rise in the depth curves for the remaining two wires. Light precipitation at Old Town on November 5, 2003, was verified. The values of the VW-1 and VW-2 depths and resulting precipitation are plotted in Figure 14 (left and right, page 11.) The plots appear to be identical. A few days later, on November 20, 2003, heavier amounts of precipitation occurred. Precipitation plots from the remaining two wires at Old Town are shown in Figure 15 (page 11.) The precipitation values derived from the depth measurements from VW-1 and VW-2 show good agreement.

Figure 13: Depth values at the time of the break at Old Town, ME

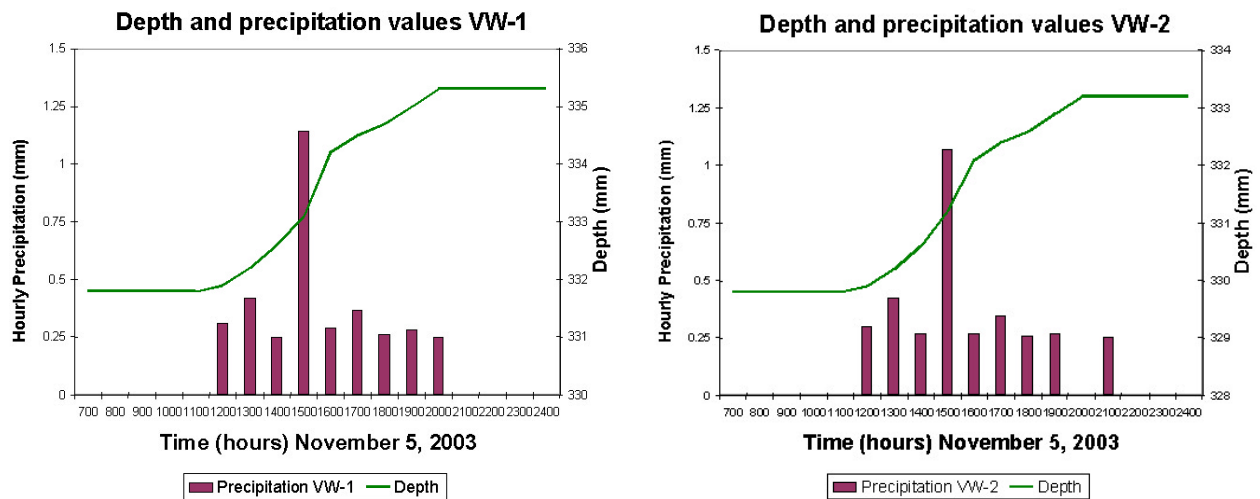
Broken Wire Example Old Town, ME

Figure 14: VW-1 (left) and VW-2 (right) depths and resulting precipitation.

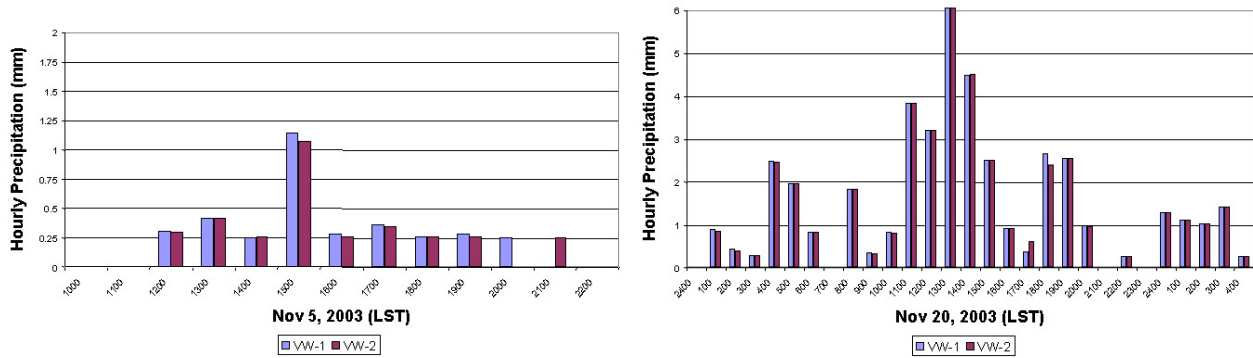
Old Town, ME, Precipitation Measurements with FPD, One Broken Wire

Figure 15: Precipitation values for Old Town sensors VW-1 and VW-2 on Nov. 5, 2003 (left), and Nov. 20, 2003 (right.)

To statistically compare the values of the VW-1 and VW-2, a Student T test was performed on both the light and heavier precipitation events at Old Town. For this test, the 15-minute precipitation values of precipitation were used in order to increase the number of samples (and degrees of freedom). Results in Table 3 (below) show that the measurements differences between VW-1 and VW-2 were insignificant in each of the events. No Tipping Bucket gauge was installed at Old Town, ME.

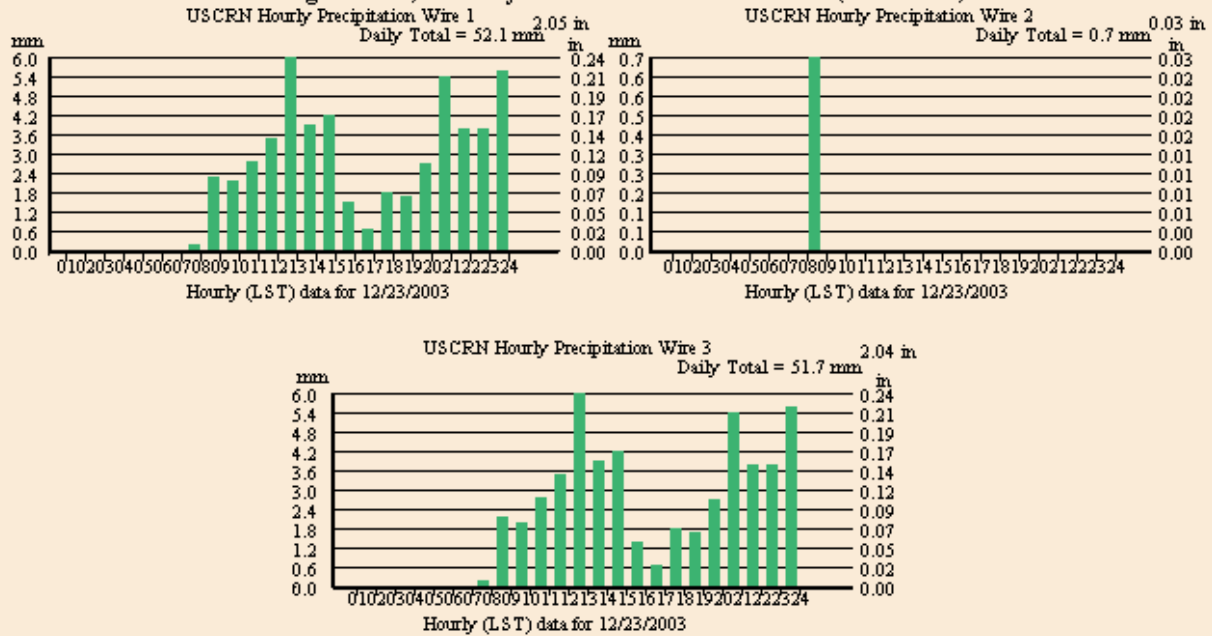
The sensors at Redding 12 WNW, CA, had been fitted with FPDs on December 3, 2003. After this, VW-2 broke during a precipitation event on December 23, 2003. According to ATS records, repairs to that sensor did not occur until January 16, 2004. Two precipitation events between that single wire break and the repair were examined, moderate precipitation on December 23, 2003 (see Figure 16, next page) and light precipitation on January 8, 2004 (see Figure 17, next page.) A student T test was performed on the 15 minute values of precipitation of both events (see Table 3.) The differences between VW-1 and VW-3 were insignificant. Total precipitation in the time period was measured at 85.8 VW-1 and 85.3mm VW-3. The Tipping Bucket Gauge installed at Redding measured 81.8 mm for the same time period.

Figure 16: Redding 12 WNW, CA, hourly precipitation for VW-1, VW-2, and VW-3 (clockwise from top left) on Dec. 23, 2003.

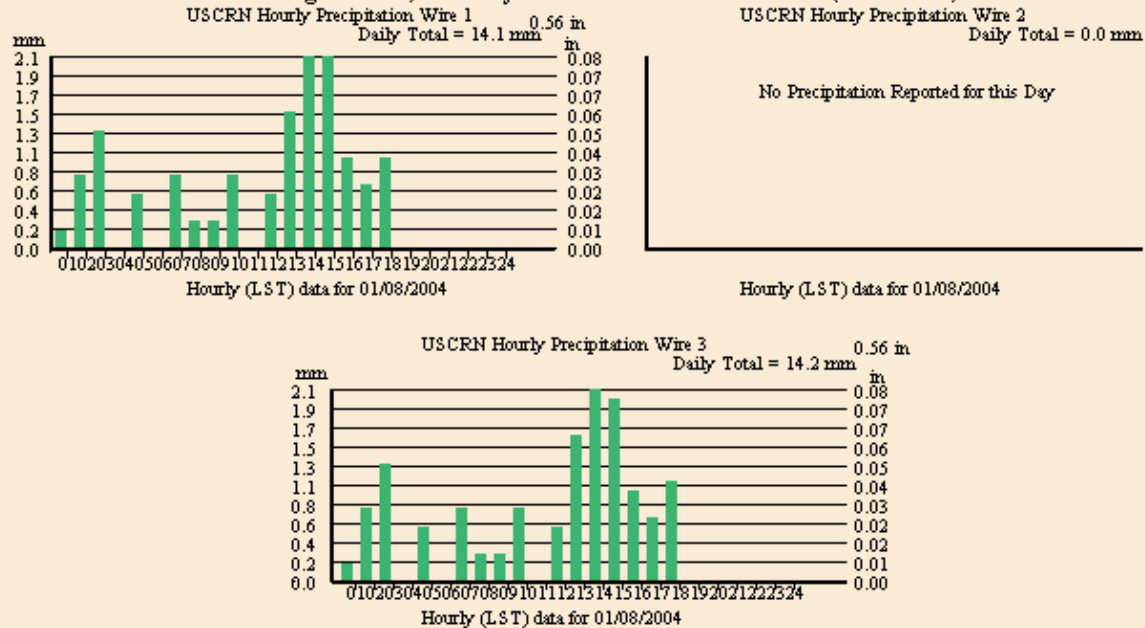
Figure 17: Redding 12 WNW, CA, hourly precipitation for VW-1, VW-2, and VW-3 (clockwise from top left) on Jan. 8, 2004.
