### 3.0 Southgate Watershed

#### 3.1 General Description

### 3.2 Potential Watershed Restoration/Project Sites

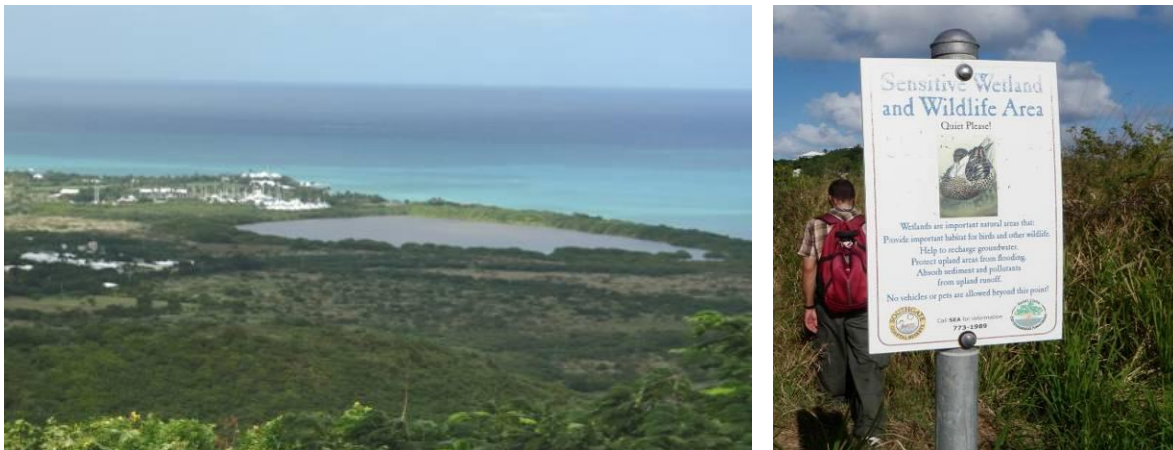
**Figure 3.1.** Southgate Pond and Reserve, an ecologically sensitive wildlife area managed by the St. Croix Environmental Association.
