5.0 Teague Bay Watershed

5.2 Potential Watershed Restoration/Project Sites

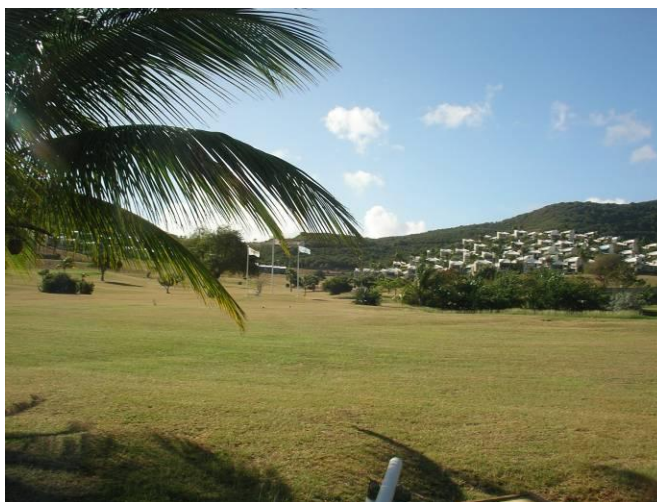
Roadways within the condominium complexes are entirely paved and curbed and in good condition. Road runoff is diverted through gutters and catchments to the ponds within the fairway, along with all roof runoff, which is piped from the gutters through an underground drainage network to the ponds. There is a small gravel parking area at the outdoor pool at the Section 2 condos. Average lot cover is approximately 20% turf, 25% landscaping, 40% rooftop, and 15% driveway and walkways. All sewage is directed to an on-site small package treatment plant located on the north side of East End Rd., immediately east of Duggan’s Restaurant. This residential community is not a source of pollutants and/or sediment and no recommendations are suggested.

Figure 5.7. View of Section 2 condos from golf fairway.
